## STATE OF CONSERVATION REPORT

### PROPOSED WORKS AT THE IMPERIAL STEEL WORKS, JAPAN, AND ONGA RIVER PUMPING STATION— COMPONENT PARTS OF THE *SITES OF JAPAN'S MEIJI INDUSTRIAL REVOLUTION—IRON AND STEEL, SHIPBUILDING AND COAL MINING.*

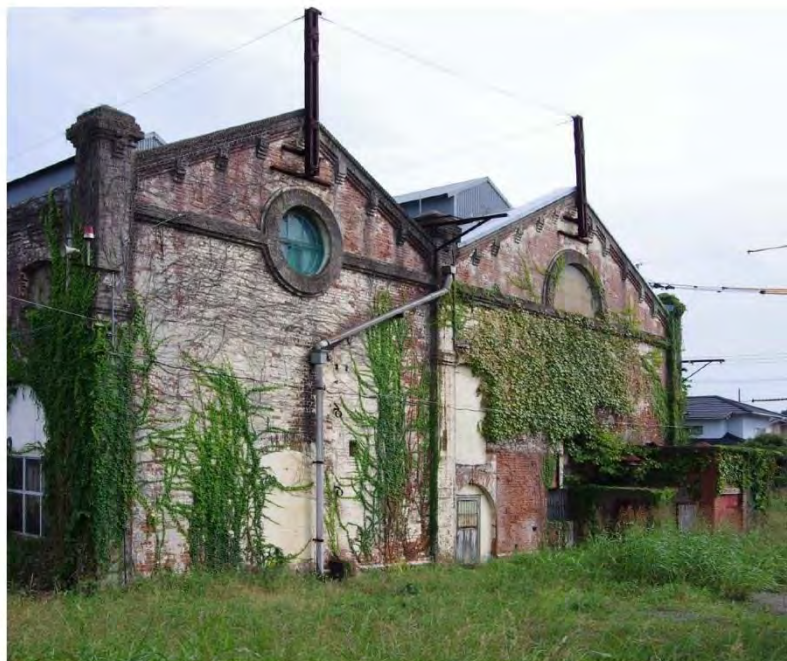
【Onga River Pumping Station (West)】 Before repair works

Over recent years a number of window openings have been overlaid with metal to prevent collapse of the window frames, and some window frames have been replaced with aluminium frames. The proposal is to remove this overcladding and metal framing, and restore or replace as necessary the timber window frames and glass.
