# State of Conservation Report

Sites of Japan's Meiji Industrial Revolution:

Iron and Steel, Shipbuilding, and Coal Mining (Japan) (ID: 1484)

**CABINET SECRETARIAT  
JAPAN**

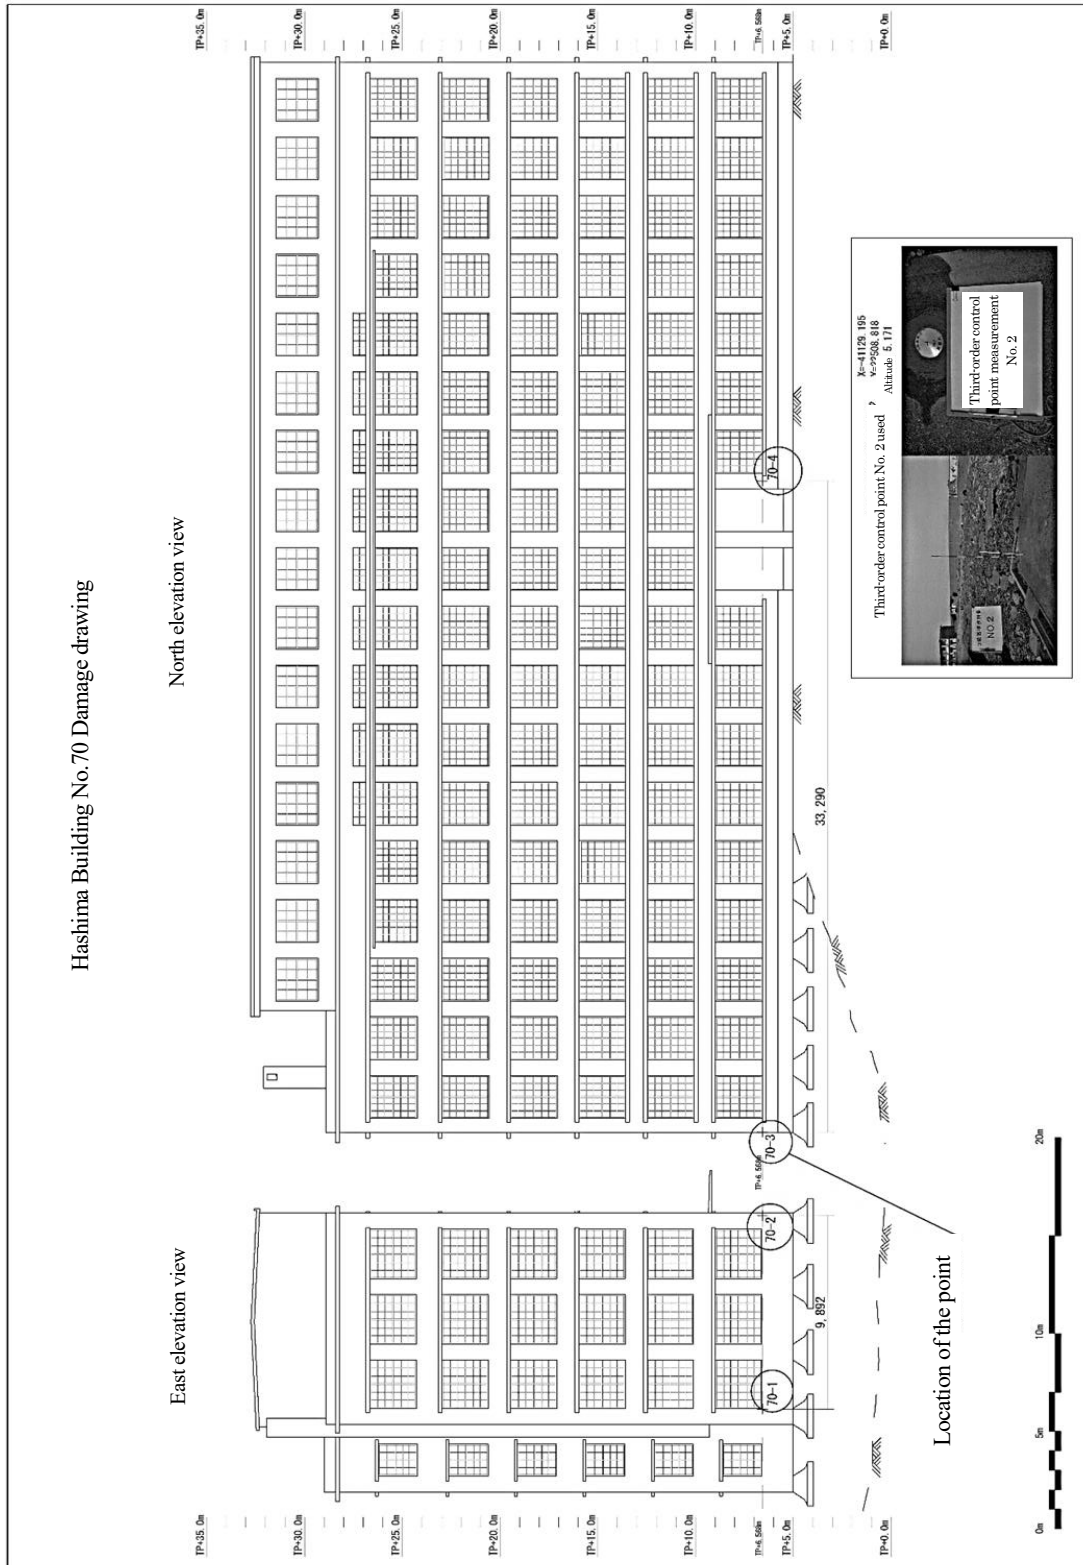
Figure 2-4-58 Building No.70 Deformed state drawing

The deformed state drawing (damage drawing) that reflects the two measurements and the three-dimensional laser measurement is shown in Figure 2-4-58.

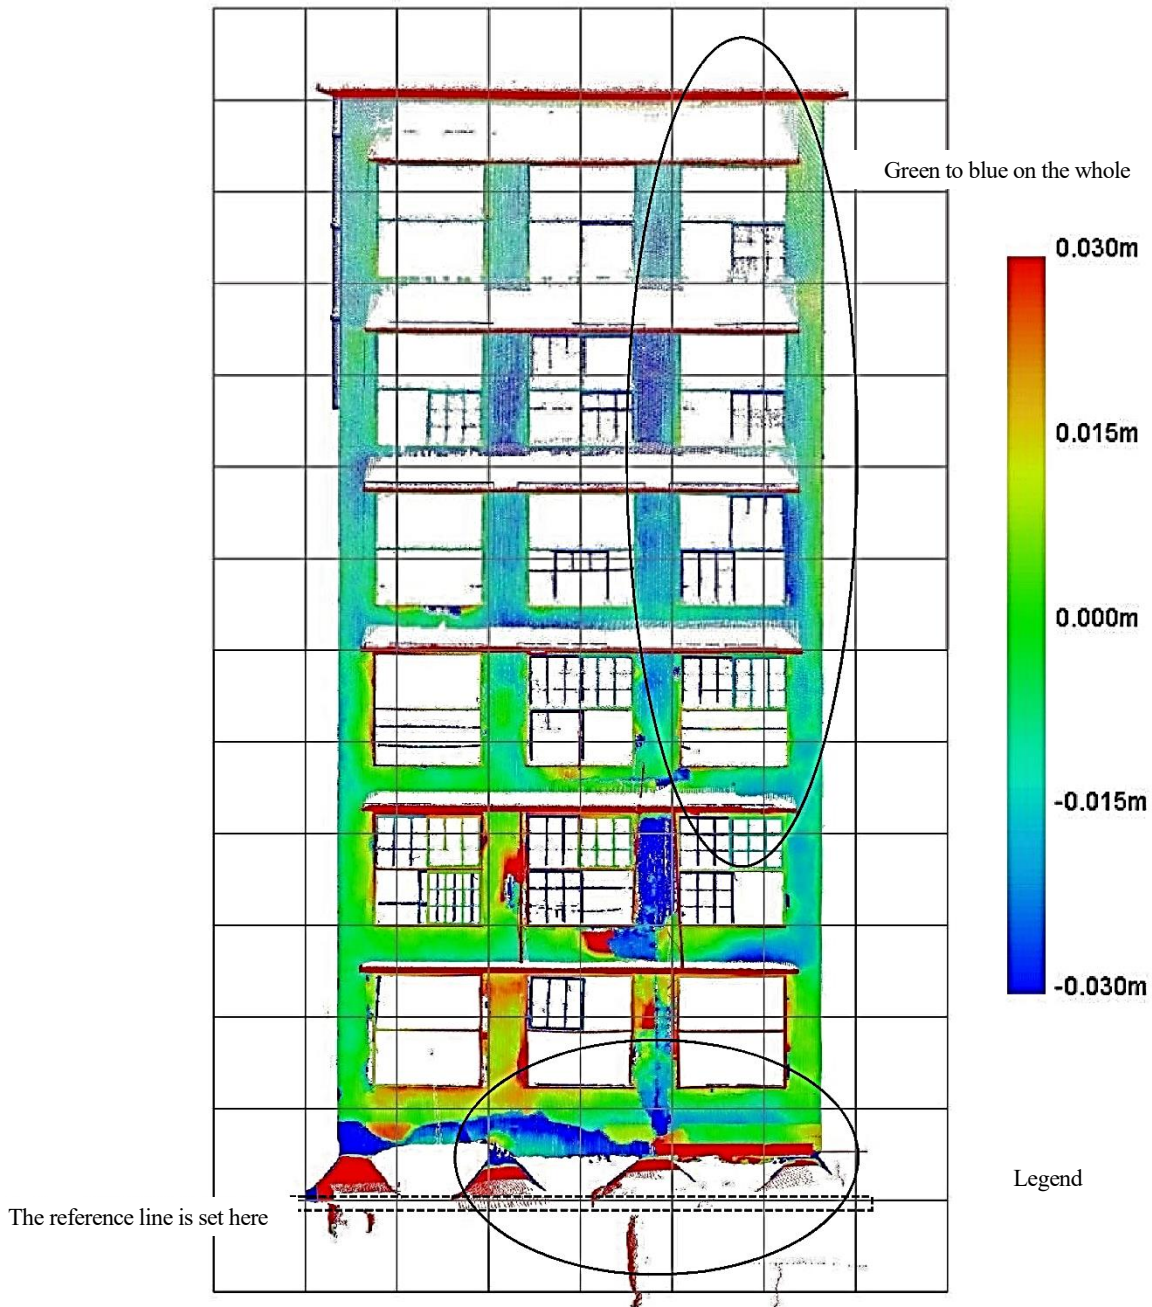
Figure 2-4-59 Building No.70 east face color contour drawing ( $\pm 30$  mm)

Figure 2-4-59 shows the displacement of a wall surface from a plane vertical to a reference line, which is set below the window on Level 1 of the east face of Building No.70, using colors. As the legends show, the green color is used as a reference, while the red and blue colors indicate the groups of points measured on the wall surfaces 30 mm front and 30 mm back of the reference plane, respectively. It should be noted that measurements were conducted only from the ground this time, and accordingly, the point density is low in the upper areas. Observation of measurement results show the upper areas exhibit colors closer to blue, suggesting that wall surfaces are at the back of the reference plane. However, because only Level 1 strongly shows a green to red color, Level 1 appears to project to the east side by 15–20 mm compared with Level 2 and upper floors.

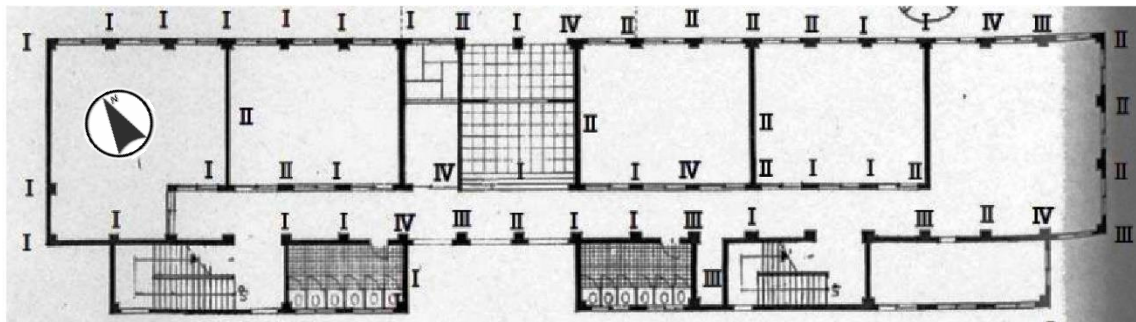
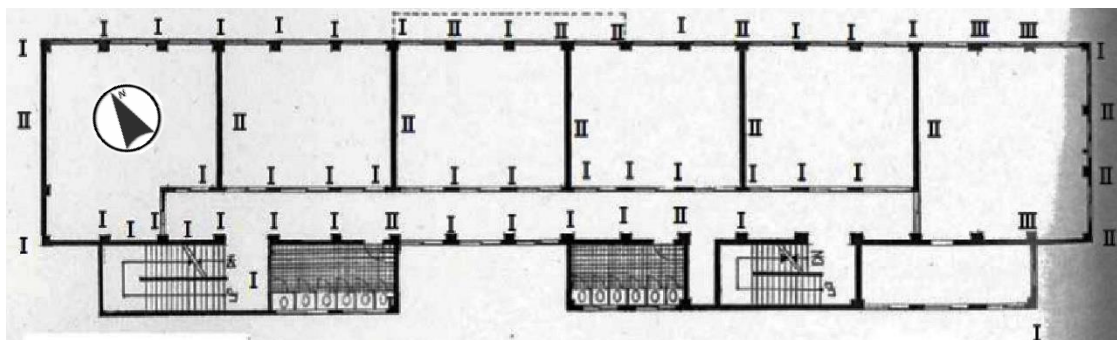
Figure 2-4-62 Building No.70 damage degree determination result (Level 1 and Level 2)

Building No.70 damage degree determination result (Level 1)

Building No.70 damage degree determination result (Level 2)

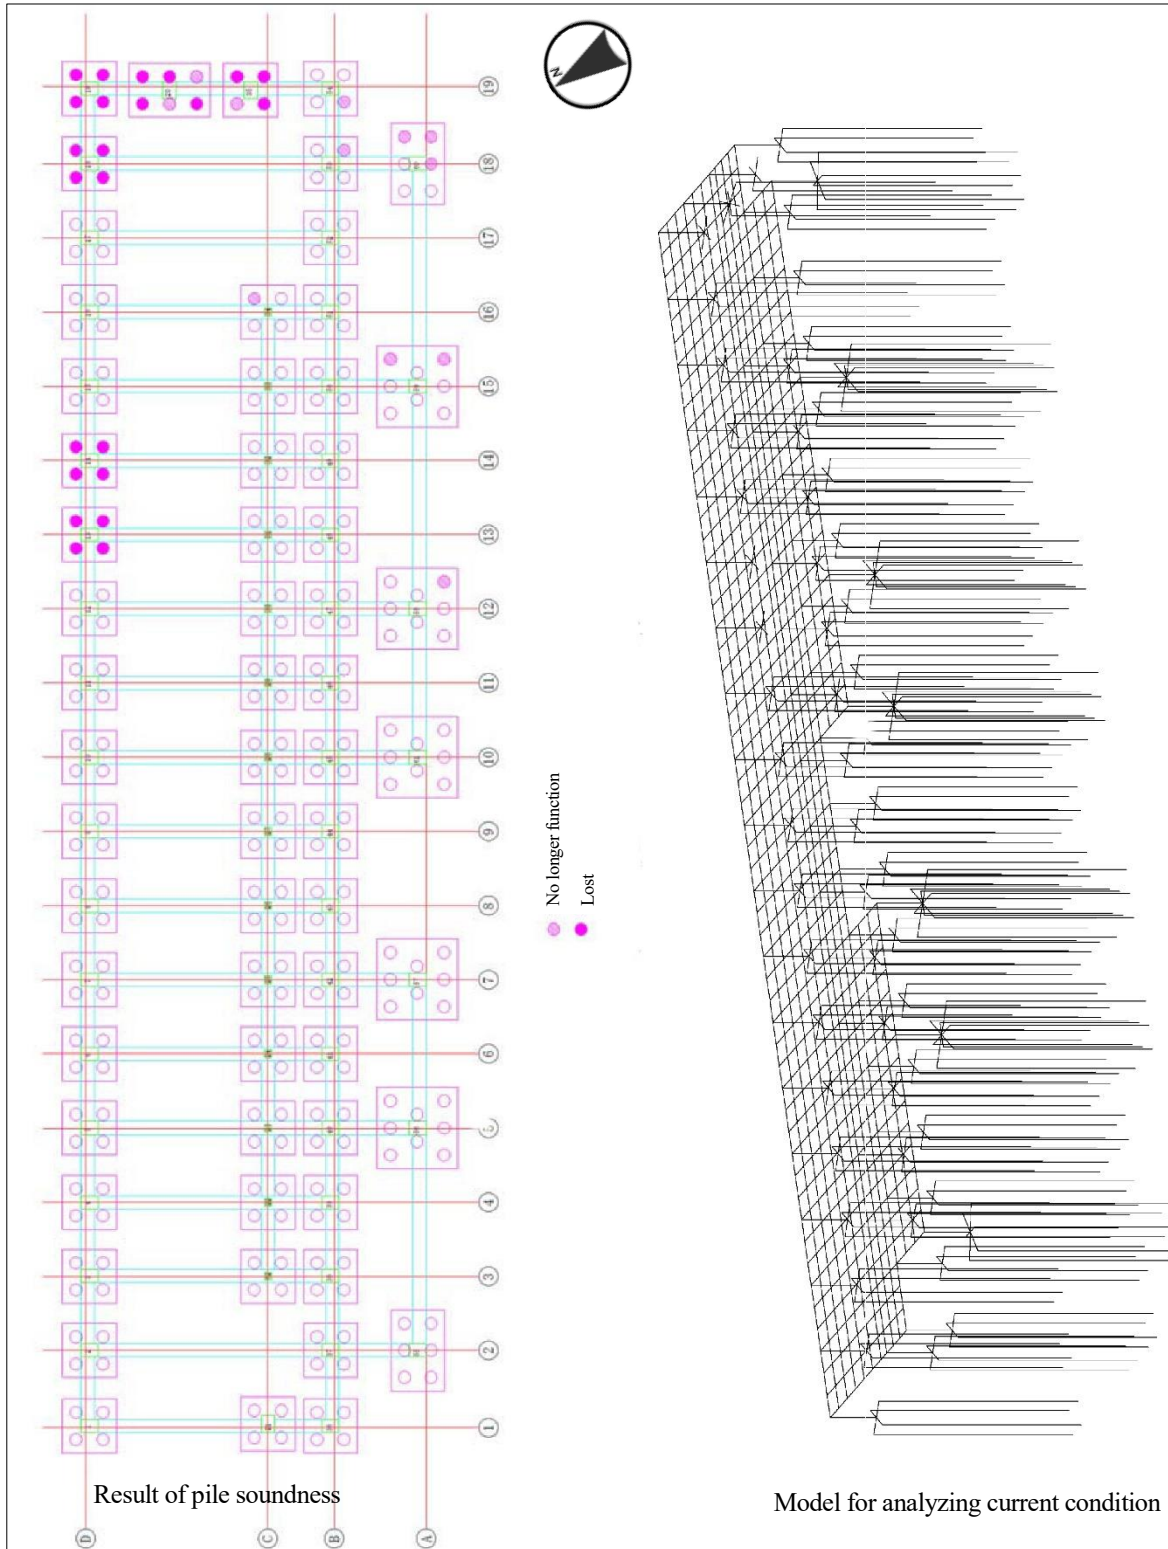
Figure 2-4-67 Result of pile soundness / Model for analyzing current condition

Figure 2-4-67 shows the result of pile soundness. On the basis of the result of pile soundness, piles that have been lost and that no longer function were excluded from the model for analyzing the construction at the time of completion, and a model for analyzing the current condition was created. The analysis and checking of the current condition at the normal time were performed by considering only the fixed load because no people enter and thus the live load can be ignored. The items checked and results of checking are shown in Tables 2-4-64 to 67 and Figures 2-4-68 to 70.

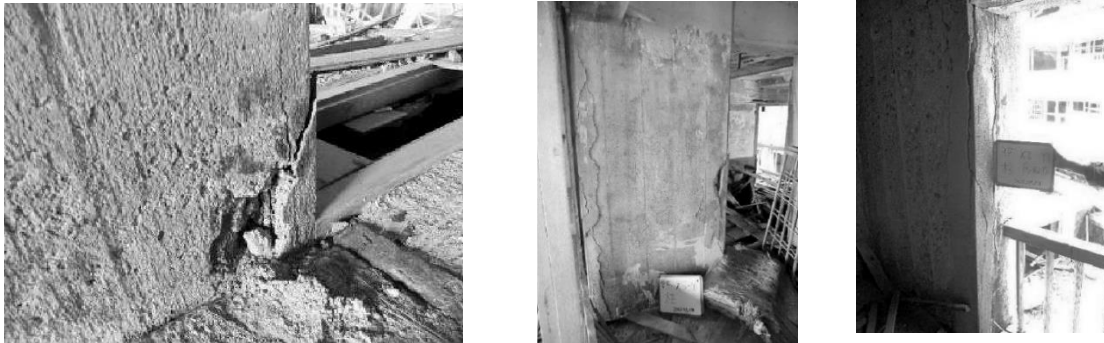
Photo 2-4-119 Deterioration level II

The condition in which there is a boundary crack between rebar and concrete, and slight bond deterioration is seen.

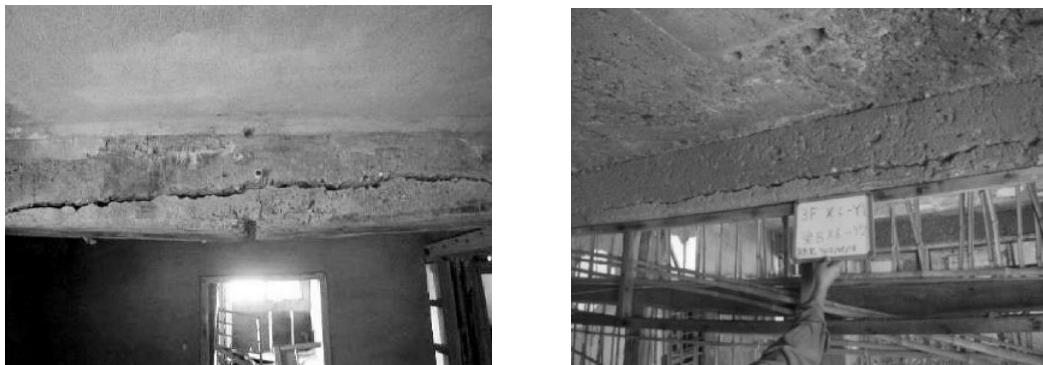
Photo 2-4-120 Deterioration level III

The condition in which concrete cover has fallen or appears to have almost fallen, and the concrete cover side of rebar virtually shows a boundary crack but the bond remains on its core side.

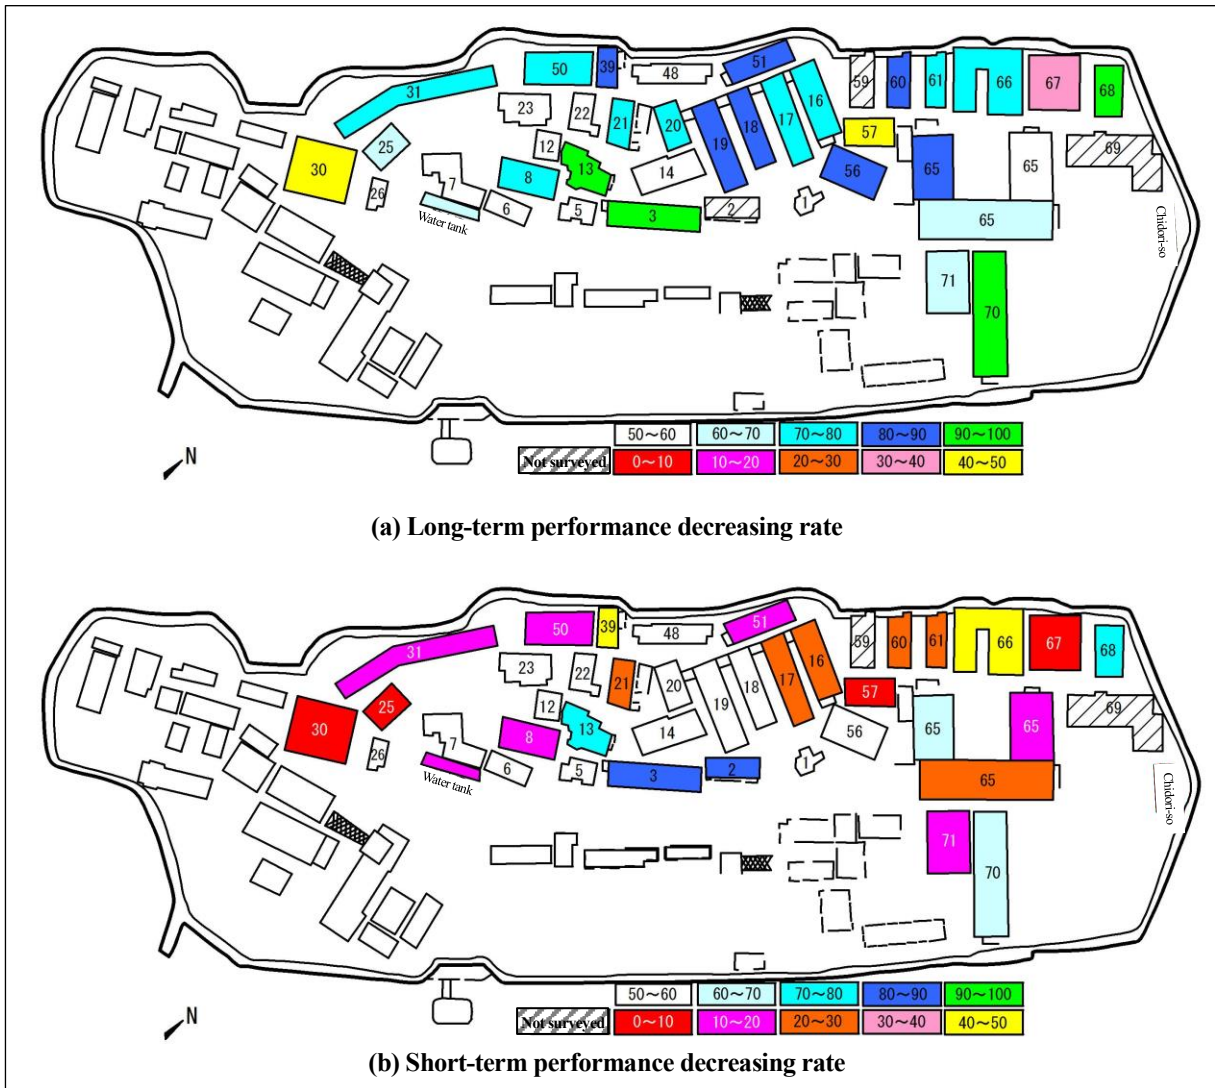
Figure 2-4-88 Long-term and short-term performance decreasing rates calculated

Table 2-4-79 and Figure 2-4-88 shows the calculation results of long-term performance decreasing rates and seismic performance decreasing rates, respectively. For the long-term performance, decreasing rates are shown to be relatively low, with the exception of some buildings including Building No.30. For the seismic performance, decreasing rates are low around Building No.3, which is located in the center of the island; however, deterioration is noticeable particularly along the coast, with single-digit decreasing rates obtained for Buildings No.25, 30, 57, 67, and Chidori-so, indicating extremely low residual seismic performance.

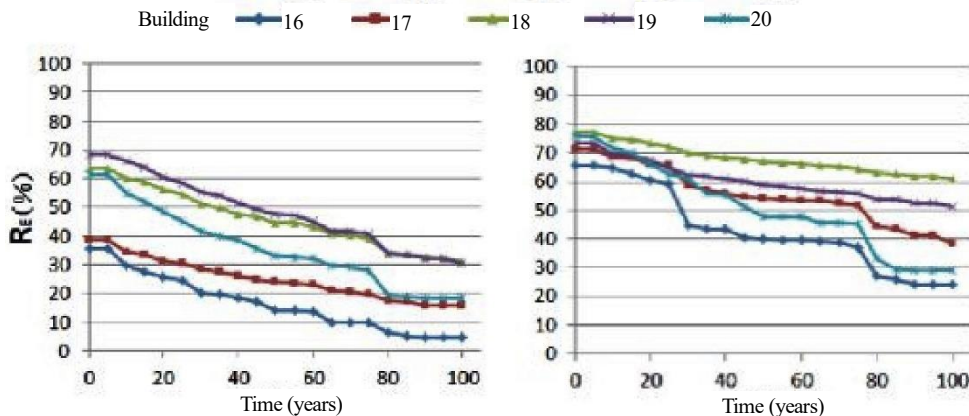
Figure 2-4-93 Prediction of residual seismic performance ratio  $R_E$  (left: X direction, right: Y direction)

Figure 2-4-93 shows the results of calculation and prediction of  $R_E$  for all Levels. For each building, the long-side direction is the X direction and the short-side direction the Y direction. The figure indicates that the Y direction has higher values of  $R_E$  and is lower in deterioration progress than the X direction across all the buildings. This is attributed to the fact that in the Y direction there are many inside wall members that have a low deterioration progress rate. Figure 2-4-94 shows the results of calculation and prediction of  $R_L$  for all Levels. Concerning  $R_L$  values, it was predicted that the values will not significantly change over the next 30 years for all the buildings, and after that, Building No.16 will deteriorate at a relatively high rate while Building No.20 will deteriorate at a relatively low rate. This difference may be affected by the distances from the coast.

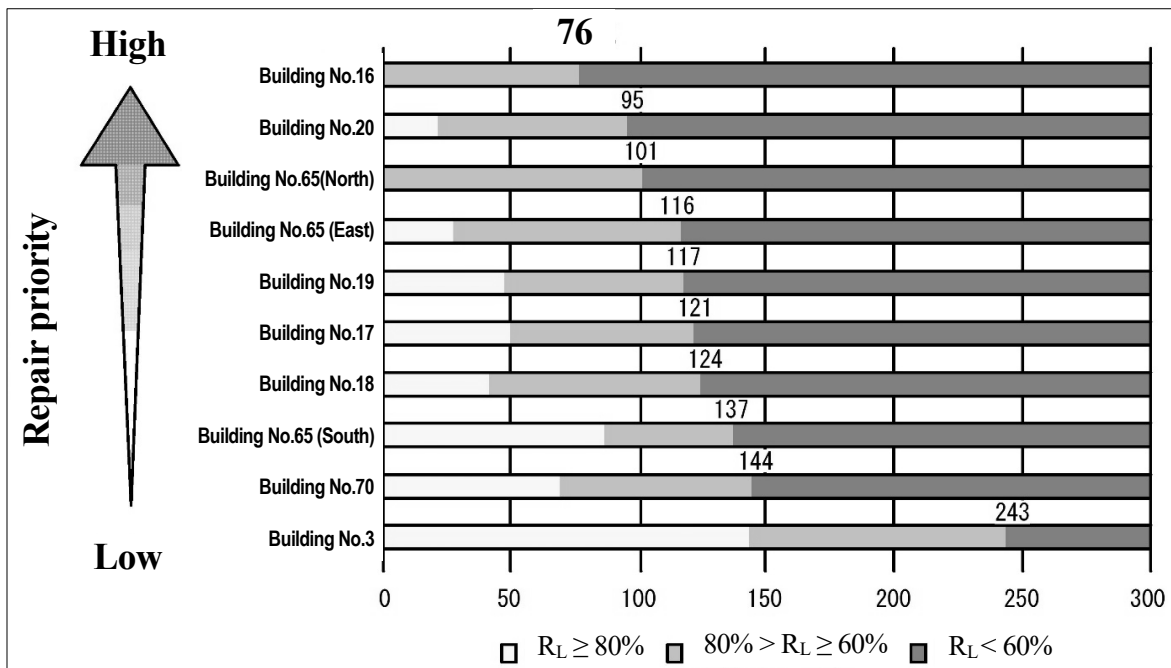
Figure 2-4-120 Determination of repair priority based on the prediction of future  $R_L$

As Figure 2-4-120 indicates, repair priority was, in order of priority, Building No.16, Building No.20, Building No.65 (North), Building No.65 (East), Building No.19, Building No.17, Building No.18, Building No.65 (South), Building No.70, and Building No.3.

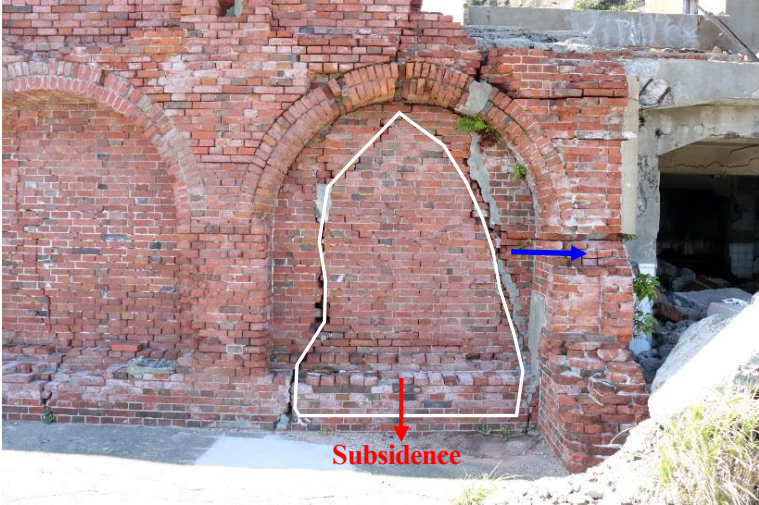
Photo 2-4-107. Damage to Arch No. 4 of brick walls

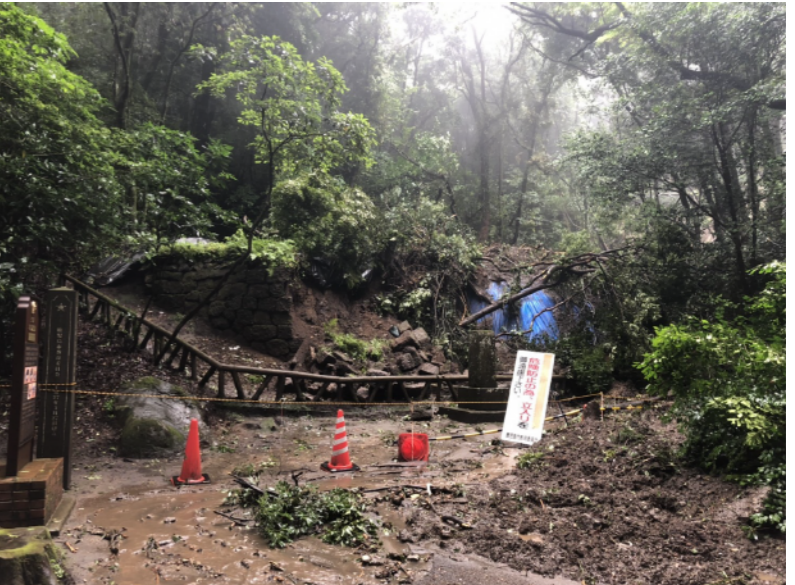
(6) Kiln soon after damage occurred (photographed July 1, 2019)
