Archaeological excavation report (A survey of the mouth of Pit at the Hashima Coal Mine remains)

(1) Survey of remains of the mouth of Pit

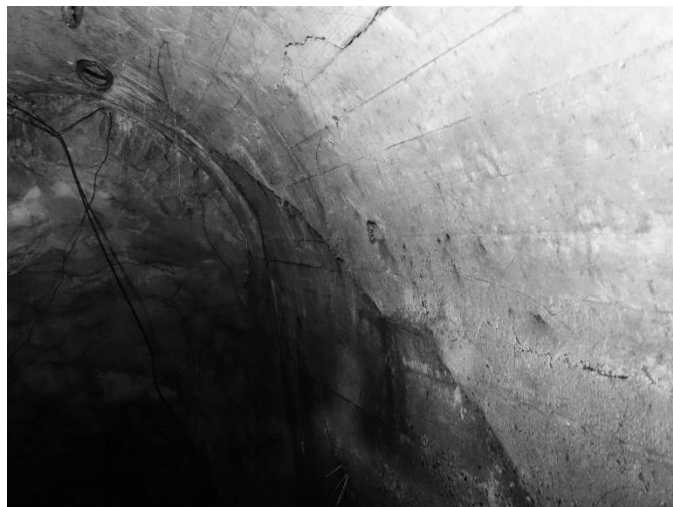
Photo 2-3-51. 1-F100; Direct front view

The survey found that the inclined passage at Mouth of Pit No. 1 was covered in concrete on the walls, with the pit running slightly to the left (west) for a length of approximately 5 meters based on visual estimates. At the end of the pit, the walls were not covered in concrete but rocks were exposed (Photo 2-3-51).

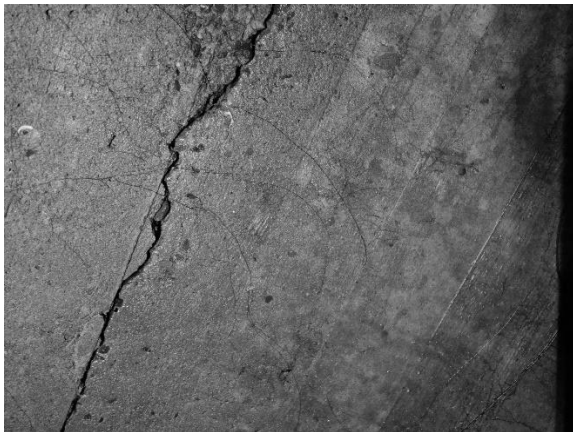
Photo 2-3-52. 1-R101; Ceiling

The concrete walls showed clear signs of forms being used there (Photo 2-3-52). It is possible that the large quantity of lumber pieces scattered around near the entry may have been remnants of forms that had fallen off (Photo 2-3-53). Assuming that the pieces of lumber had been the material of forms, it would mean that the forms

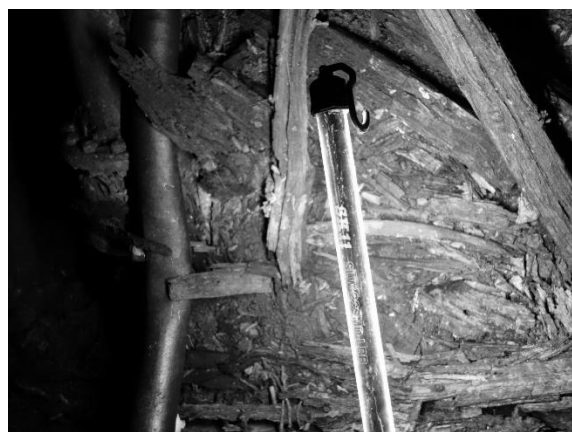
Photo 2-3-53. 1-R105; Floor

were left there at the time the business was opened. Since the scattered pieces of lumber were boards, rather than rods as those photographed in Photo 2-3-50, it is likely that they were used for forms. A pipe can be seen on the floor, what it was used for is unclear.

If the scattering pieces of lumber and pipes are removed, it will not be difficult to look closely inside the pit to the rock walls at the end, meaning it should be possible to investigate to determine if the pit is designed to lead down to underground areas near the exposed rock walls.

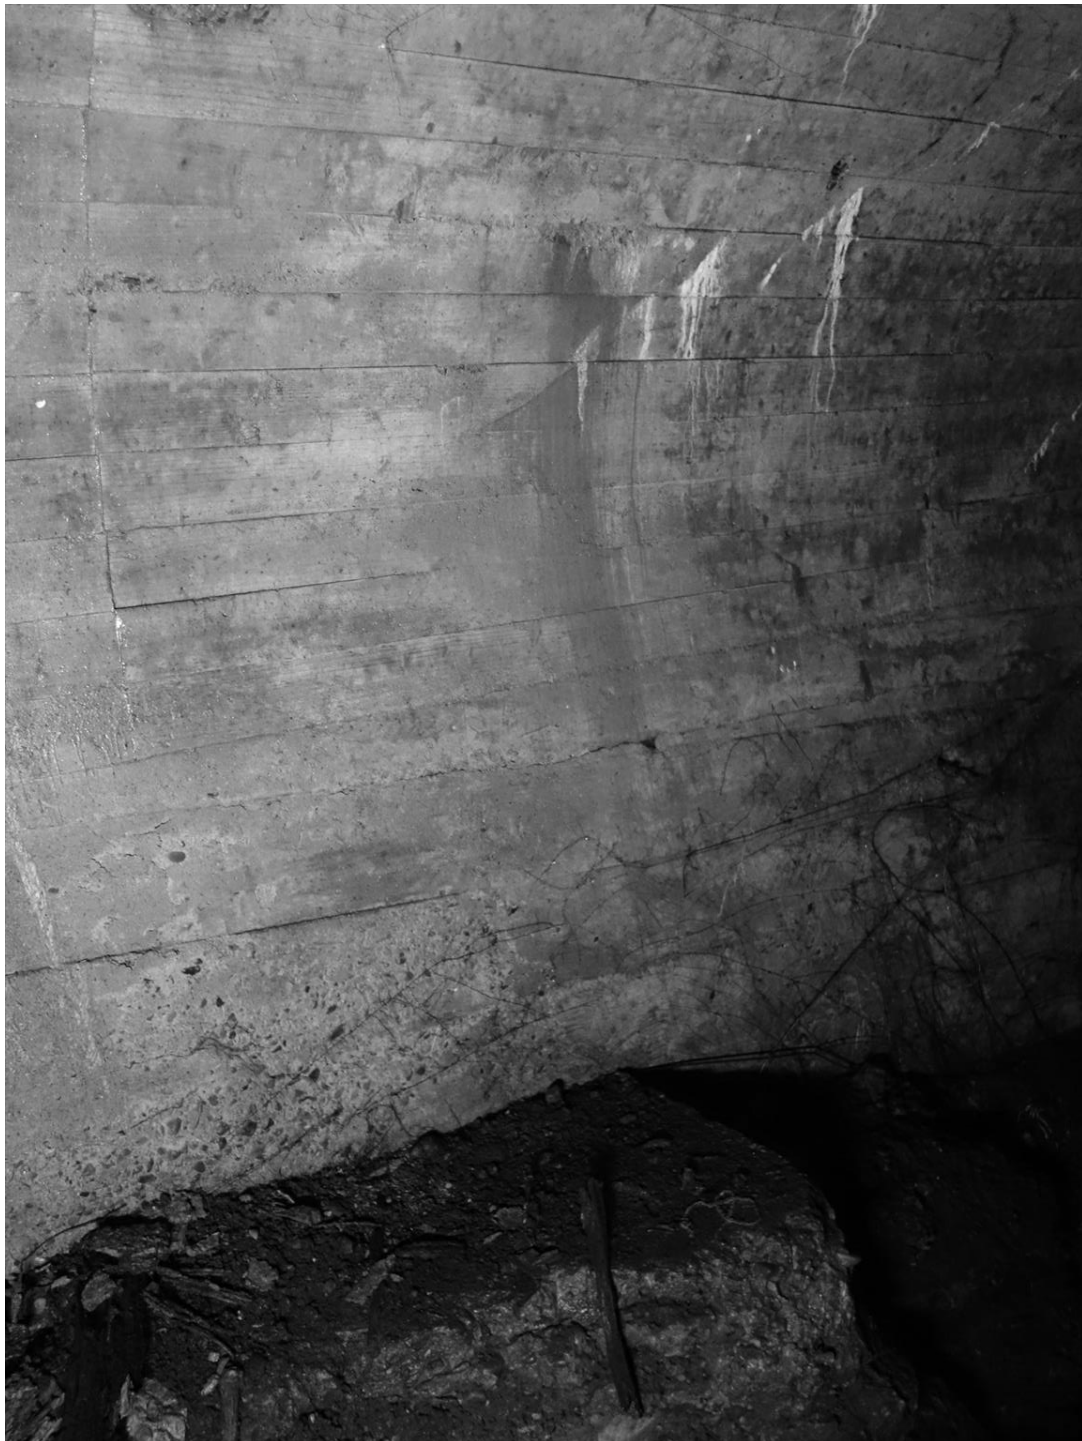
Photo 2-3-54. 1-R107; Wall

Judging by the pictures taken during the survey, the area appeared to be in good condition, with no toxic gas, etc. identified although pieces of lumber and pipes were scattered. Likewise, the concrete walls that cover the rock walls beneath, although some cracks were observed, did not appear to be in an immediate danger of falling off (Photo 2-3-54).

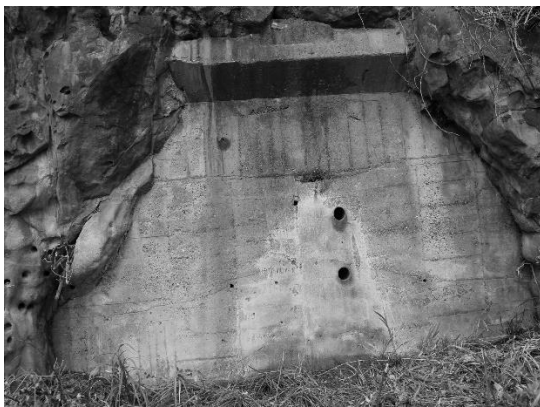
Photo 2-3-56. Mouth of Pit survey 2; Full view

The entrance of the mouth of Pit was sealed off in concrete, after the tram tracks had been buried with soil (Photo 2-3-56). Parts of the tracks still remain outside the entrance (Photo 2-3-57). While pictures taken in 1957 show four tram tracks inside the mine, only two could be confirmed through the views from the outside of the entrance (Photos 2-3-57, -58, and -59).

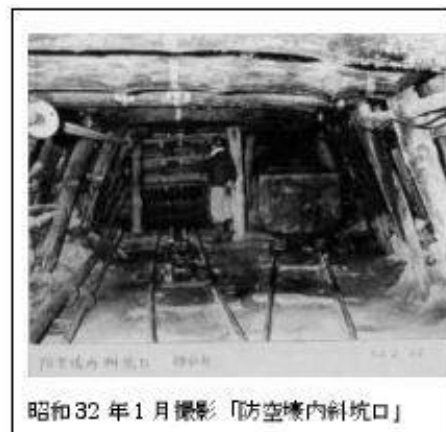
Photo 2-3-59. Mouth of Pit survey 2; Picture taken in 1957; Diagonal mouth of Pit in the bomb shelter

Unlike the inclined passage at Mouth of Pit No. 1, the walls inside Mouth of Pit No. 2 were not cast in concrete. The picture taken in 1957 (Photo 2-3-59) shows wood framings along the walls. While Photo 2-3-59 shows four tracks, or two pairs of tracks, they were not visible in the pictures taken during the present survey due to the buildup of wooden and coal pieces. Given the sections of tracks which still exist outside the entrance, however, it is likely that the tracks may be made visible if the pieces of wood are removed. Judging by the directions in which the remaining sections of tracks run, the tracks were considered to be leading to the right (northern) fork of the pit.

Although it is a matter of speculation, assuming that Photo 2-3-59 was a picture of the inside of the inclined passage at Mouth of Pit No. 2, it is possible that tracks were laid in each of the two forks of the pit, running deeper into the mine. That only two tracks, or one pair of tracks, remain outside the mine may be because the fork was inside of the pit, not outside (Figure 2-3-76).

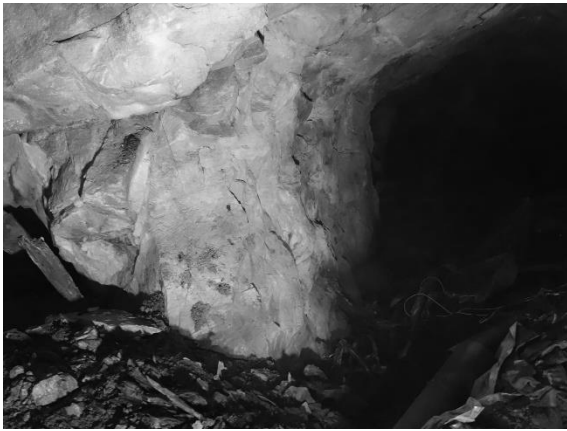
Photo 2-3-60. 2-F01_Direct front view

Review of the pictures taken through the holes drilled open revealed that the pit was forked into two at a few meters from the entry (Photos 2-3-60 and -61), that the walls were rocks exposed (Photo 2-3-62), and that the tram tracks, which had been found outside the mine, were not visible buried under pieces of wood and coal (Photo 2-3-63).

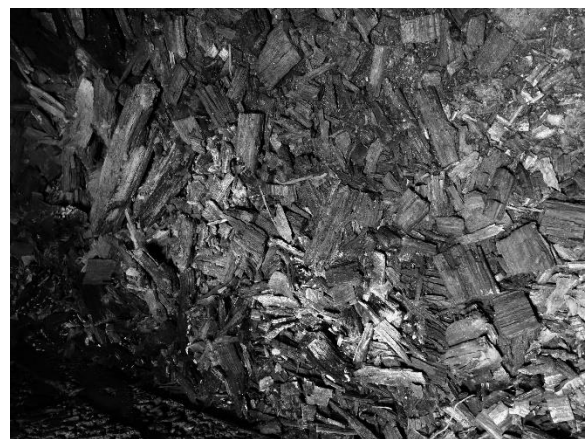
Photo 2-3-63. 2-F03_Floor

Given the buildup of coal pieces inside the pit, and the fact that sections of tram tracks remain outside the pit, it is doubtful if the inclined passage at Mouth of Pit No. 2 was used as drainage. A possibility of it having been for coal mining cannot be ruled out, either.

Other than the buildups of pieces of wood and coal on the floor inside the pit, no damage was observed on the walls of exposed rocks, and the area appeared to be in good condition. If the pieces of wood on the floor are removed, it will be possible to see any remaining sections of tracks inside the pit. Examining such tracks may also help offer clues to understanding how they may have been related to the pit fork, and what the inclined passage may have been used for.

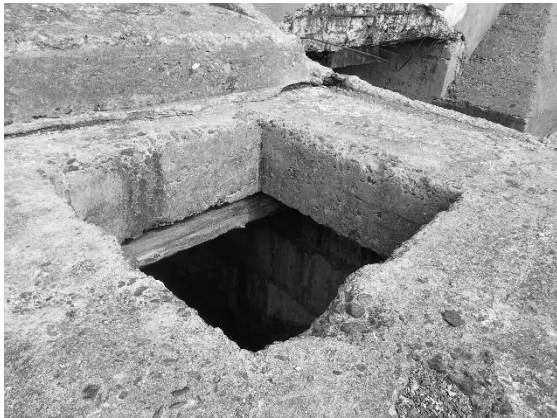
At Pit No. 3, one could go approximately 7.45 meters below the opening (0.97 m × 0.93 m) to reach soiled surface, beneath which was filled. Inside the pit, there was spring water in part (Photos 2-3-65 and -66), and there was a 6.0-m × 3.81-m space observed. The walls surrounding this space were partly ashlar masonry of sandstone from the ground up to approximately 4-meter levels; the upper parts of the eastern, western, and southern walls above the masonry were cast in concrete with forms still remaining (Photo 2-3-68). The upper parts of the northern wall, meanwhile, were brickwork, laid to form an inverted arch, and above the brickwork the empty space continued further on (Photos 2-3-69 and -70).

Photo 2-3-65. 3-A26_Opening

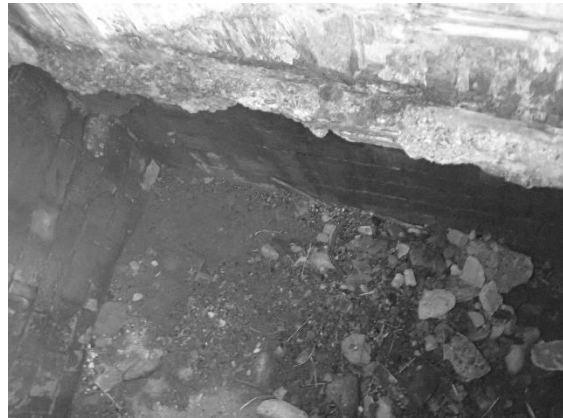
Photo 2-3-66. 3-A35_Underground

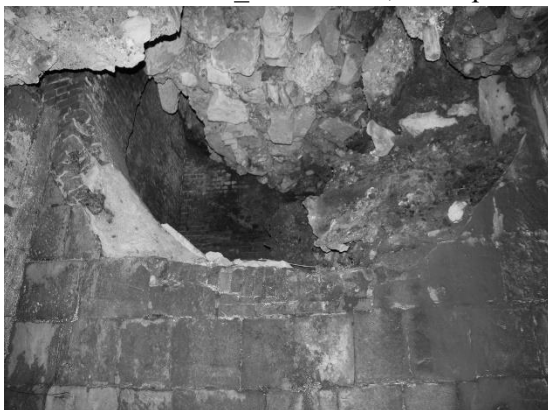
Photo 2-3-69. 3-N18_Nothern wall

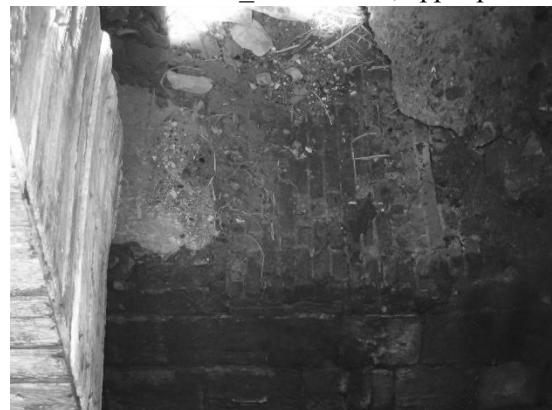
Photo 2-3-70. 3-A32_Nothern wall

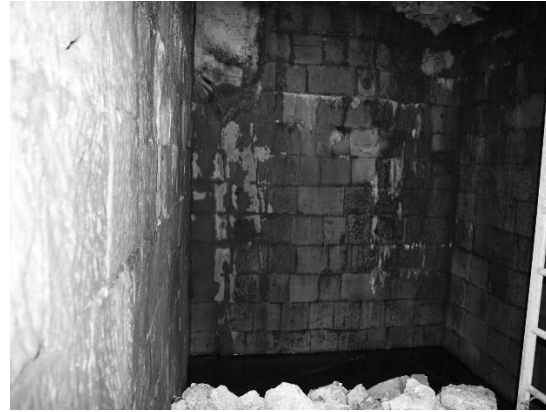
Photo 2-3-76. 3-S10

Similar to the other walls, the southern wall was also a Nunozumi masonry made of cut blocks of sandstone, and the protruding concrete portion of the eastern wall could be seen in the upper parts on the right (eastern) side, and the concrete column attached to the western wall in the upper parts on the left (western) side (Photo 2-3-75). It was not possible to investigate the southern wall up close, due to spring water observed around the wall (Photo 2-3-76).

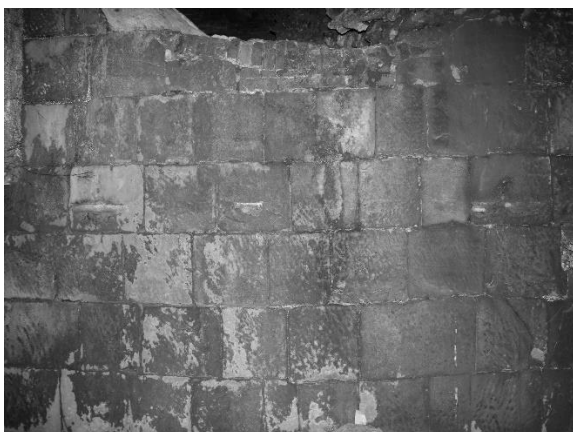
Photo 2-3-77. 3-N05

While the stone masonry in the lower parts were in general done in the same manner as with the other walls, there were horizontally long remnants of metal observed in three locations at approximately 1.4 meters from the floor (Photo 2-3-77). It is speculated that these may have been connected to a tool or machinery, but no definite sign could be found nearby, and details are unknown. In the meantime, the bricks observed on the eastern and western walls were laid in such a manner that they were connected to the arch-shaped brickwork of the northern wall (Photo 2-3-78). This suggests the bricks were probably supposed to serve their roles when connected to something, but this, too, remains unknown.

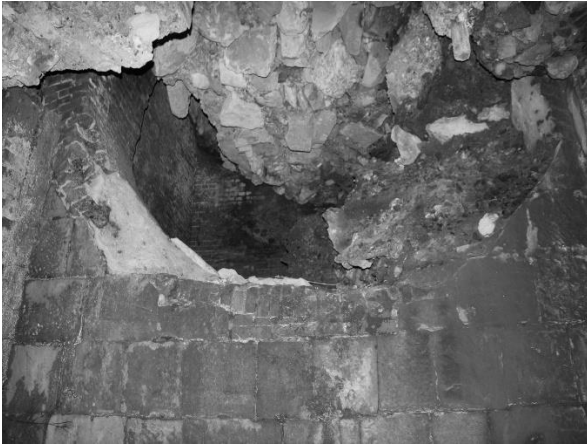
Photo 2-3-79. 3-A31

As for the opening in the upper parts of the northern wall, portions of concrete with brick and gravels attached to them could be seen on the ceiling, and the floor (of the space beyond the masonry) was laid with bricks (Photos 2-3-79 and -80).

As for the opening with bricks laid created in the upper parts of the northern wall, it will be possible to determine if the space beyond it is sealed off or continues further on if the floor is cleared of rubble.
