Survey of the structure of Pit No. 3 winding machine room
(Survey of Hashima Coal Mine buildings, etc.)

Appendix 3

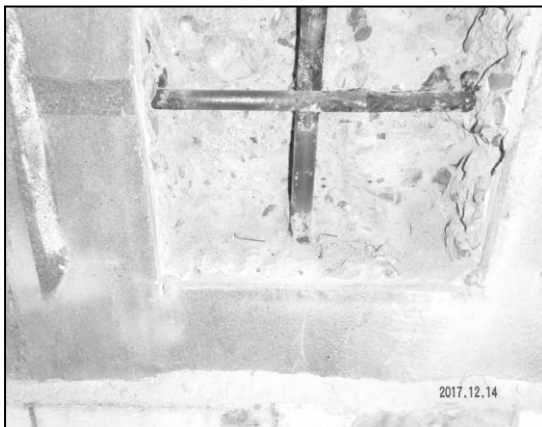
Rebar conditions (column)

The rebar diameter, rebar spacing, concrete cover thickness, and degree of rebar corrosion (as determined visually) measured at each measurement sites are provided in Table 2-4-33. The degree of rebar corrosion was Class III for the beams and columns, with floating rust observed around the circumference and along the entire length of the rebars. The rebars in the columns, in particular, had the hoops showing a loss of cross-sectional area, indicating significant levels of corrosion.

The thickness of concrete cover was greater at all the sites compared to the standards specified in the Order for Enforcement of the Building Standard Act (Photo 2-4-66).

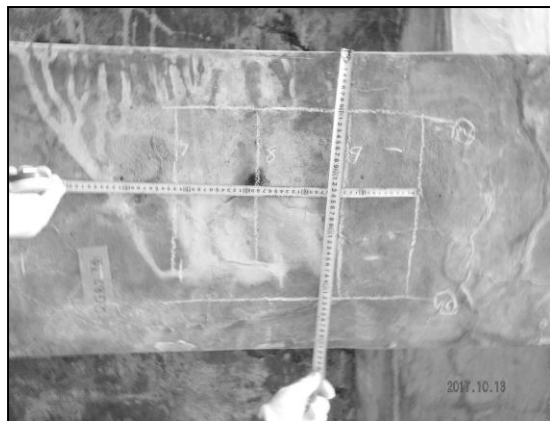
Rebar arrangement at bottom of beams

A rebar exploration conducted on the beams from down below showed that there were only two rebars for the bottom reinforcement.

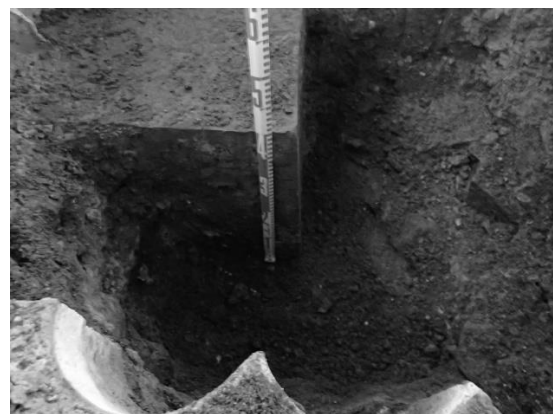
Prior to manual drilling, a layer of concrete with a thickness of approximately 35 cm was removed from the floor, to reveal a concrete structure that was presumed to be the foundation (Photos 2-4-84 and -85). When the areas around the foundation were drilled out, the undersurface was observed at 40 cm deep. The depth from the floor level to the undersurface of the foundation was 75 cm. At Exploratory Drilling Site ①, the existence of a concrete structure that was presumed to be a foundation of the building was confirmed. No deterioration or subsidence was observed with the foundation.

Photo 2-4-85 Exploratory Drilling Site ①, foundation

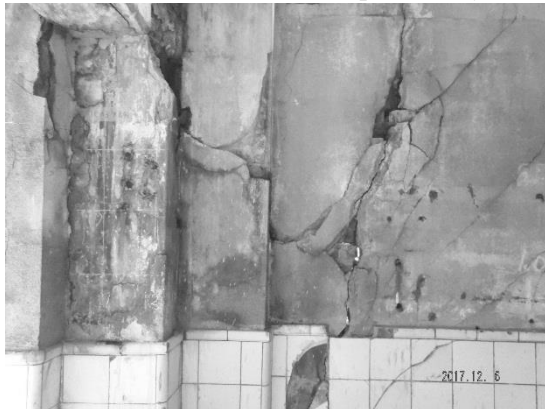
Cracks were observed in the entire area. While many were smaller than 1.0 mm in width, some cracks were wider than 5.00 mm or grown almost causing damage. Hexagonal pattern cracks in mortar such as those found in plane A (North) (Photo 2-4-96) are considered to have been caused by the mortar expanding and shrinking due to changes in temperature. Hexagonal pattern cracks such as these were found primarily in the column, beams, and walls of the warehouse on Level 1, and the slabs on Level 2. Cracks running vertically along the columns, such as those found in the Column on the intersection between base lines C and 2, Level 1 (Photo 2-4-97), occurred along the main reinforcements and are considered to have been caused as a result of the expansion of the main reinforcements. Other cracks were presumably caused by mortar shrinkage due to changes in temperature.

Photo 2-4-95. Mortar cracks and falling-off; plane C (South), inner wall

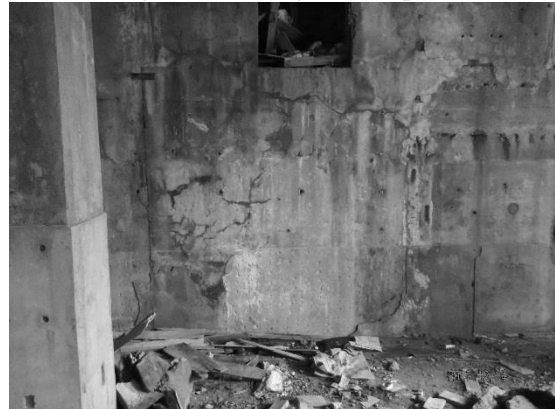
Photo 2-4-96. Plane A (North), outer wall

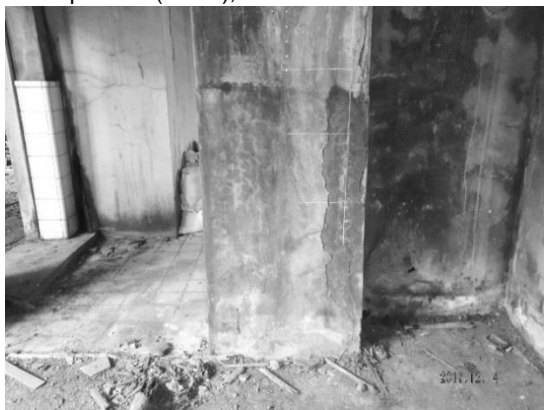
Photo 2-4-97. Cracks; column on base lines C and 2 intersection, Level 1

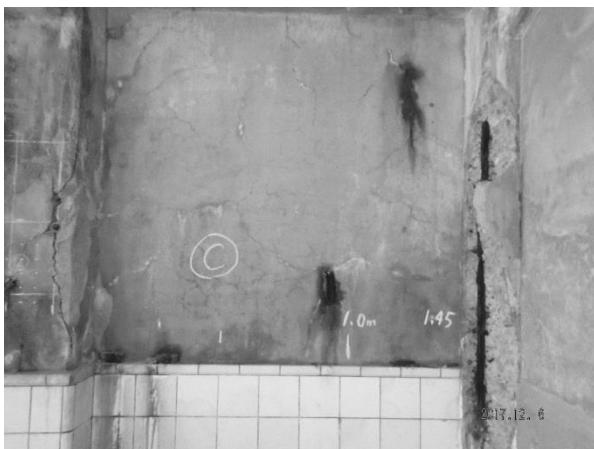
Given the loss of the main reinforcements of the columns which provide resistance to the horizontal load, and a large loss of cross-sectional area of the columns, the structure was at an extremely high risk of collapsing.

Photo 2-4-98. explosion and corrosion;
on base lines A and 2 intersection, Level 1

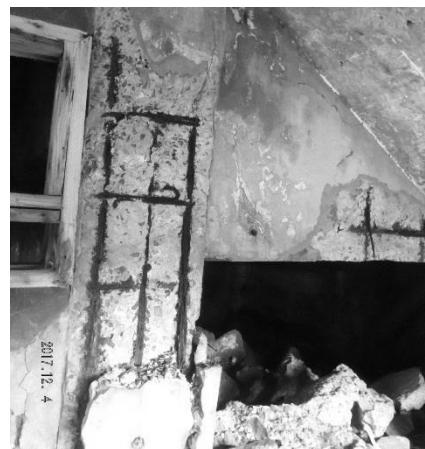
Photo 2-4-99. explosion and corrosion;
on base lines B and 1 intersection, Level 1

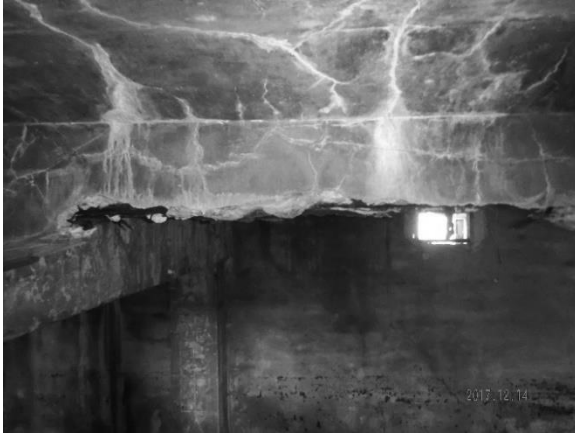
Photo 2-4-100. explosion and corrosion;
Beam 2G1Aa, Level 2

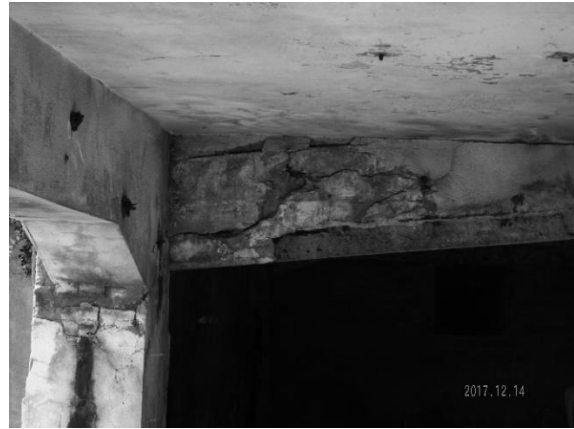
Photo 2-4-101. Cracks and falling-off;
Beam 2G3A, Level 2

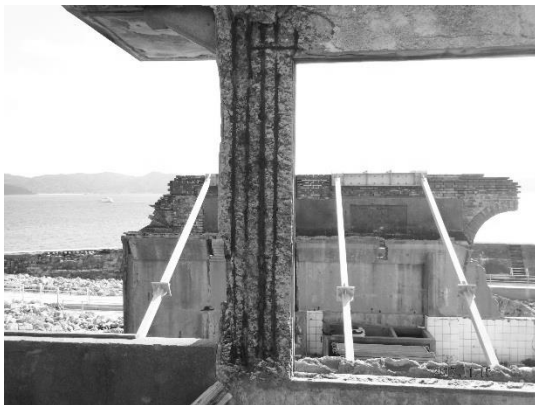
Photo 2-4-102. explosion; Eaves on base lines C and 2 intersection

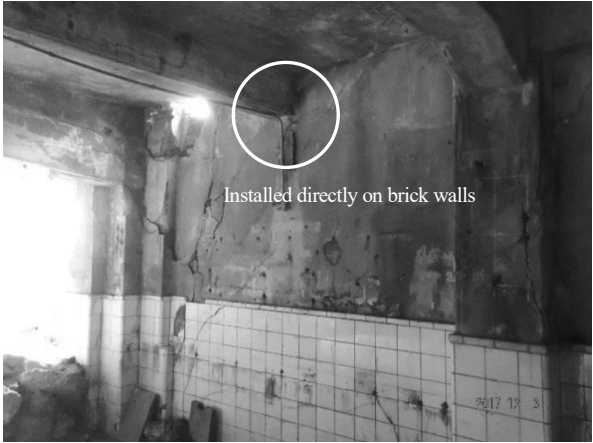
Photo 2-4-106. Joint condition between Beam B5 and brick walls

Visual examination found that the slab supported by this beam showed signs of having been newly placed or re-cast. This indicates that the beam which was laid on top of the arch, too, would have been added at the same timing.

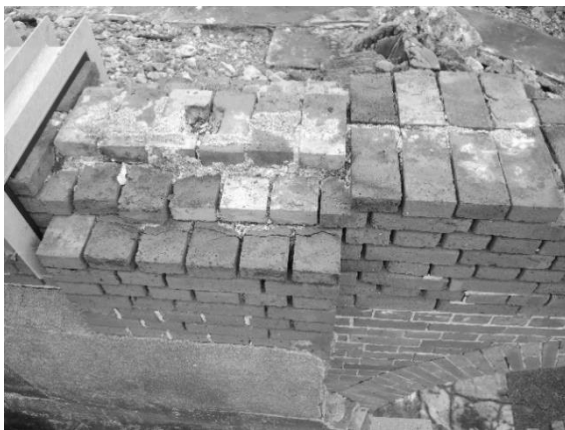
Photo 2-4-108. Top of brick walls

Although it could not be determined in this examination whether or not rainwater was penetrating inside through the walls, considering that joints of the top of the walls were significantly deteriorated, rainwater infiltration was entirely possible. It will be necessary to repair the damaged joints and the large cracks, and make the wall waterproof.

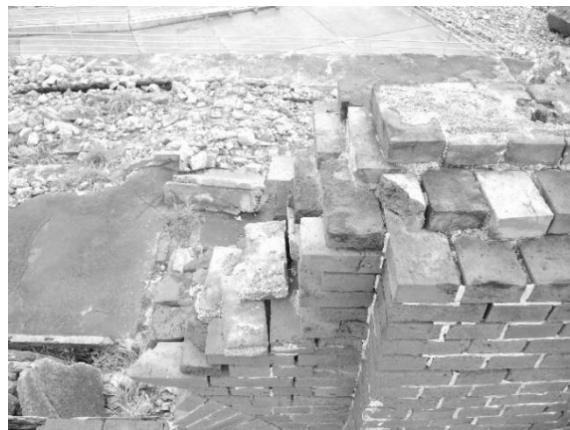
Photo 2-4-109. Western side of brick walls
