**World Cultural Heritage “Sites of Japan’s Meiji Industrial Revolution: Iron and Steel,  
Shipbuilding, and Coal Mining” (No. 1484)**

**Heritage Impact Assessment Report for the Post-Disaster Recovery and Repair Project at  
the Terayama Charcoal Kiln in Area 2 Kagoshima (Component Part 2-2)**

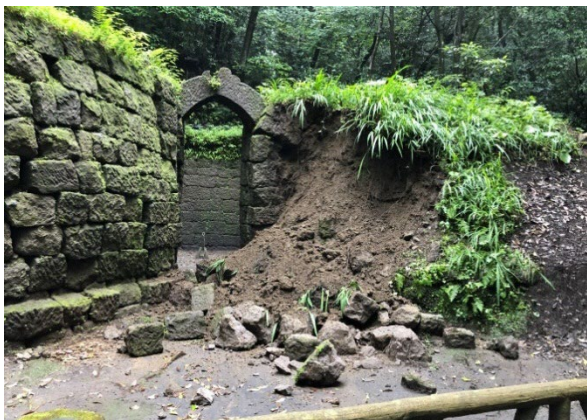
Heavy rainfall between June 27 and July 4, 2019 caused the Terayama Charcoal Kiln to partially collapse on two occasions, on June 28 and July 1 (Photos 1 to 4).

Photo 1. State of damage (taken June 28, 2019)

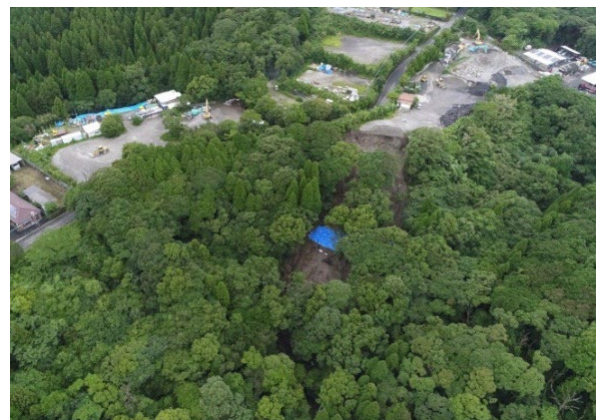
Photo 2. State of damage (distant view; taken July 1, 2019)

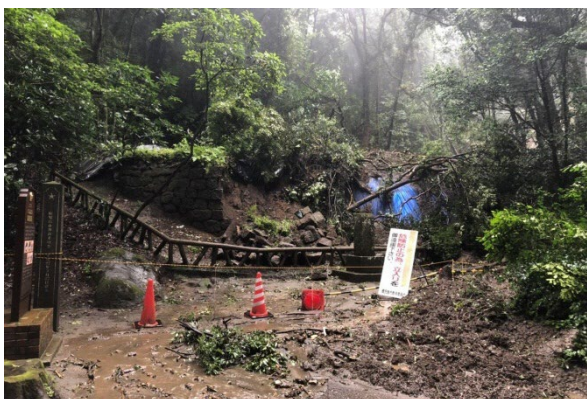
Photo 3. State of damage (charcoal kiln; taken July 1, 2019)

The positions of fallen stones were recorded, after which the stones were moved for safekeeping. Of the portion that has not yet collapsed, the extent of impact from the landslides was confirmed. The results confirmed that of the 667 stones in the masonry visible above ground, a total of 139 stones collapsed; on the northeast side of the masonry, 54 stones collapsed; and from the arch and on the southwest side of the masonry, 85 stones collapsed. Stones in the vicinity of the collapsed areas were also found to have shifted.

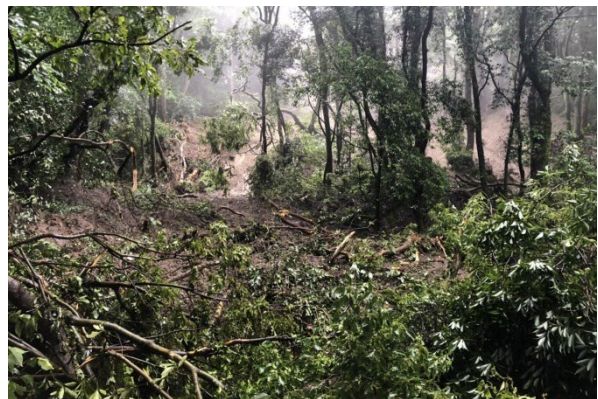
Photo 4. State of damage (slope; taken July 1, 2019)

- The slope in the buffer zone where the landslides occurred is steep and unstable. To prevent further collapse, it will be reformed into a more stable incline. As measures against underground seepage water, which is a cause of the collapse, and drainage of rainwater accumulating on the slope will be improved, and slope erosion control will be implemented. For greening of the embankment, vegetation mats will be used, and a natural vegetation dispersal method will be adopted, by which seeds carried by the wind from nearby vegetation are relied on for recovery.

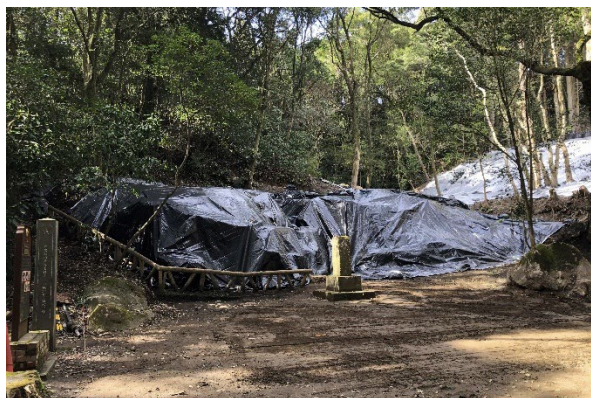
Photo 5. Updated state of charcoal kiln (taken March 12, 2020)

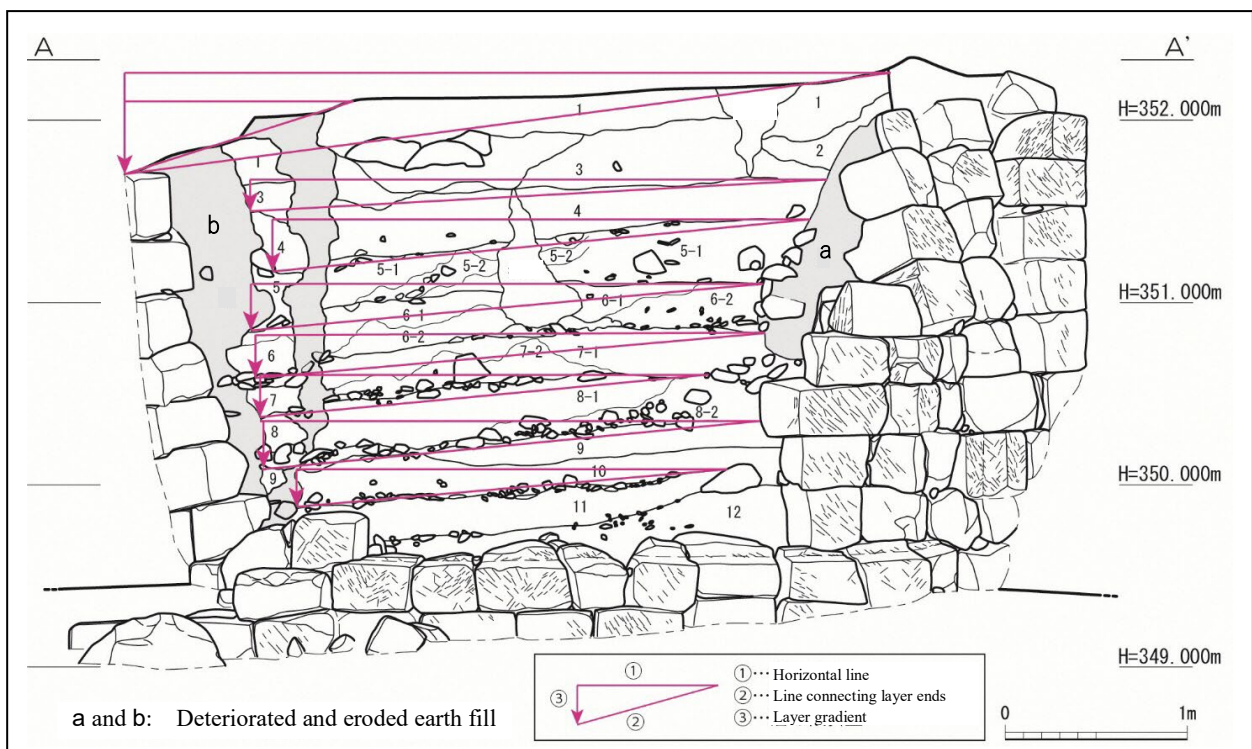
Figure 4. Cross-sectional view of the collapsed southwest side of the kiln (structural survey result)

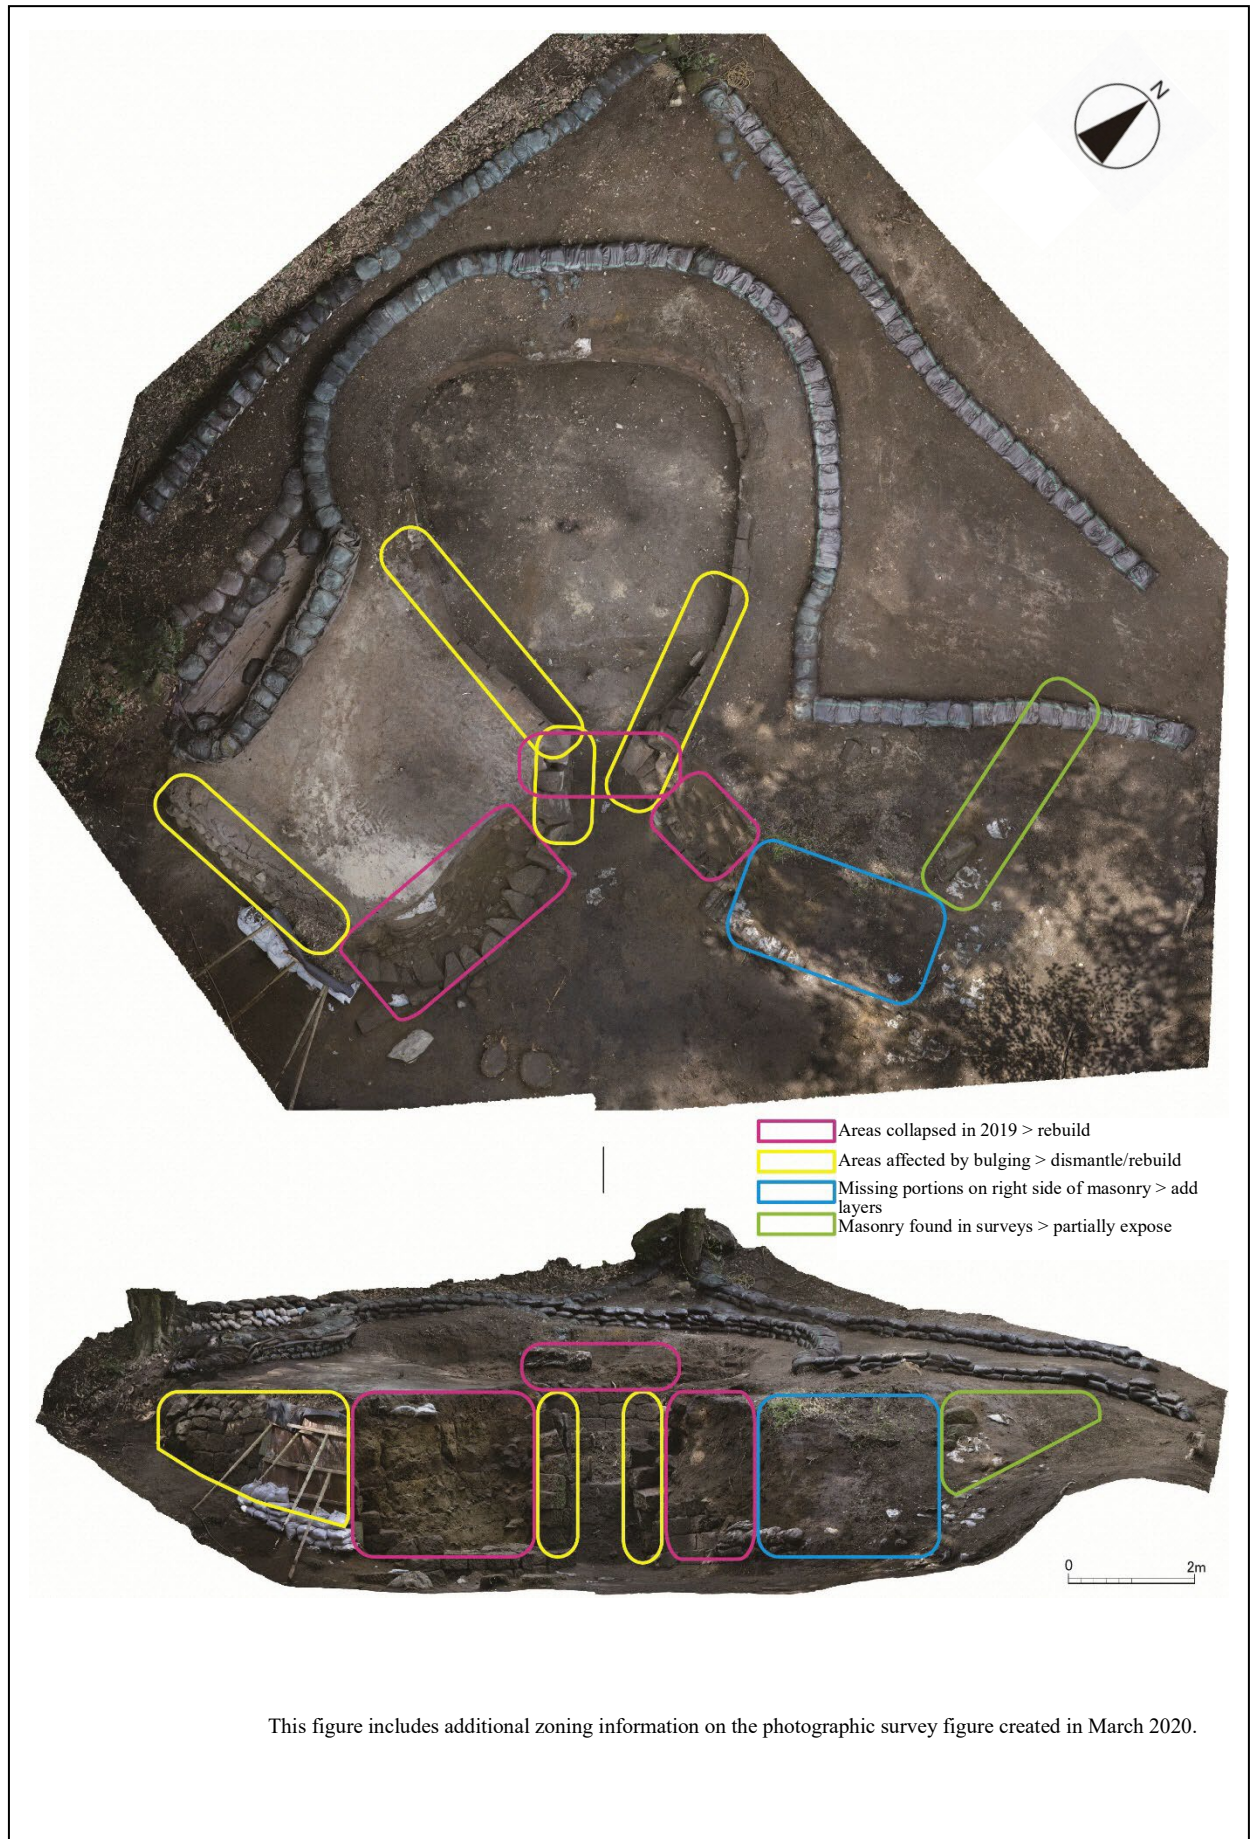
The current main issue is that simply putting back in place the stones that collapsed will not ensure a stable structure. Along with putting these in place, it will be necessary also to use new stone materials to fill in missing sections in the masonry that were confirmed before the disaster, and to dismantle and rebuild places where bulging occurred. Otherwise it will be difficult to restore the masonry to a stable structure.

Places where the stone masonry has missing sections were found on the northeast side of the kiln, and periodic displacement measurements revealed that the stones surrounding that area are shifting, causing an unstable state. The foundation of the relevant area was identified in the excavation surveys conducted in 2020, and there is clear archaeological evidence for filling in the missing sections with new stones on top of the foundation.

Analysis to determine the cause of bulging was conducted before the disaster occurred. The bulging was found to be caused by deterioration of masonry stones and infiltration of rainwater into the upper portion of the masonry, which led to deterioration of the earthen layer backing the masonry walls. It was planned to dismantle and rebuild the structure in fiscal 2019 and after. The collapse of the masonry of the charcoal kiln caused by the heavy rainfall led to the conducting of various surveys to understand the construction of the masonry backing, and in turn to the discovery that the bulging of the masonry may have been caused by uneven land subsidence due to differences in the foundational layers of the charcoal kiln.

Figure 5. Approach to post-disaster recovery and repair of each portion of the charcoal kiln

- The recovery and repair work will be carried out from the standpoints both of preserving evidence from the end of the Edo period (1850s and early 1860s) and evidence of changes over time on the Terayama Charcoal Kiln, and of securing stability in the kiln as a structure.
- While the fundamental aim will be to restore the places damaged in the disaster, stone masonry discovered underground in the surveys will also be partially exposed and reconstructed. The masonry that had already collapsed prior to World Heritage inscription will be restored to a minimal extent, and missing sections will be replaced by new layers of stones to secure stability of the charcoal kiln as a structure.

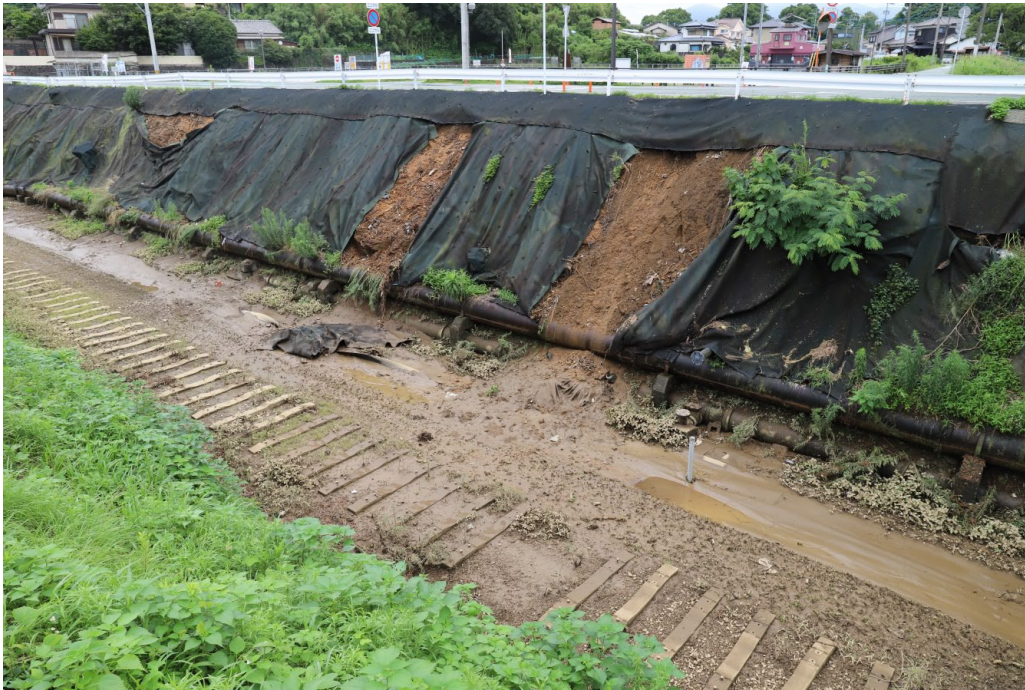
Miike Coal Railway: Photo of damage status

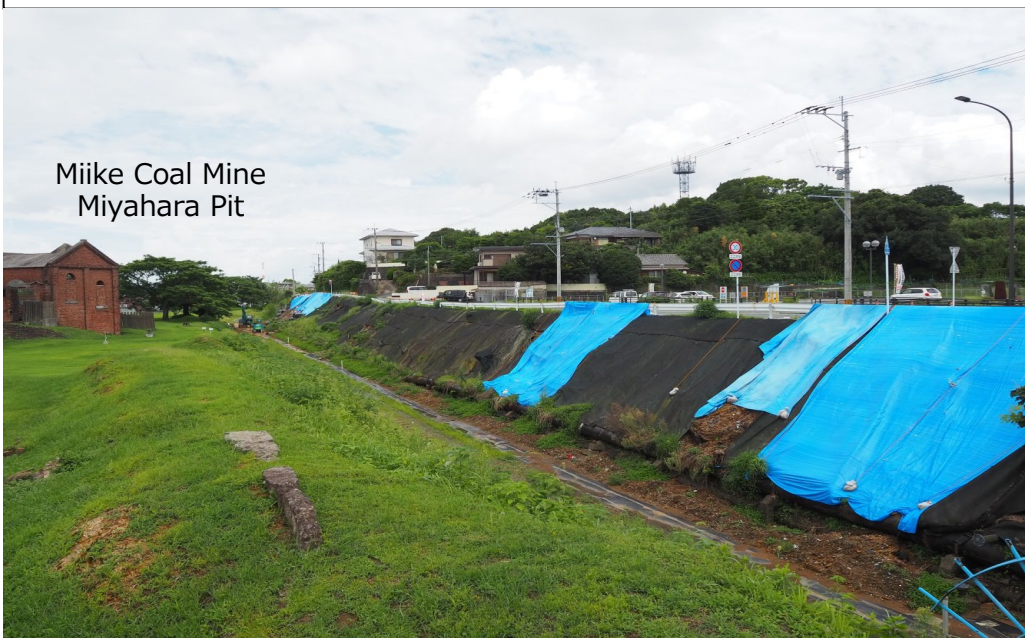
Miike Coal Railway: Photo of emergency measures in place

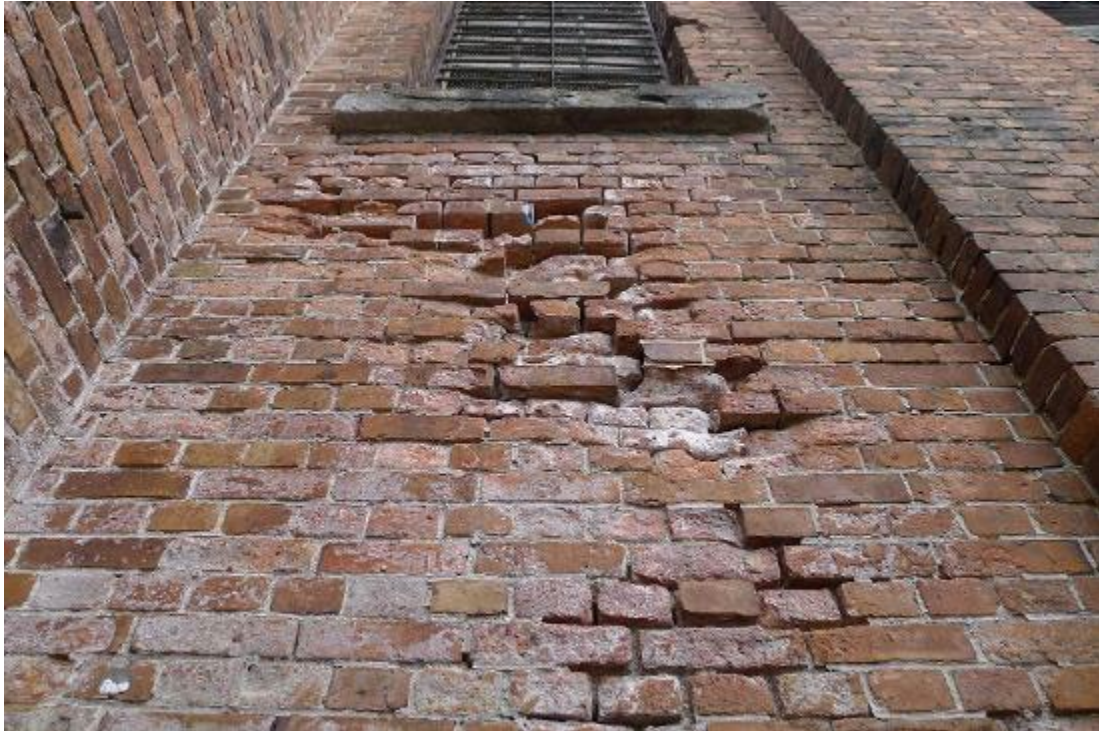
Repair bricks: Place supplementary bricks on a section where the bricks have been deeply deteriorated and lost, as seen in this photo
