II. Overview of Accident at the Fukushima Dai-ichi Nuclear Power Station

1. Overview of the Fukushima Dai-ichi Nuclear Power Station

3. Overview of Damage at the Fukushima Dai-ichi NPS as Revealed by Investigation So Far

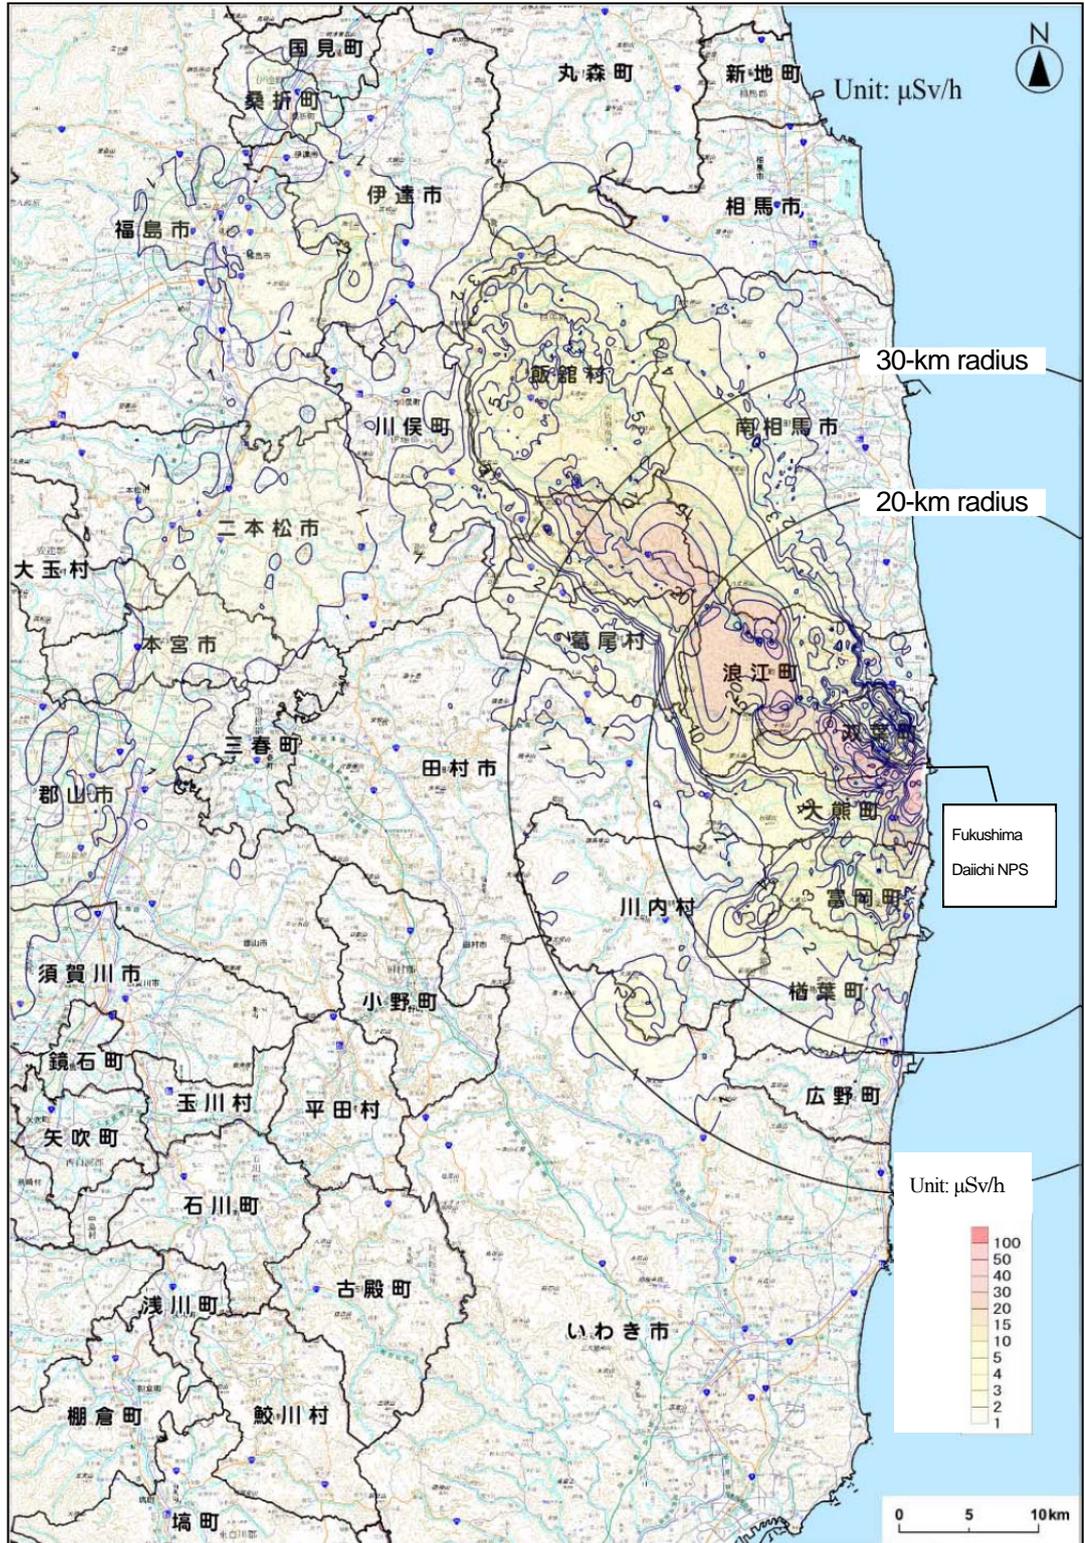
After the occurrence of the accident, the Ministry of Education, Culture, Sports, Science and Technology (MEXT) has regularly made reports on the spatial distribution of dose rates and cumulative doses in the area around the Fukushima Dai-ichi NPS. According to these reports, the spatial dose rate distribution around the Fukushima Dai-ichi NPS on November 11, 2011, was as shown in Fig. II-3, the cumulative dose up to the same date was as shown in Fig. II-4, and the cumulative dose in the period up to March 11, 2012, is expected to be as shown in Fig. II-5 (forecast).

Fig. II-3 Spatial dose map (as of November 11, 2011)

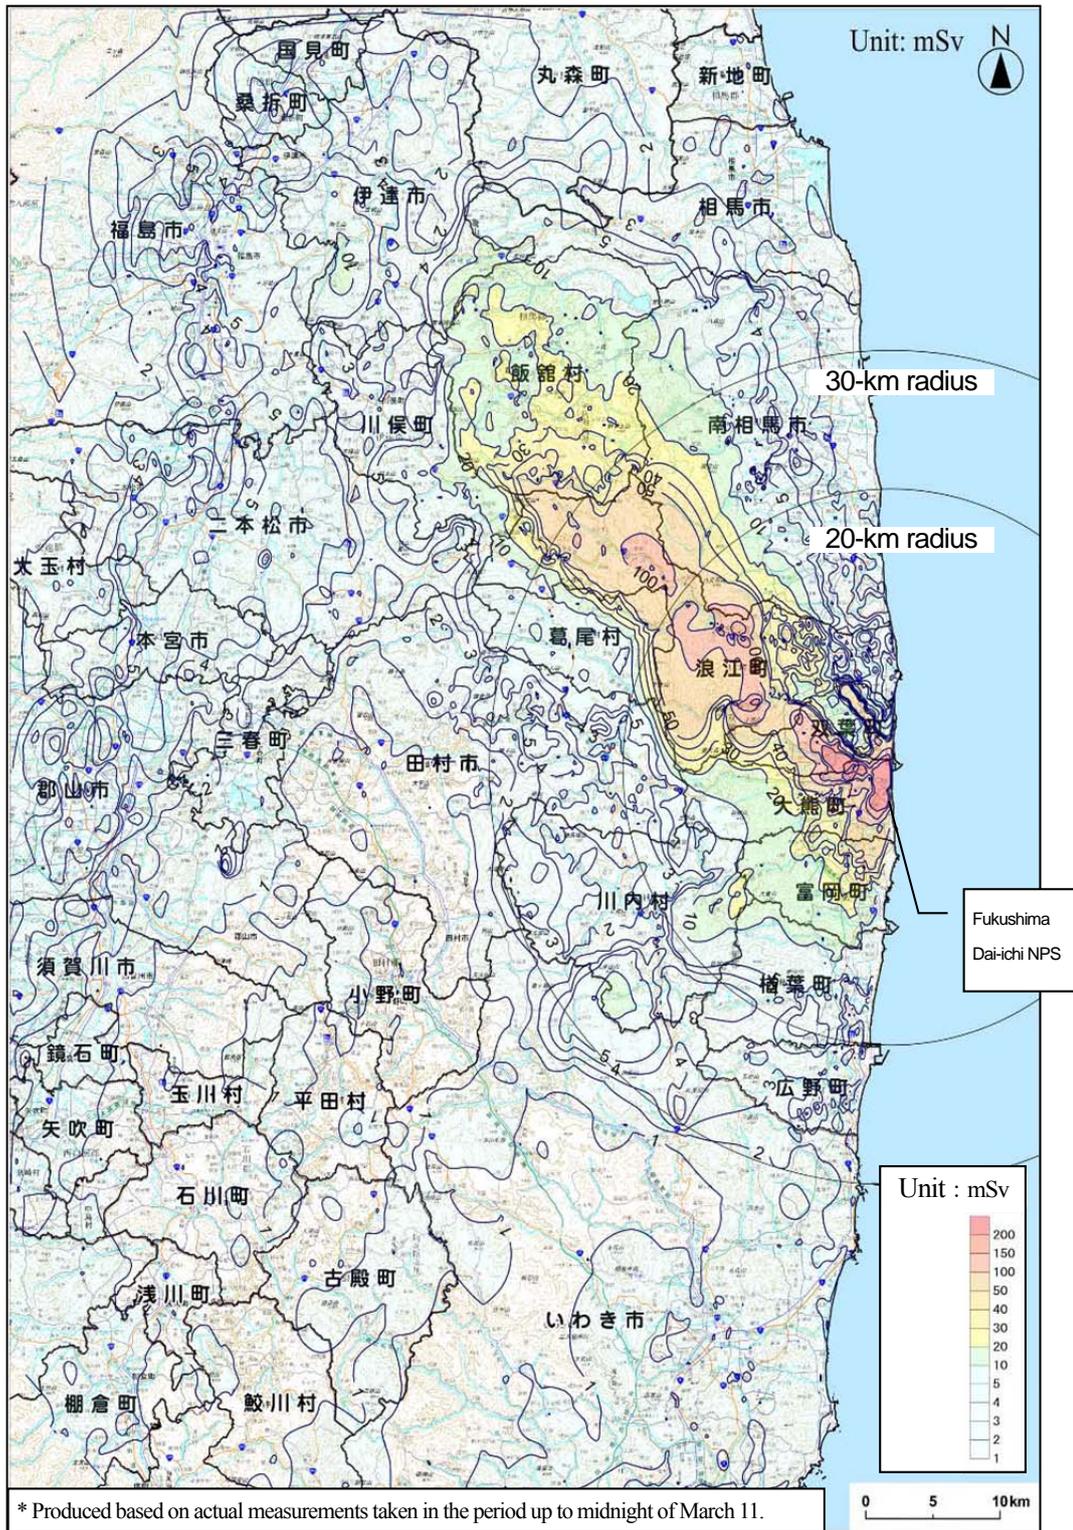
Fig. II-4 Estimated cumulative dose distribution map (cumulative dose in the period up to November 11, 2011)

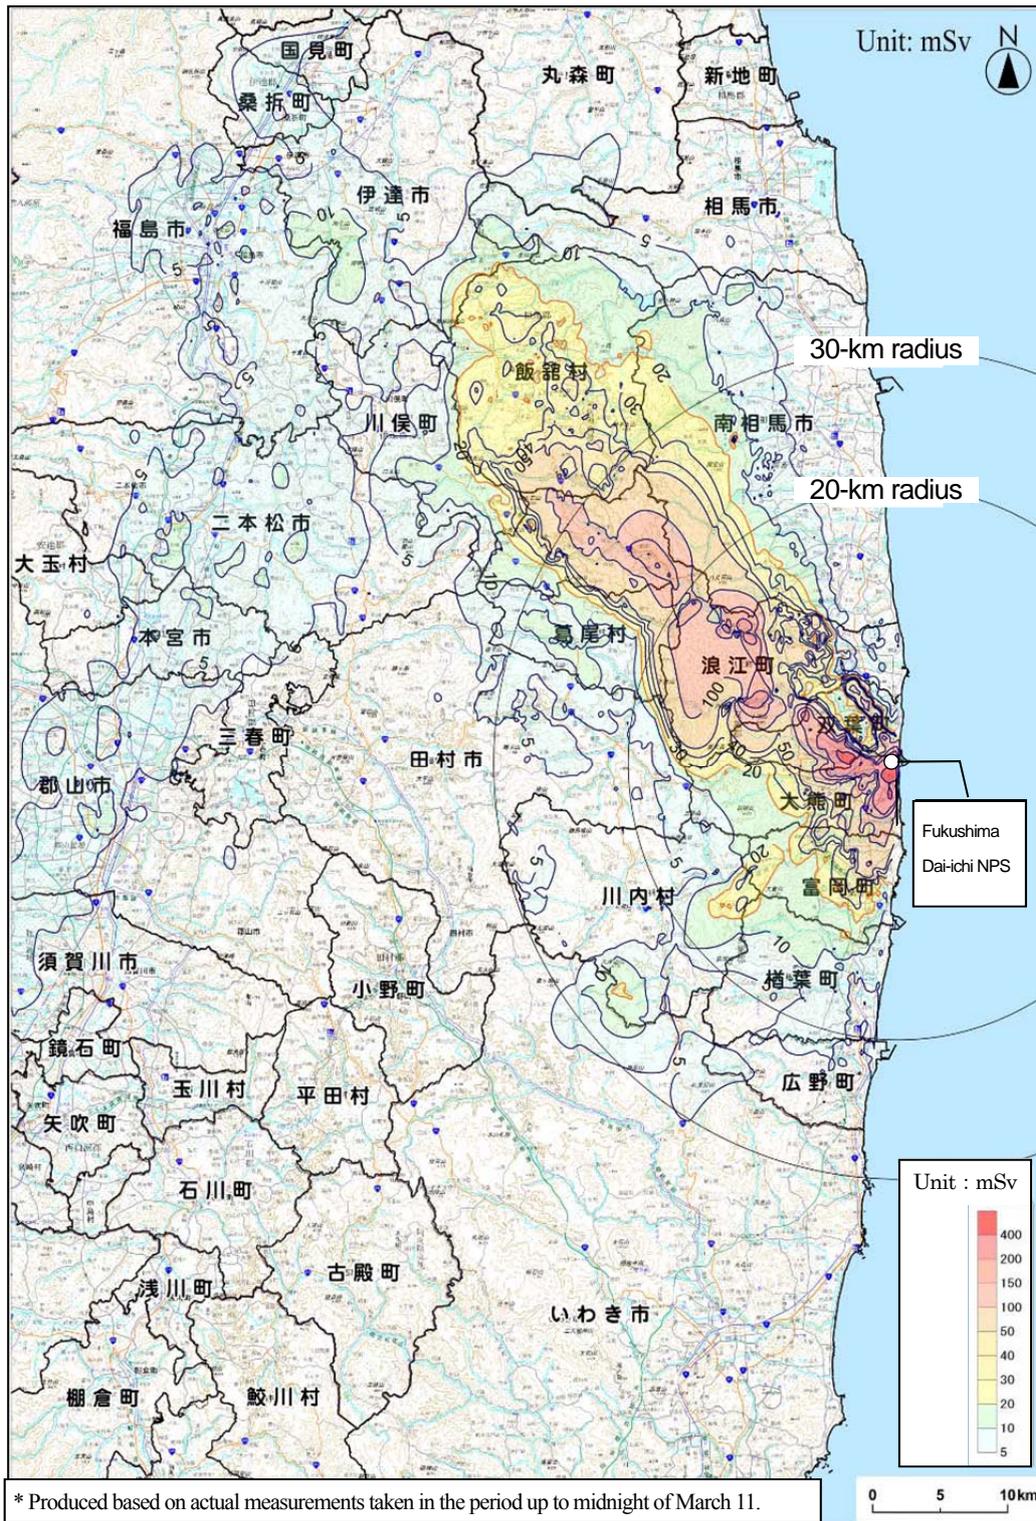
Fig. II-5 Estimated cumulative dose distribution map (cumulative dose in the period up to March 11, 2012)
