Photographs showing damage to the Unit 1 reactor building

Damage to the emergency diesel generators (DGs), metal clad switchgear (M/C) and power centers (P/Cs)

Photographs showing damage to facilities required for the supply of external power

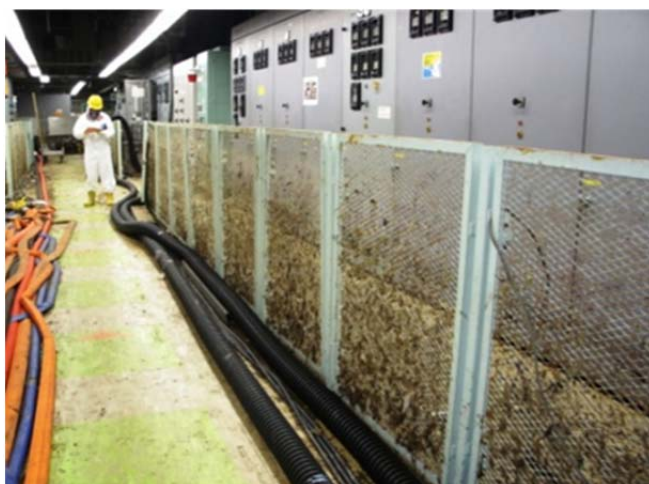
Picture (i): M/C on the north of the first floor, Unit 1 turbine building.
(Traces of the tsunami remain at shoulder height.)

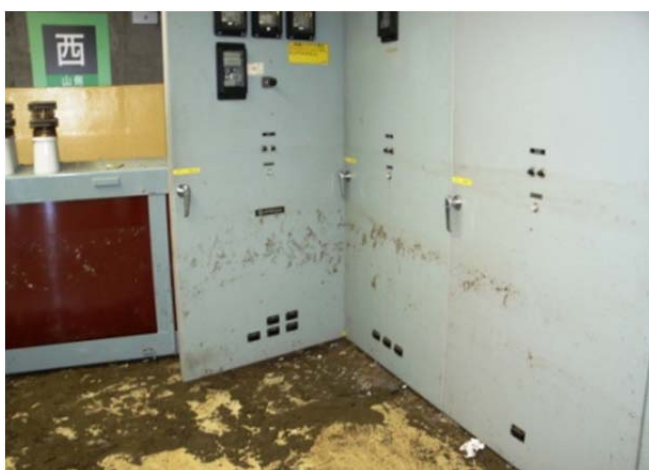
Picture (ii): M/C on the north of the first floor, Unit 1 turbine building.
(The device in the back is a breaker drawn out of the box.)

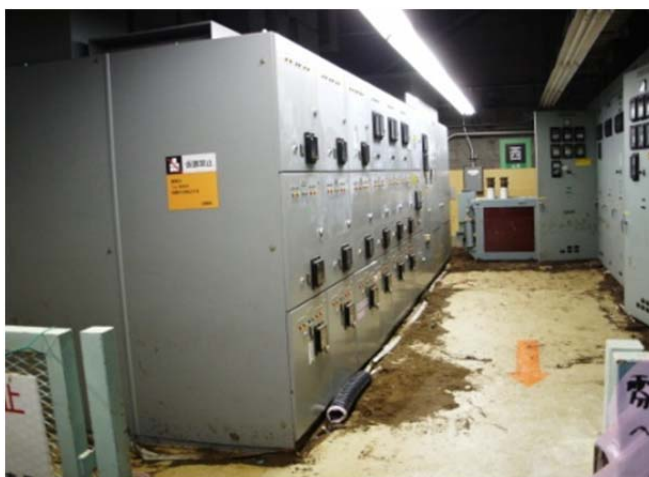
Picture (iii): P/C-1S on the first floor, Unit 1 turbine building.

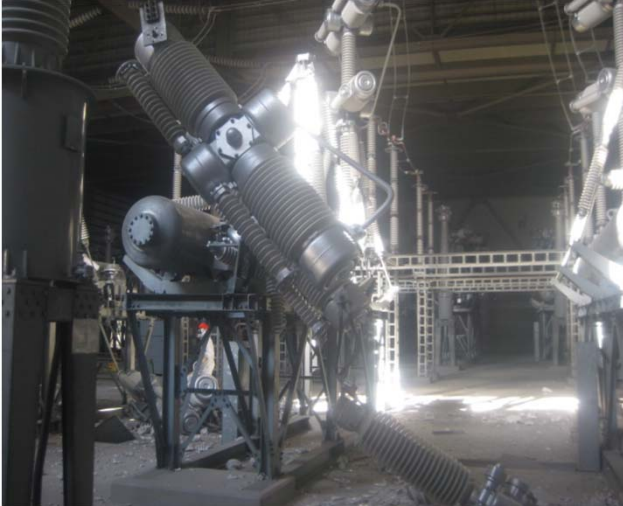
March 23, 2011 Photographed by Tokyo Electric Power Company
Picture (i): Breaker (O-81) having fallen inside the switching station for Units 1 and 2.

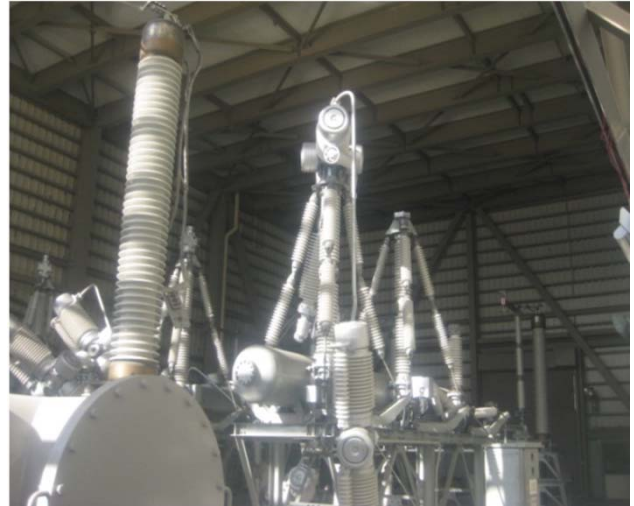
March 23, 2011 Photographed by Tokyo Electric Power Company
Picture (ii): Breaker (O-82) having fallen inside the switching station for Units 1 and 2.

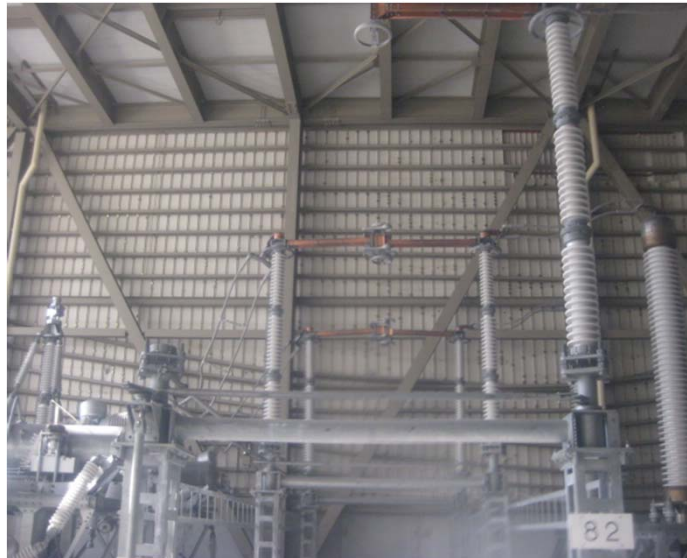
March 23, 2011 Photographed by Tokyo Electric Power Company
Picture (iii): Disconnection switch having fallen inside the switching station for Units 1 and 2.

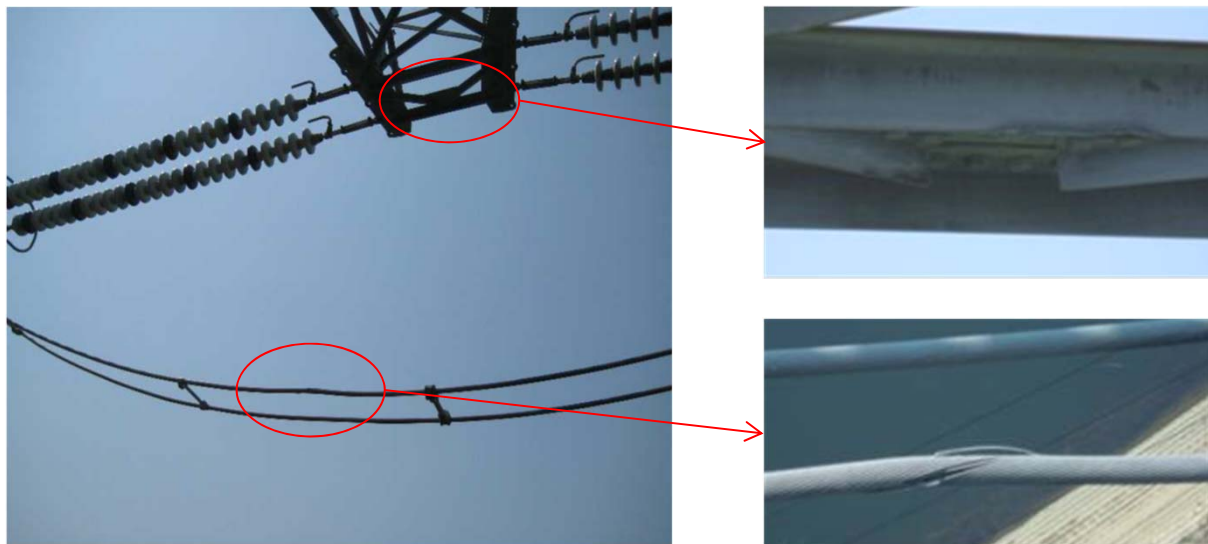
Picture (iv): Arc scratches confirmed on L3 of the Okuma Transmission Line (Pylon No.7 of L3 and L4 of the Okuma Transmission Line).

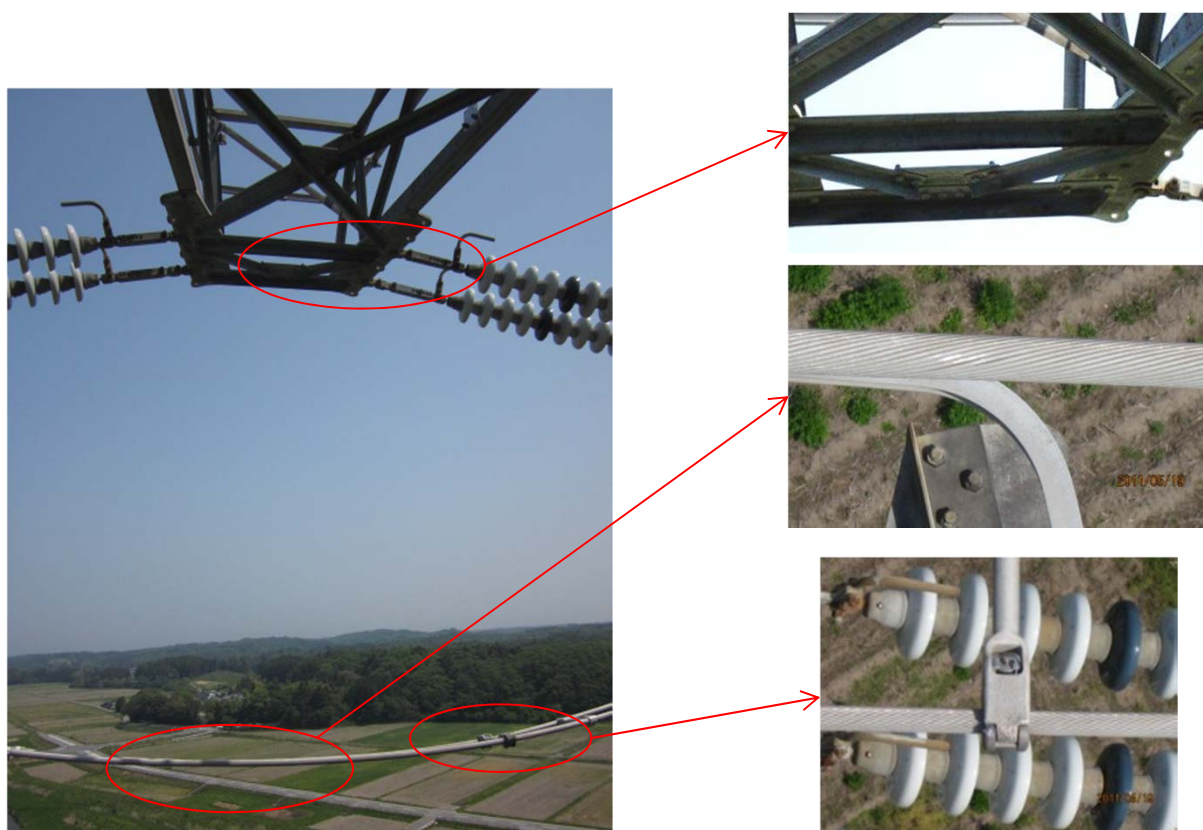
Picture (v): Arc scratches confirmed on L4 of the Okuma Transmission Line (Pylon No. 11 of L3 and L4 of the Okuma Transmission Line.)

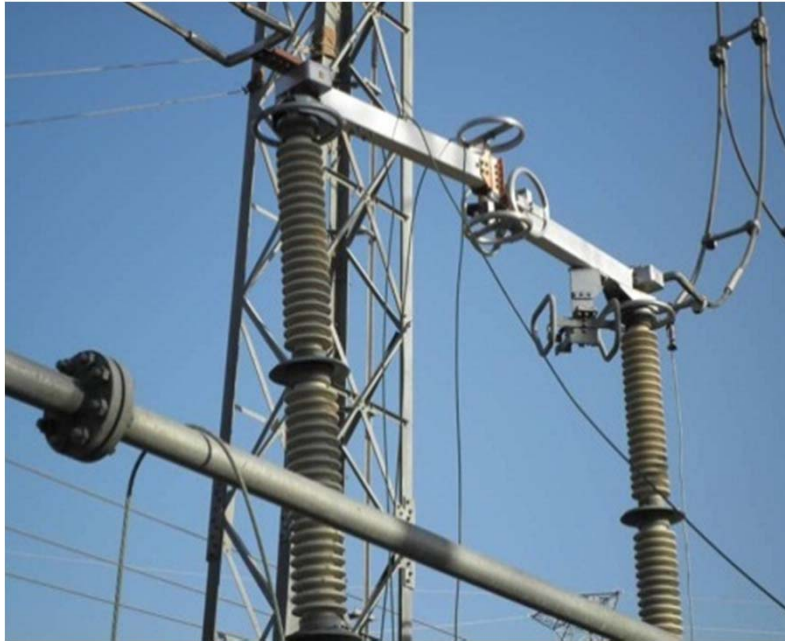
Picture (vi): Disconnected ground wire inside the Shin Fukushima Substation (Okuma Transmission Line, L3).

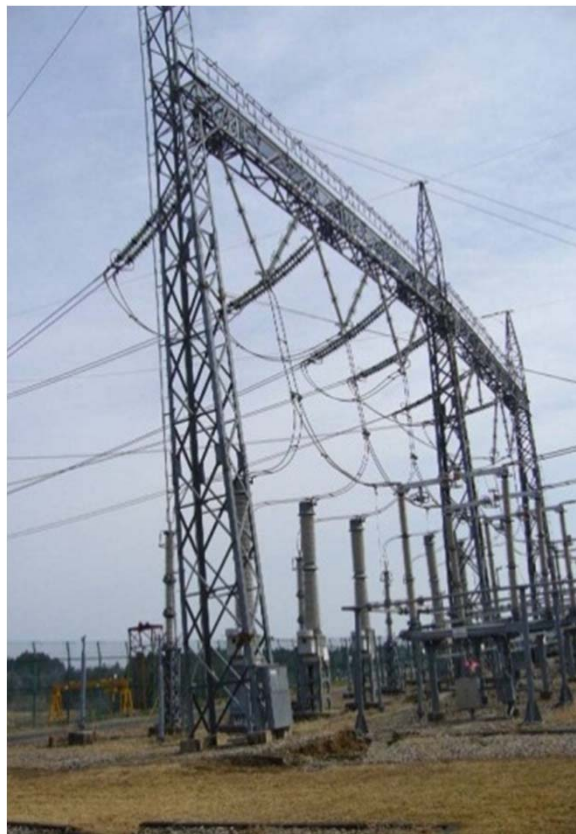
Picture (vii): Tilted steel structure for lead-in, Okuma Transmission Line, L3 and L4.

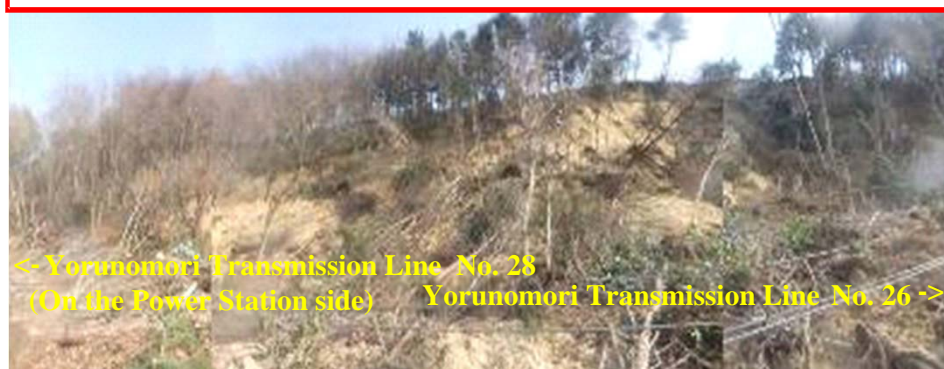
Collapse of the pylon (Viewpoint (ii))

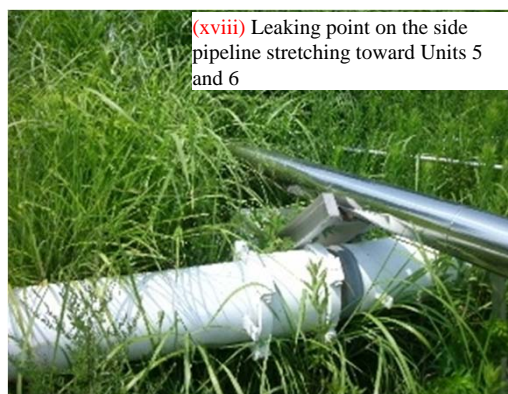
(xviii) Leaking point on the side pipeline stretching toward Units 5 and 6
August 15, 2011 Photographed by Tokyo Electric Power Company

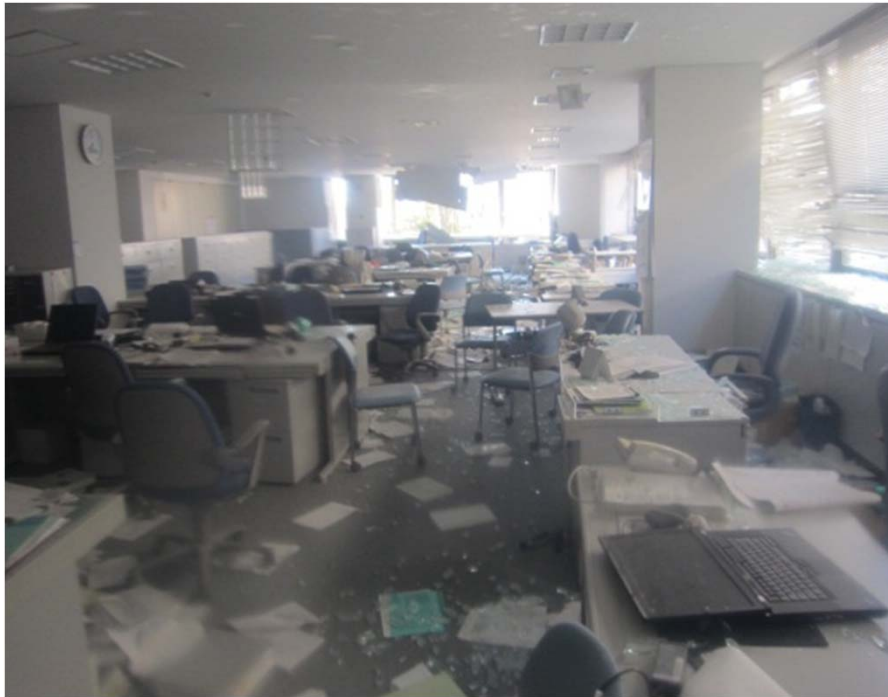
Picture (i): Inside the office of the Public Relations Department on the first floor.

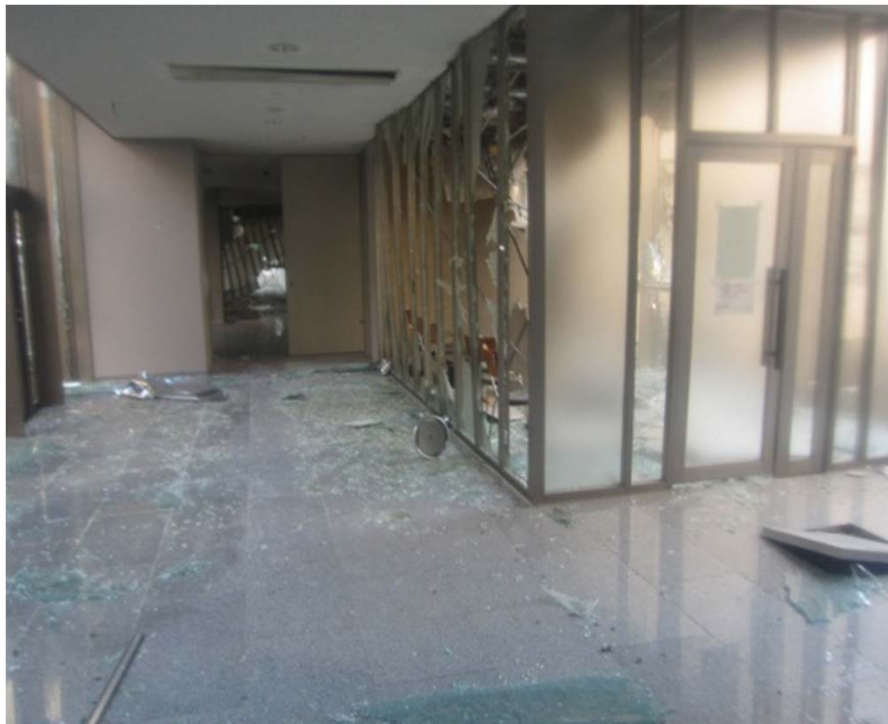
Picture (ii): Hallway near the entrance on the first floor.

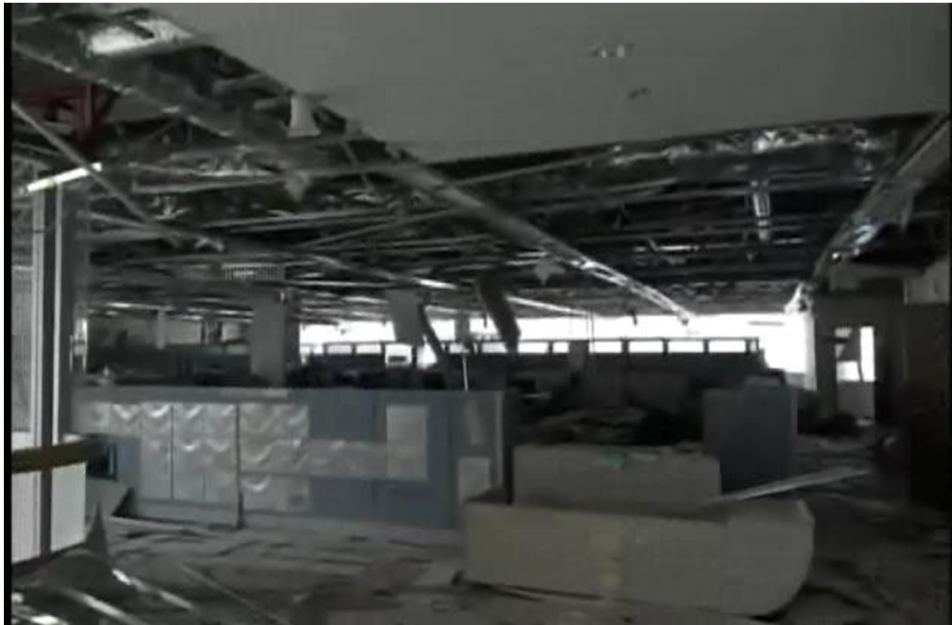
Picture (iii): Inside the office of the General Affairs Department on the second floor.

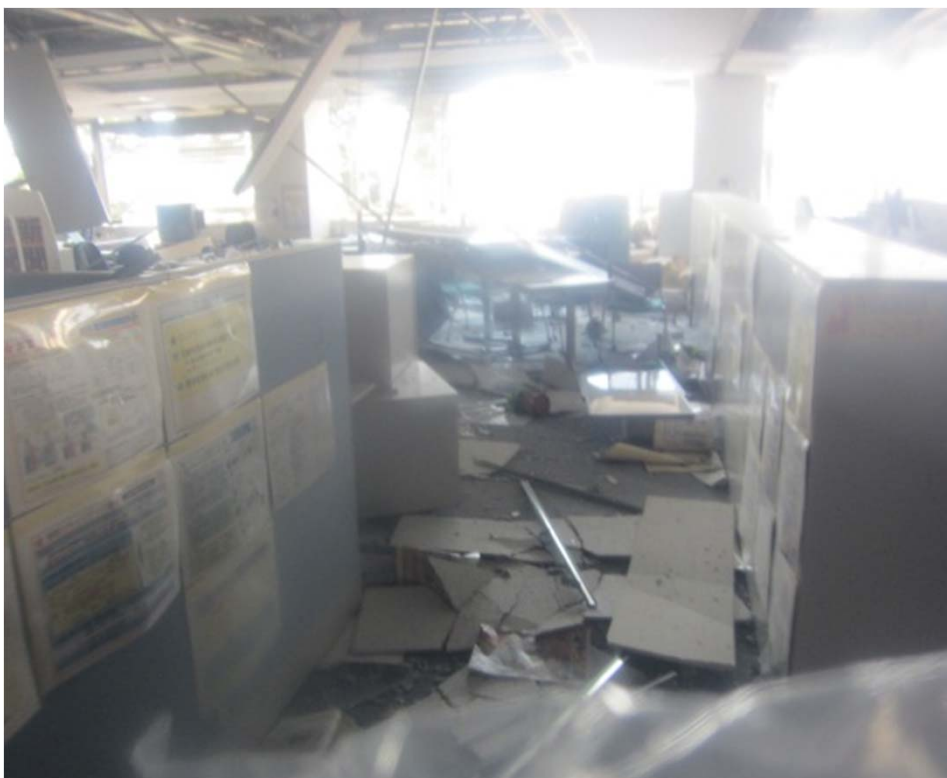
Picture (iv): Inside the office of the General Engineering Department on the second floor.

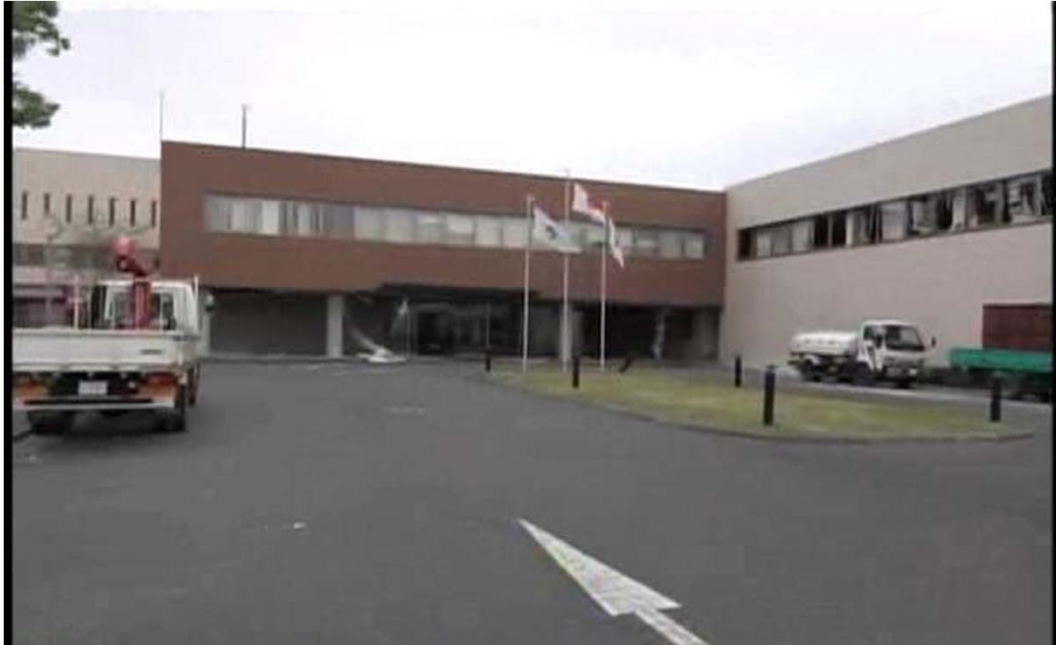
Picture (v): Exterior of the main building.

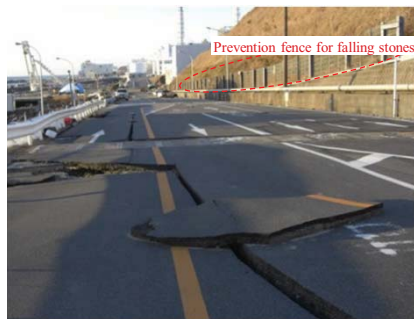
The lane on the sea side cracked parallel to the road and created a gap. The west side was passable. Photographed by TEPCO on March 17, 2011.

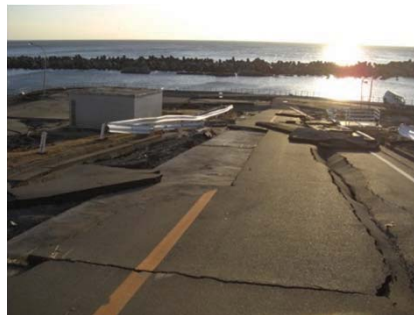
Although this area had had reinforcement work, cracks and gaps occurred on the sides of road which had not been reinforced. Photographed by TEPCO on March 17, 2011

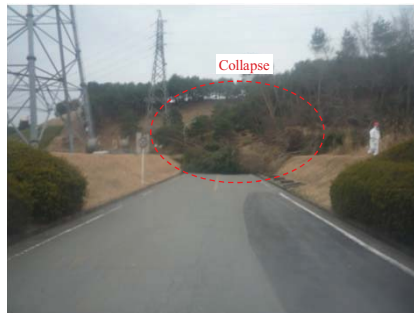
Although this is not an emergency access road, the slopes collapsed and blocked the road, leaving it impassable. Photographed by TEPCO on March 20, 2011

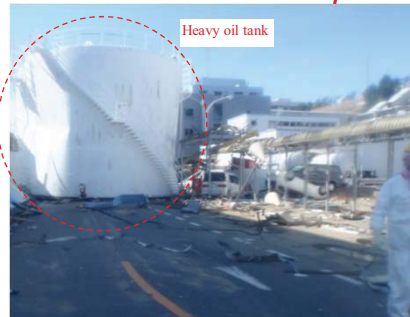
Although there was no major damage to the road, a heavy oil tank washed in by the tsunami. No particular problem was observed on the straight road stretching from the main gate road, leaving it impassable. Photographed by TEPCO on March 17, 2011

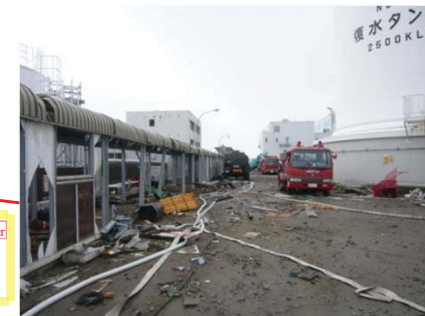
Although no particular problem was observed with the road, rubble scattered around due to the tsunami and explosion Photographed by TEPCO on March 16, 2011

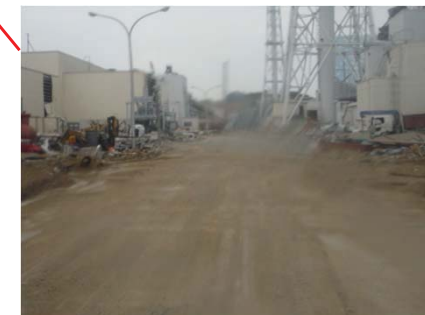
No particular problem was observed on the west sides of Units 1 to 4. When Units 1, 3 and 4 were damaged, rubble scattered around. Photographed by TEPCO on March 20, 2011

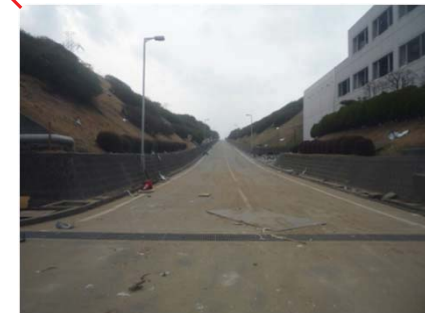
Despite the scattering of some rubble, no particular problem was observed on the road.
 Photographed by TEPCO on March 20, 2011
