Attachment V-1

# Overview of the penetration of groundwater into the basement of Unit 6 buildings

# Highly contaminated water outflow routes near the Unit 2 water intake (plane view)

# Response to the outflow of highly contaminated water near the Unit 2 water intake (status at the time of detection)

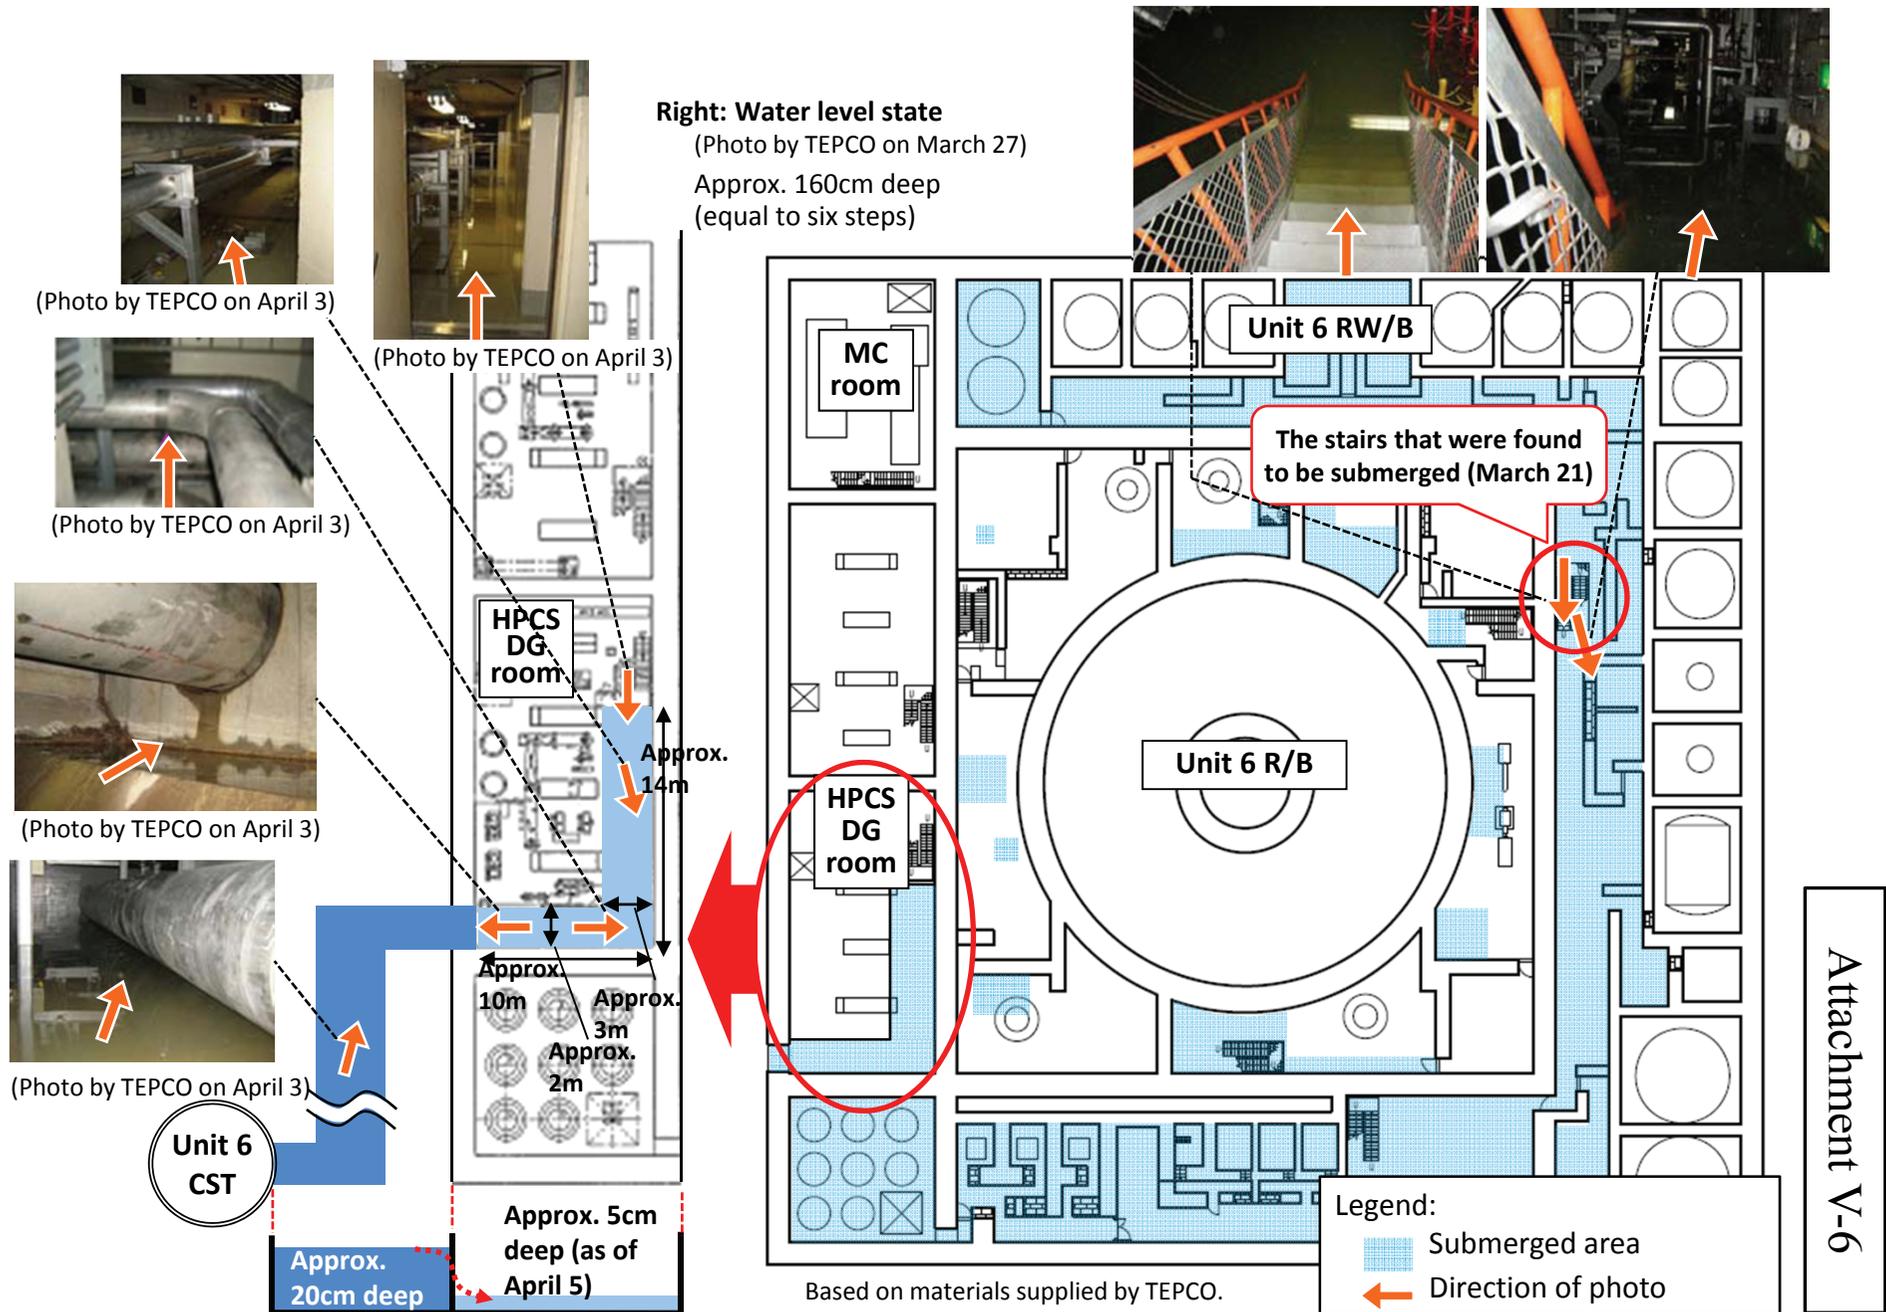
# Overview of water that remained in the second basement area of the Unit 6 R/B and RW/B

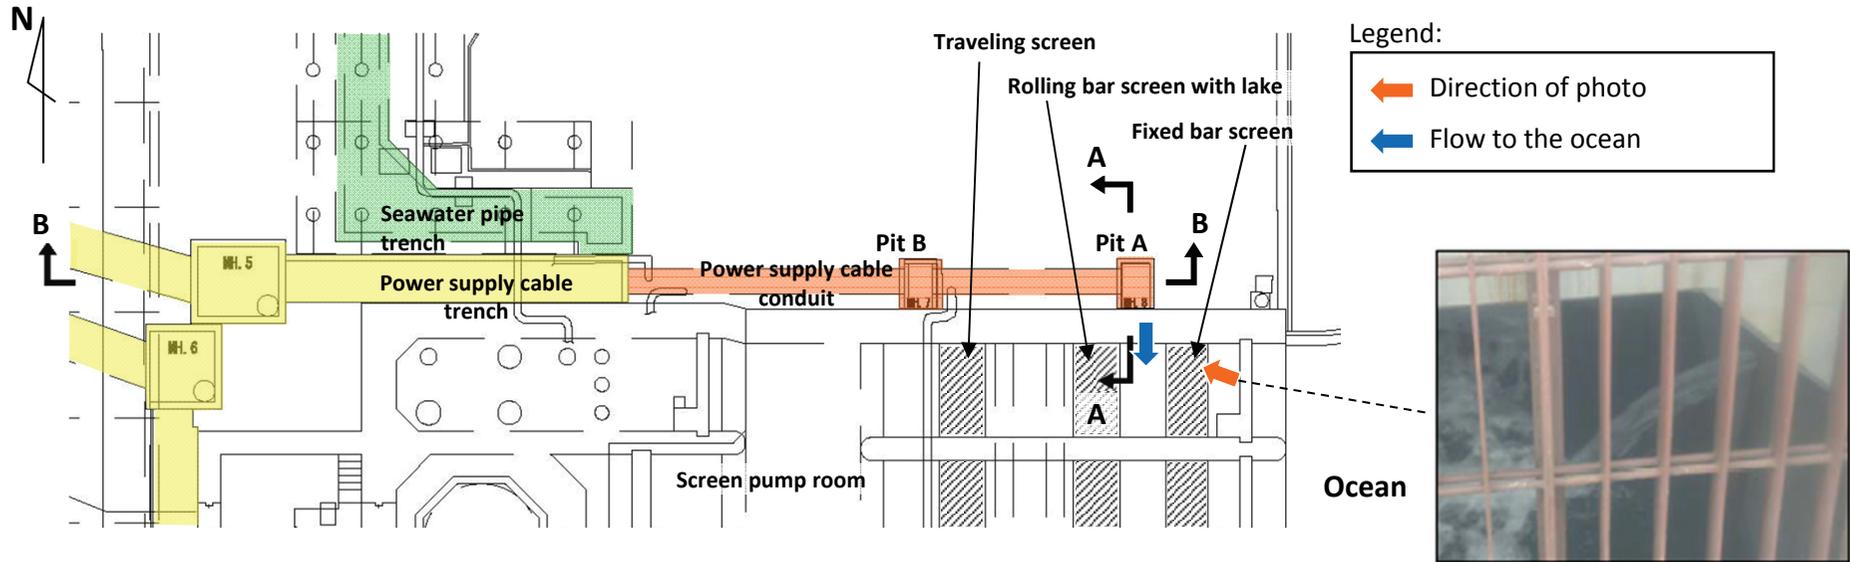
Attachment V-10

Photo of outflow (taken by TEPCO at approximately 12:40 on April 2)

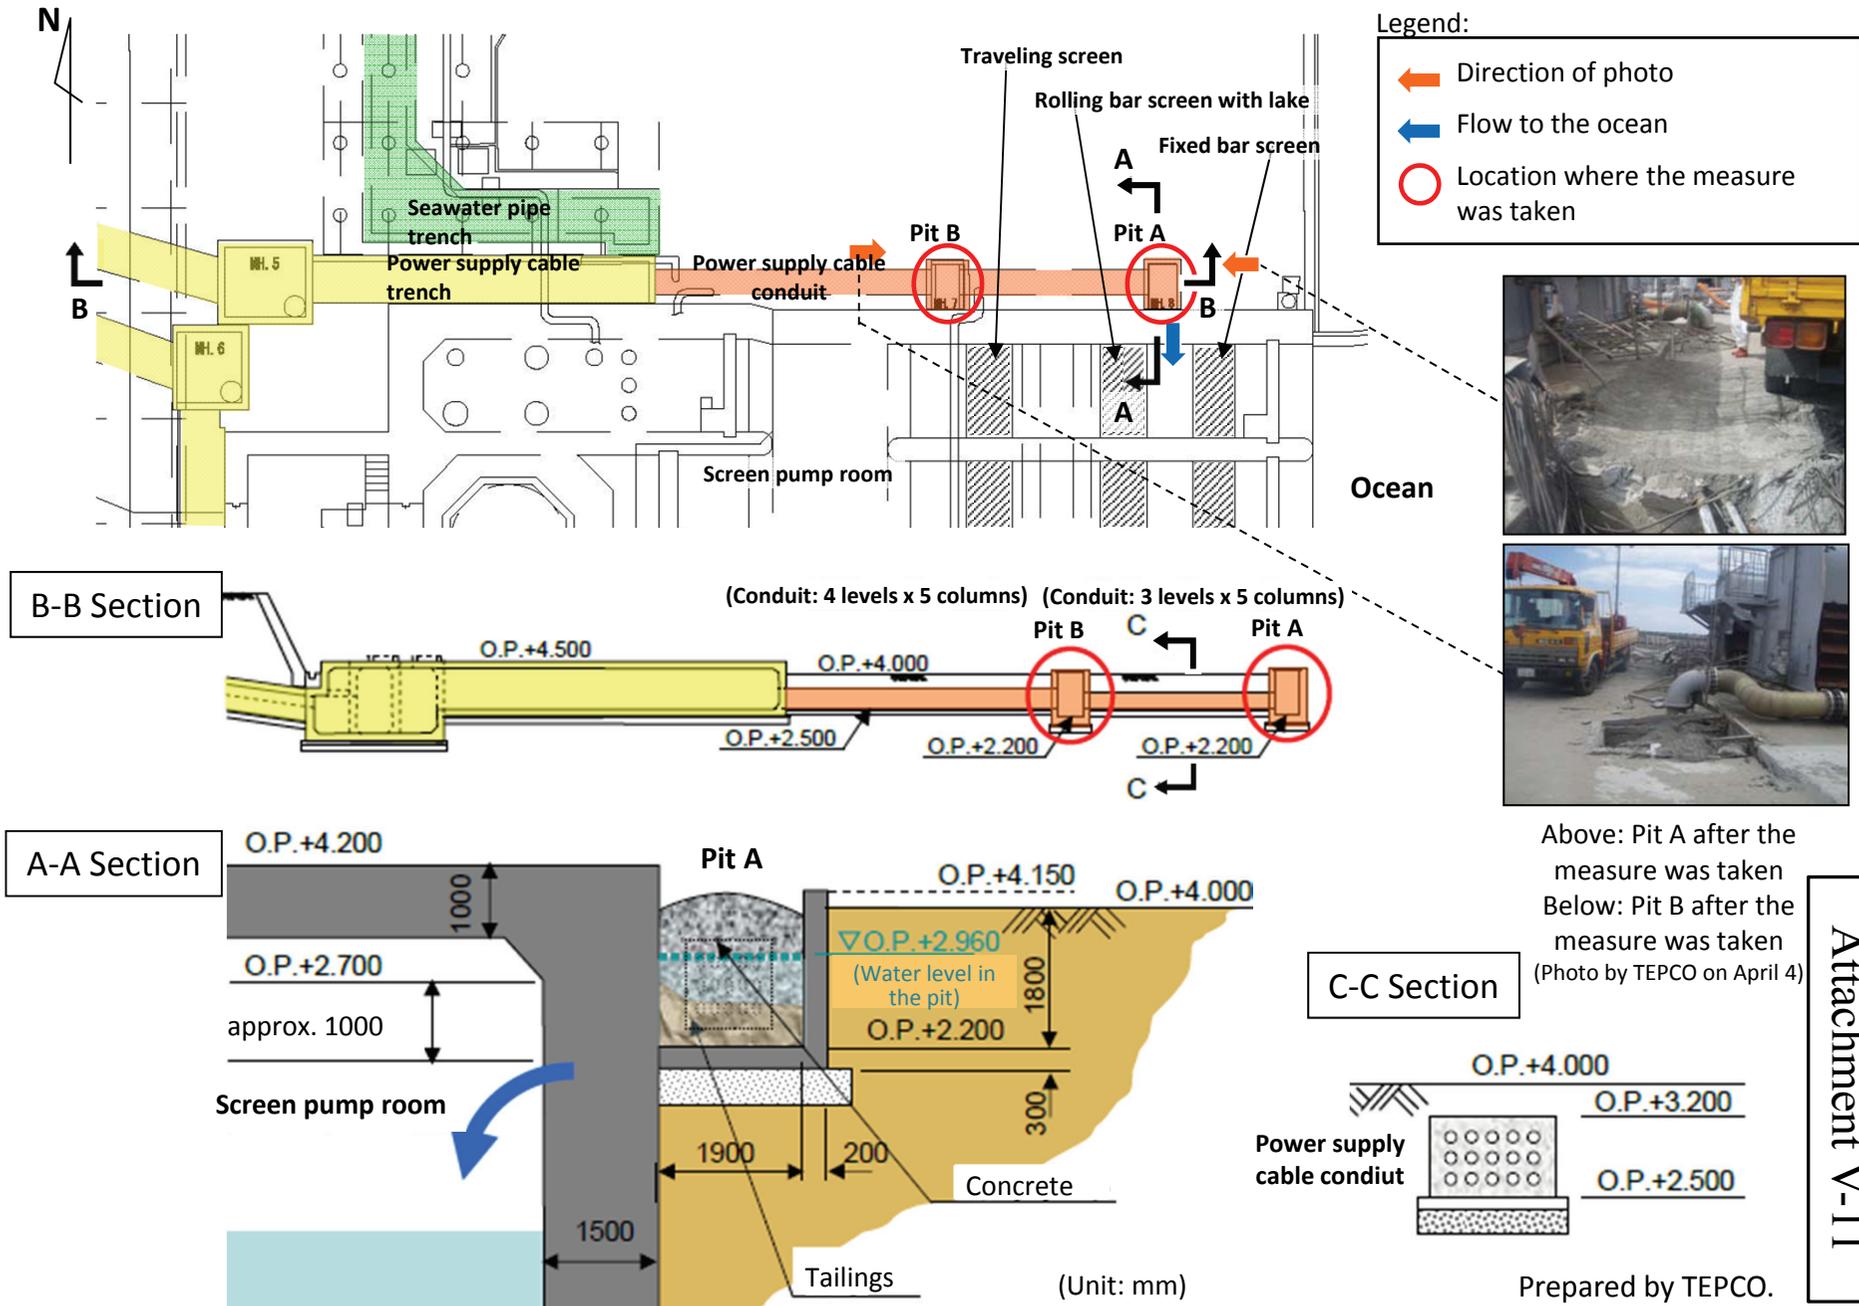
Attachment V-11

# Response to the outflow of highly contaminated water near the Unit 2 water intake (status after the injection of concrete)

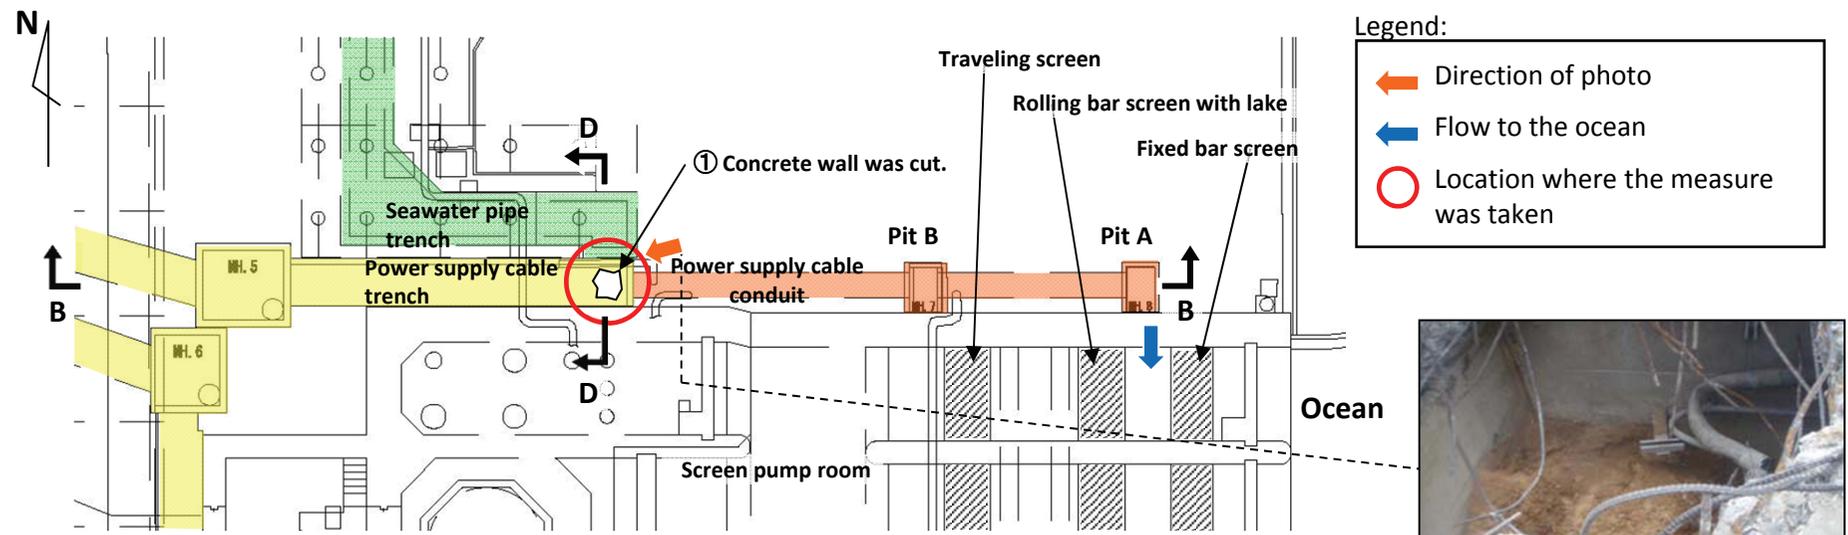
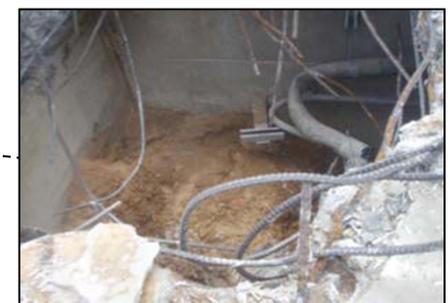
Attachment V-12

# Response to the outflow of highly contaminated water near the Unit 2 water intake (status after the injection of polymer, etc.)

Polymer injection  
(Photo by TEPCO at 13:47 on April 3)

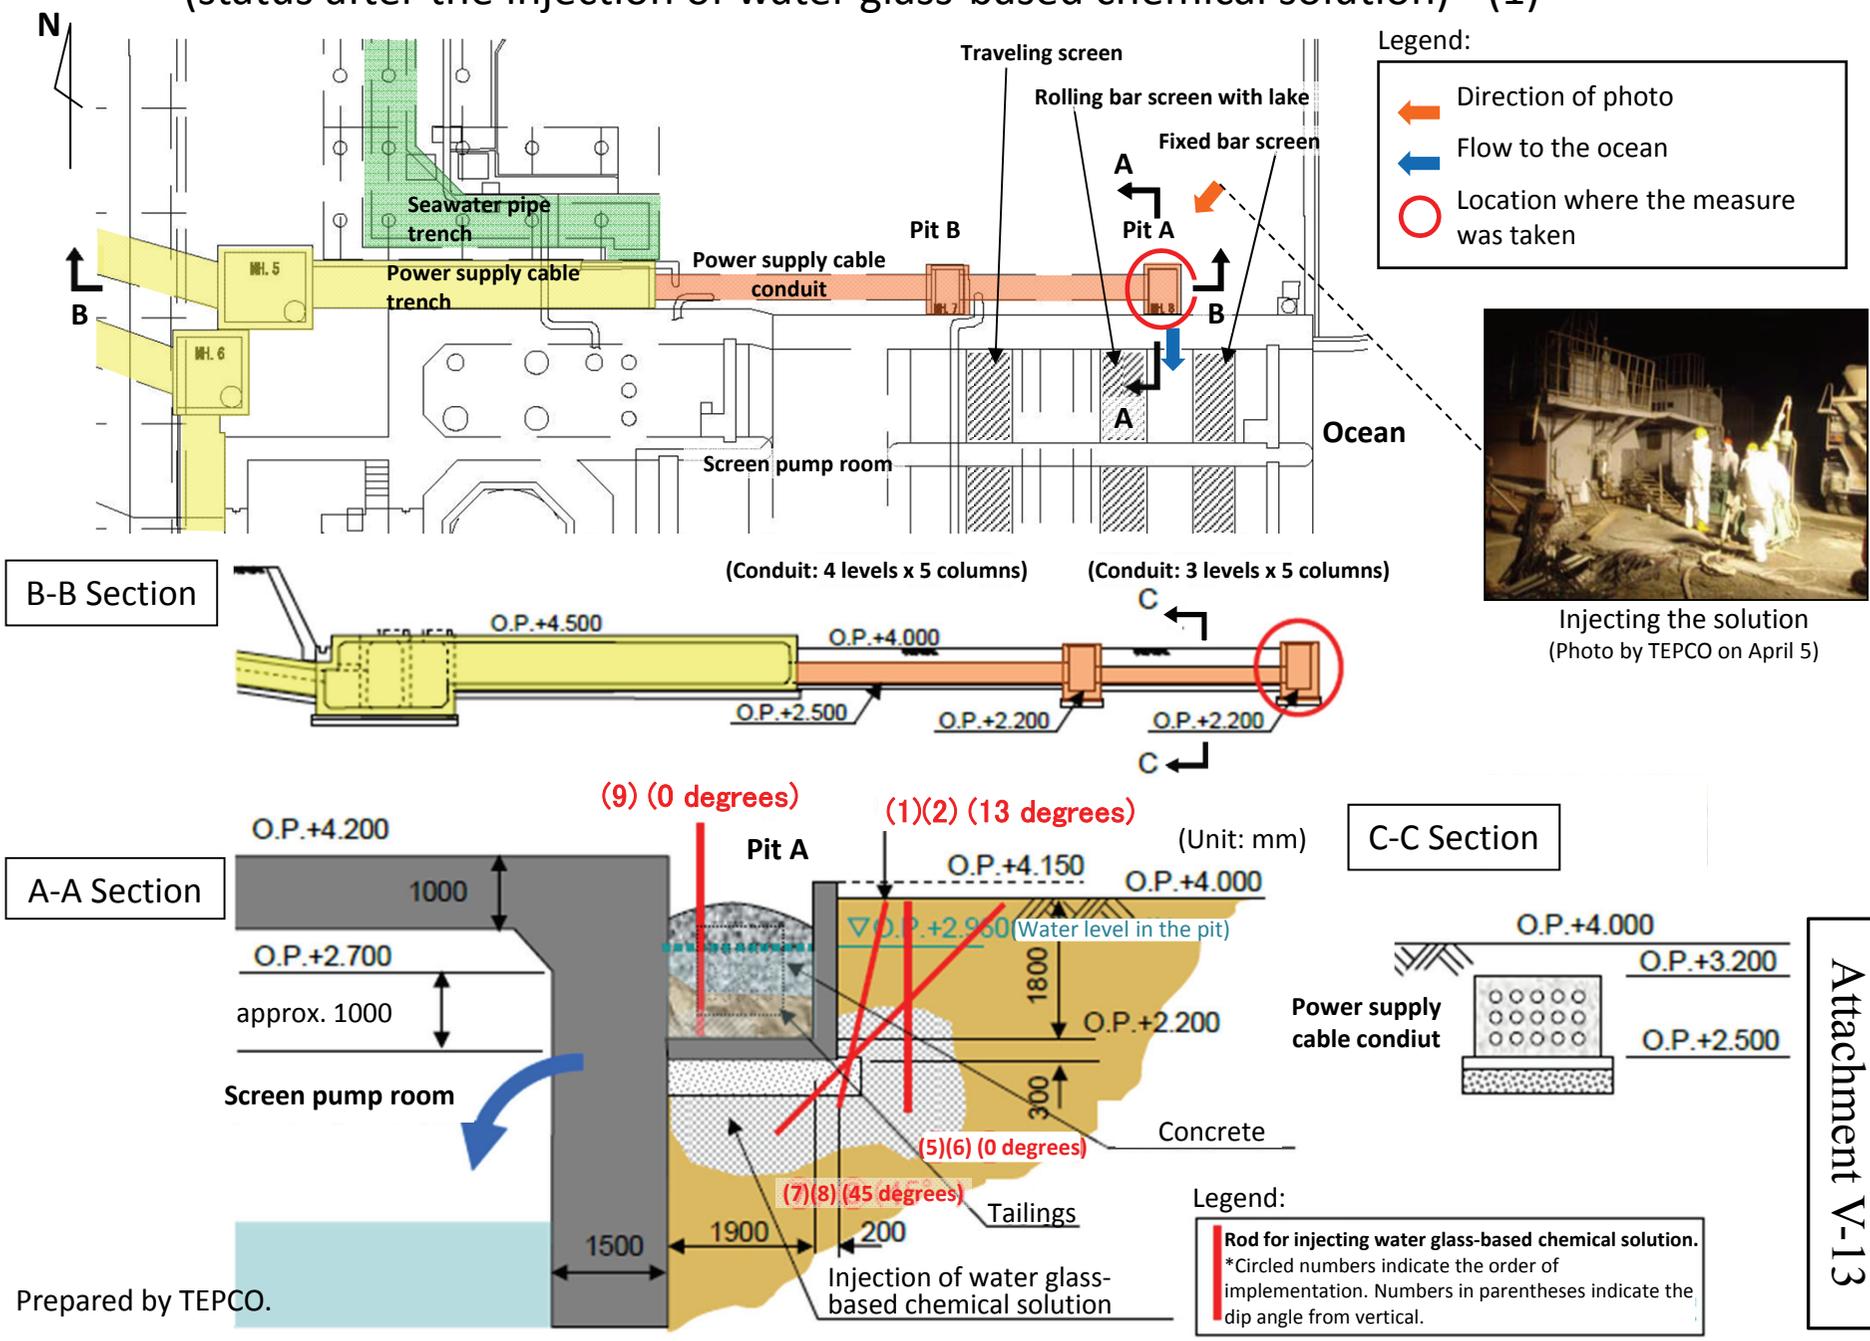
# Response to the outflow of highly contaminated water near the Unit 2 water intake (status after the injection of water glass-based chemical solution) - (1)

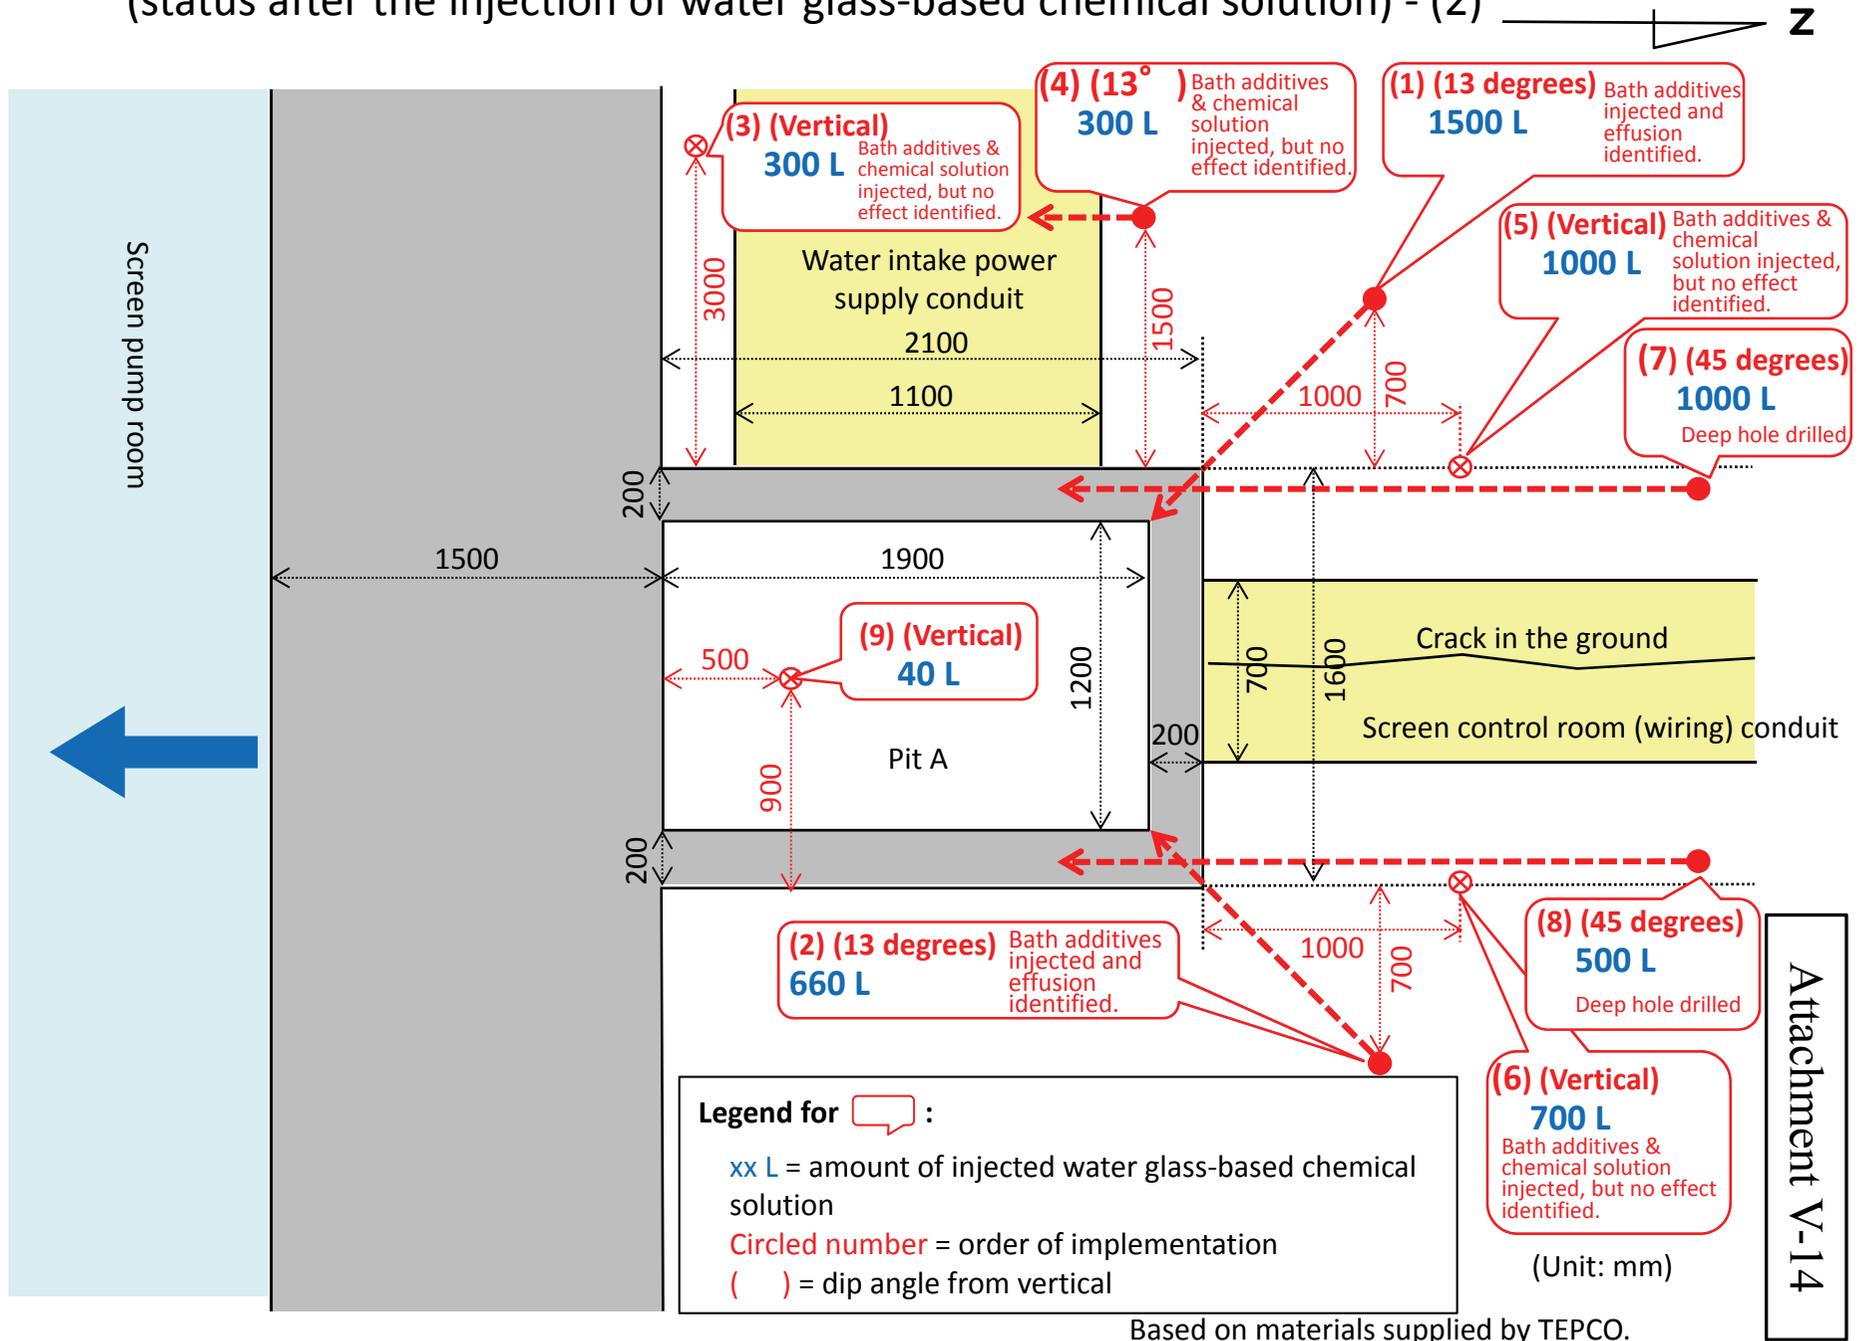
# Response to the outflow of highly contaminated water near the Unit 2 water intake (status after the injection of water glass-based chemical solution) - (2)

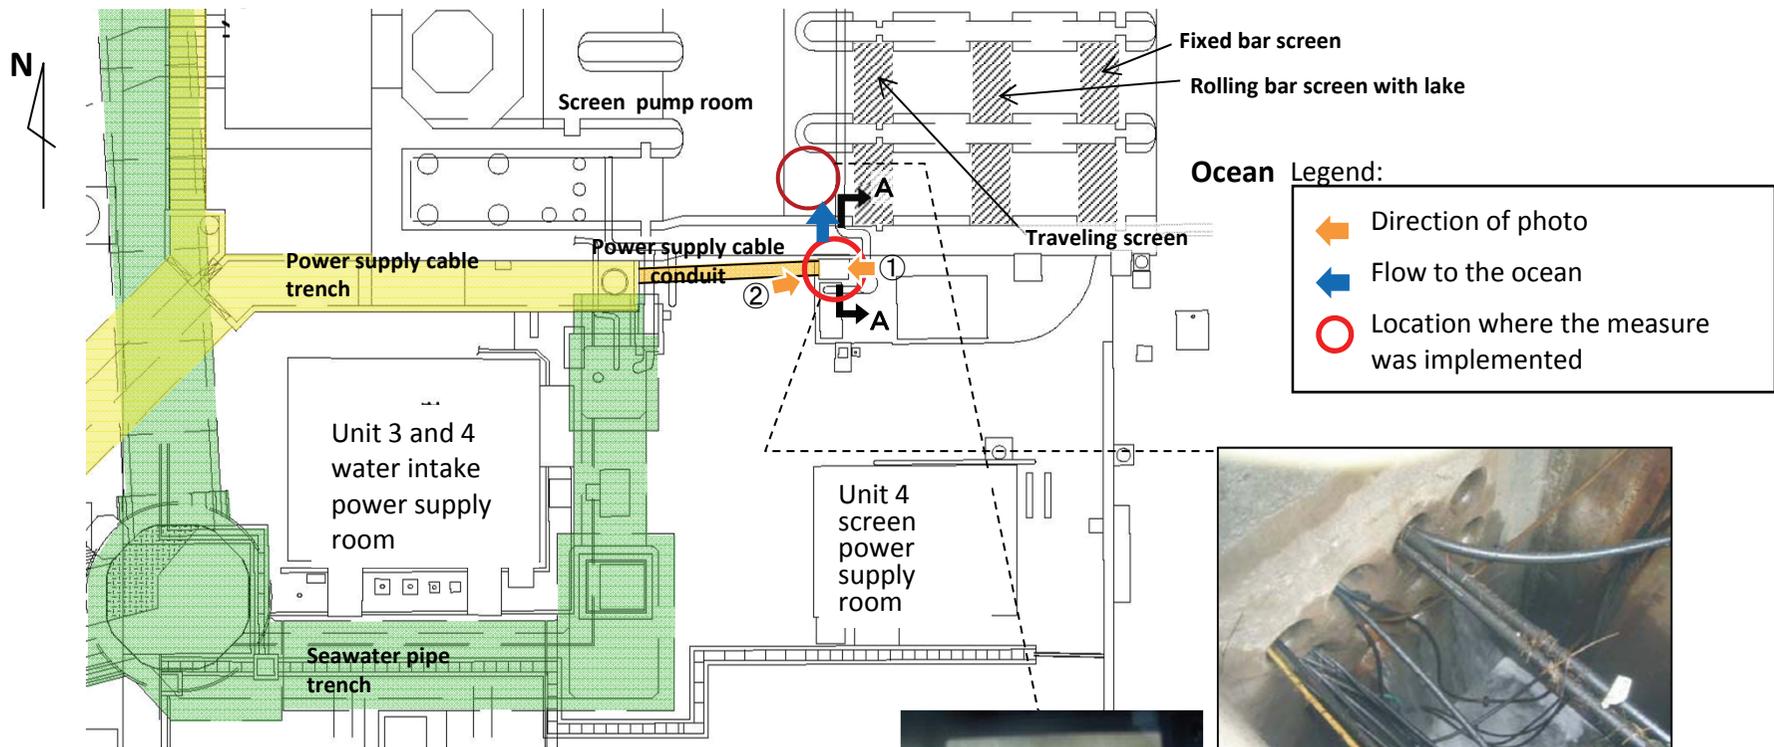
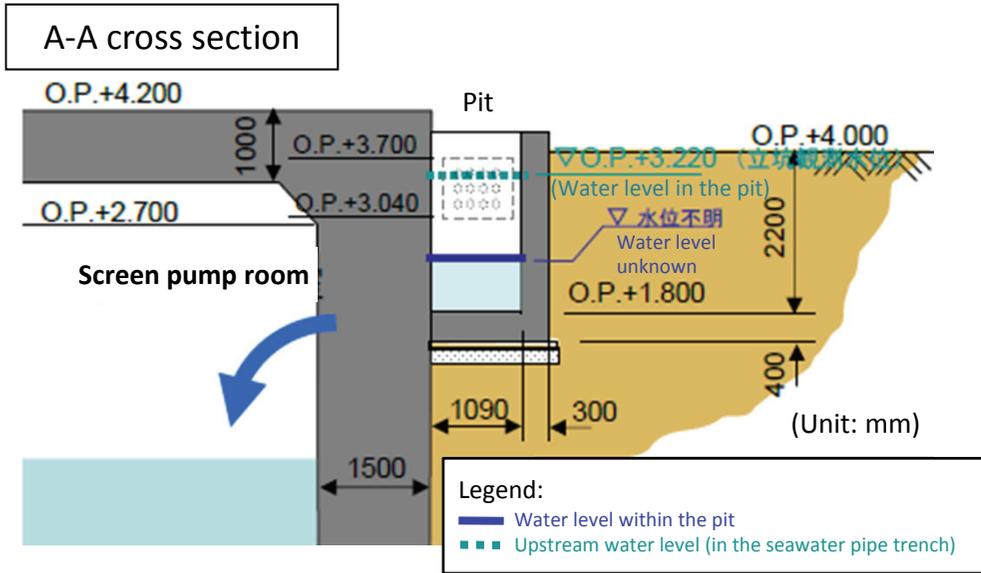
Attachment V-20

# Response to the outflow of highly contaminated water near the Unit 3 water intake

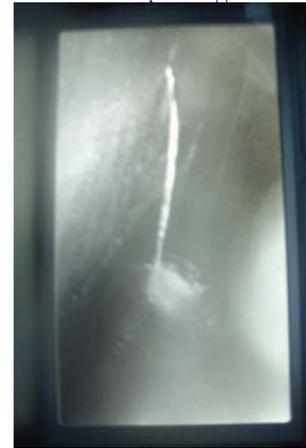
Water leakage from the power supply cable pit to the screen area (photo by TEPCO at 18:30 on May 11)

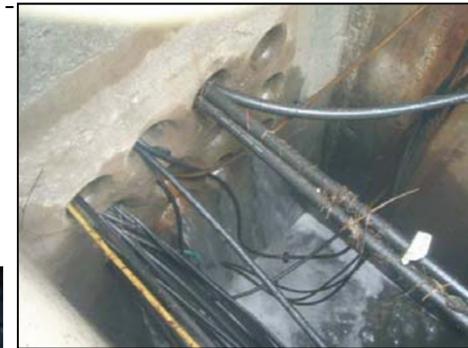
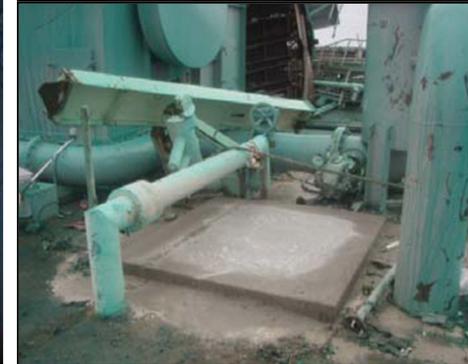
Above: water flow to the power supply cable pit (photo by TEPCO at 10:30 on May 11)  
Below: after concrete injected into the pit where leakage found (photos by TEPCO at 17:30 on May 12) Prepared by TEPCO.
