PROGRESS STATUS OF PROJECT PROPOSALS CONCERNING THE IMPERIAL STEEL WORKS AND ONGA RIVER PUMPING STATION

PROJECT PROPOSALS FOR THE IMPERIAL STEEL WORKS AND ONGA RIVER PUMPING STATION, COMPONENT PARTS OF THE “SITES OF JAPAN’S MEIJI INDUSTRIAL REVOLUTION: IRON AND STEEL, SHIPBUILDING, AND COAL MINING”

3.1.1. First Head Office (from report by Nippon Steel Corporation)

3.1.2. Former Forge Shop and Repair Shop (from report by Nippon Steel Corporation)

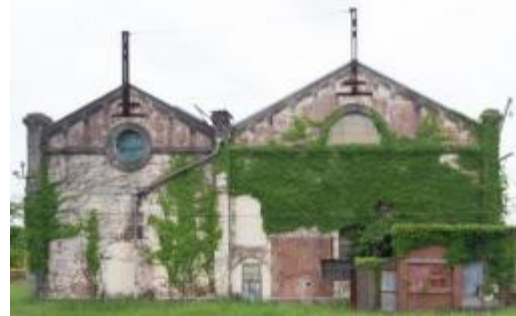
Onga River Pumping Station
(view of west side)

- Although the intrinsic energy in the east-west direction exceeds the input energy, Q_u/ZW (load resistance when interstitial deformation limit is 1/150) is small, indicating a lack of aseismic performance. In the out-of-plane direction, gable wall deformation is large, and both horizontal bending and perpendicular bending fail to meet the targets, so that reinforcement is necessary.

- In the north-south direction, roof braces will break first of all and not be able to transfer support to the two gabled brick walls, indicating a lack of aseismic performance. In the out-of-plane direction, deformation of the central portion is large, and both horizontal bending and perpendicular bending fail to meet the targets, so that reinforcement is necessary. In addition, eccentricity occurs.

- From the above analysis, in both the east-west and north-south directions, reinforcement is necessary to improve out-of-plane load resistance and reduce out-of-plane buckling.

***Based on the diagnosis performed in FY2018, aseismic design is scheduled to be carried out in FY2019. Thereafter, the aseismic reinforcement work is to be implemented.**

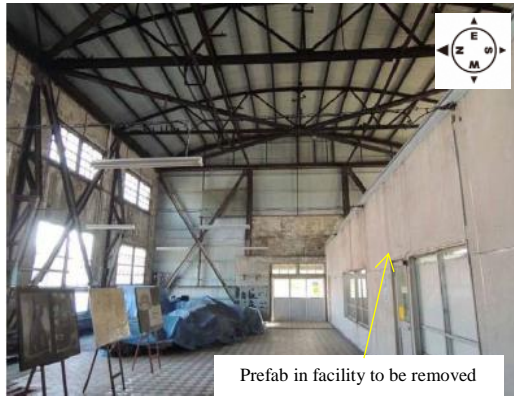
1) Current status photo (west → east)

This facility is in use as an archive of historical documents and other materials from the time the business was founded. Reinforcing it to safe level would require doubling the number of steel members for reinforcement, leaving space only in the central portion and making it difficult to use the facility effectively.

(1) Proposed reinforcement method (Work period: around one year (after relocation of historical materials))

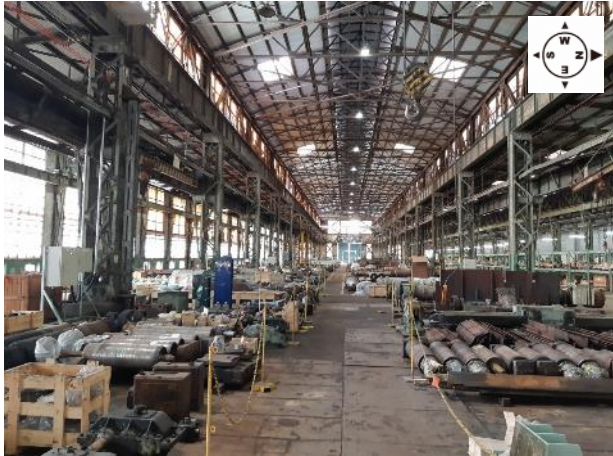
1) Current status photo (east → west)

This facility is in use for offline operations during periodic repairs and as a storage place for spare materials. Reinforcing it to safe level would require doubling the number of steel members for reinforcement, leaving no space for storing spare materials and making it difficult to use the facility effectively.

(1) Proposed reinforcement method (Work period: around two years (including measures for obtaining spare materials storage capacity and relocation))

In the case of this reinforcement proposal as well, measures will be needed such as relocation of spare materials racks interfering with reinforcement members in the north wing and provision of new racks due to inability to use the hoist crane in the south wing. Measures for obtaining storage capacity for spare materials are thus under study.
