## Monitoring charts for the “Sites of Japan’s Meiji Industrial Revolution: Iron and Steel, Shipbuilding and Coal Mining”

Appendix e)-2 Monitoring charts consisting of general and individual charts for Shuseikan (Component Part 2-1/Area 2),  
the Terayama Charcoal Kiln (Component Part 2-2/Area 2),  
and the Sekiyoshi Sluice Gate of Yoshino Leat (Component Part 2-3/Area 2)

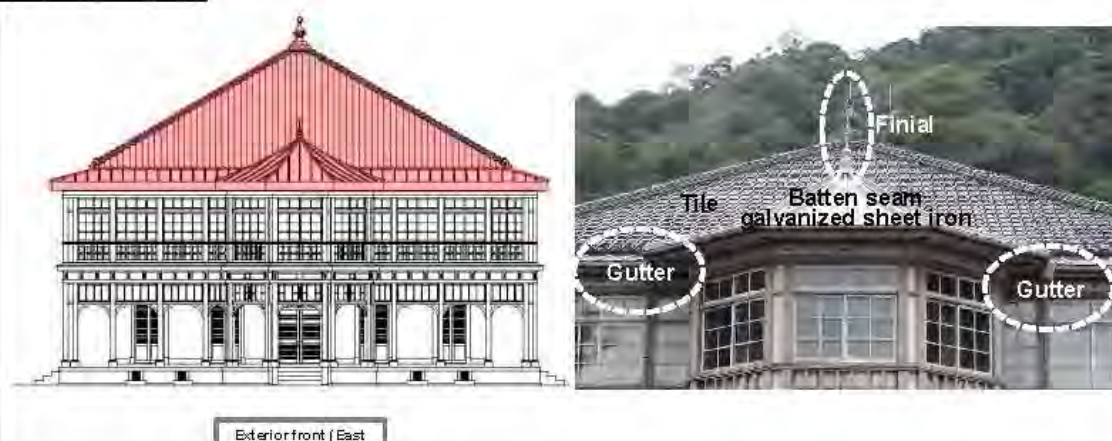
Floor No.	Roof	Part 1	Exterior front (East side)	Part 2	Roof
Materials	State/Remarks		Points to keep in mind (points to pass along in particular, etc.)		
Tile	Good		Check for tile damage, missing tile, cracks, etc.		
Batten seam galvanized sheet iron	Good		Check underlying materials for warping, displacement, breaks, corrosion, etc.		
Gutters (copper plate)	Good		Check for damage, fallen portions, instability of support hardware, etc.		
Exterior wall finial (tile)	Good		Check for damage, missing tile, cracks, etc.

Position of degradation or damage		
Date of record		Position of damage (location)
Position diagram/photo		
Special remarks (measures to be taken)		
History of repairs, etc.	Repairs were made in two spots to damaged gutters (March 1-31, 2016).

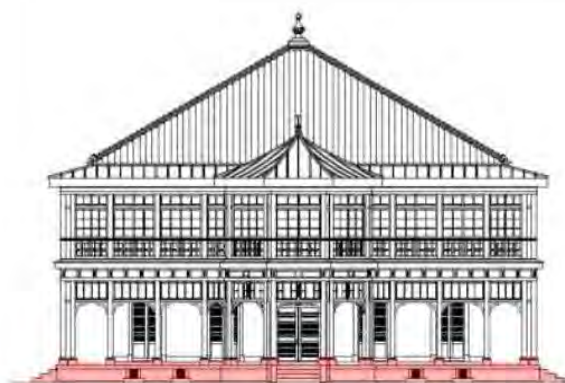
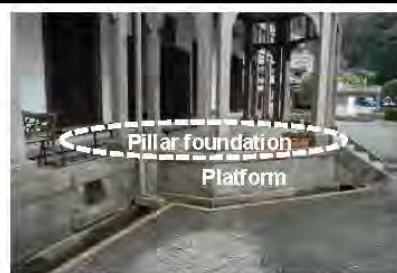
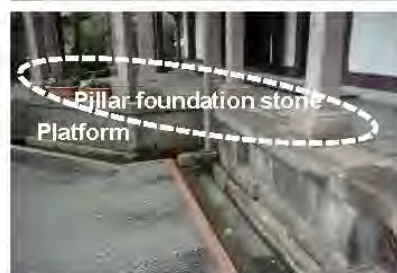
Floor No.	1st floor	Part 1	Exterior front (East side)	Part 2	Foundation
Materials	State/Remarks			Points to keep in mind (points to pass along in particular, etc.)	
Foundation stone	Good			Check for cracks, break away parts, damage, etc., to stone	
Pillar foundation stone	Crack in stone in 1 location			Check for cracks, break away parts, damage, and termite damage to stone	
[Diagram, photos, etc.]

Position of degradation or damage			
Date of record	2016/12/15	Position of damage (location)	Pillar foundation stone near front entrance
Position diagram/photo	<p>Exterior front (East side)</p>		
Special remarks (measures to be taken)	A crack can be seen in the pillar foundation stone. Since this does not require immediate repair, we will monitor how it progresses. It will be fixed the next time repair work is being carried out.		
History of repairs, etc.

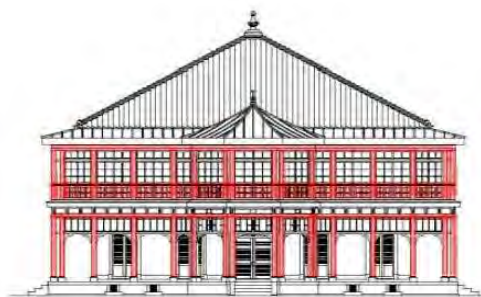
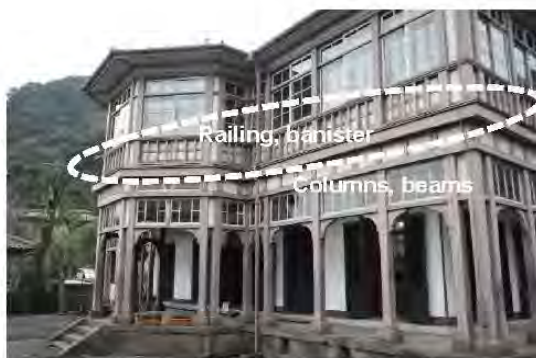
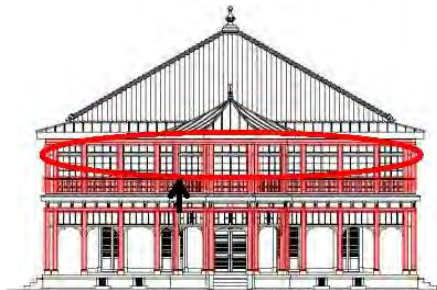
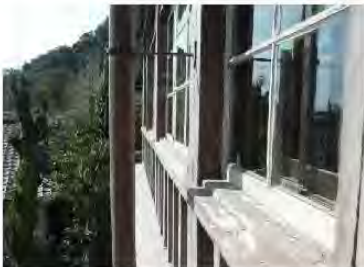
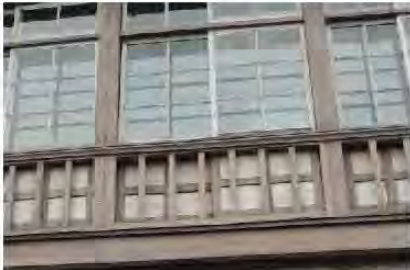
Floor No.	1st and 2nd Floor	Part 1	Exterior front (East side)	Part 2	Columns, beams
Materials	State/Remarks			Points to keep in mind (points to pass along in particular, etc.)	
Wooden columns, beams	Overall fading, some paint peeling			Check for peeling paint, cracks, fading, corrosion, termite damage, etc.	
Railing, banister	Overall fading, some paint peeling			Check for peeling paint, cracks, fading, corrosion, etc.	
[Diagram, photos, etc.]

Position of degradation or damage			
Date of record	2016/12/15	Position of damage (location)	2nd floor railing
Position diagram/photo

Special remarks (measures to be taken)	There is deterioration of the paint on the columns, beams, railings, and banisters due to UV light, and along with fading, there is some peeling. We will continue to monitor the impact on the base wood materials and will paint it at the appropriate time.		
History of repairs, etc.

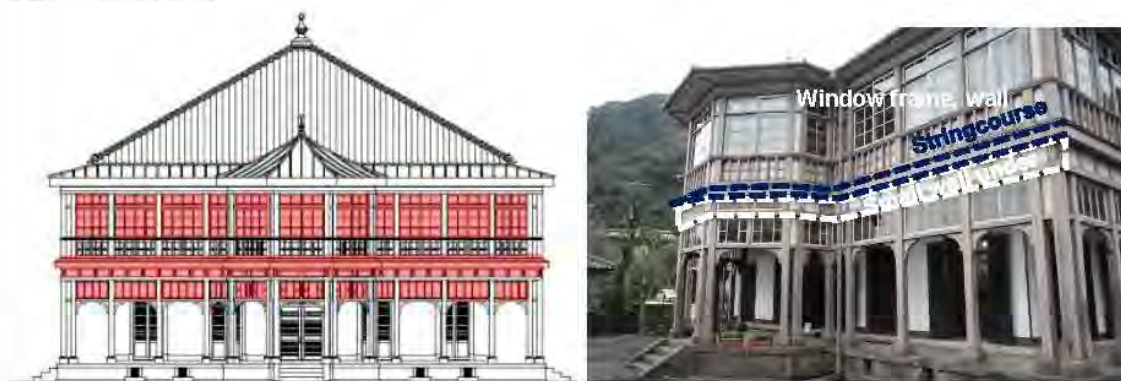
Floor No.	1st and 2nd floors	Part 1	Exterior front (East side)	Part 2	Exterior wall
Materials	State/Remarks		Points to keep in mind (points to pass along in particular, etc.)		
Wall surface (wood & plaster)	Good		Check plaster surface for cracks and peeling, fading, stains, dirt, etc.		
Stringcourse (galvanized steel)	Good		Check for fissures and breakage, peeling, cracks, etc.		
Small wall under eaves (wood)	Good		Check for fissures and breakage, peeling, cracks, etc.		
Window frame (wood)	Overall fading, some paint peeling		Check for fissures and breakage, peeling, cracks, etc.

Position of degradation or damage			
Date of record	2016/12/15	Position of damage (location)	Window frame (wood)
Position diagram/photo	<p>Exterior front (East side)</p>		
Special remarks (measures to be taken)	There is deterioration of the paint on the window frame due to UV light, and along with fading, there is some peeling. We will continue to monitor the impact on the base wood materials and will paint it at the appropriate time.		
History of repairs, etc.

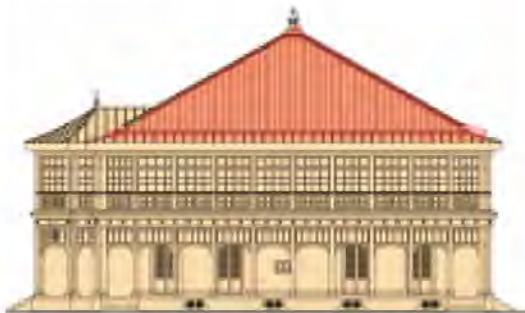
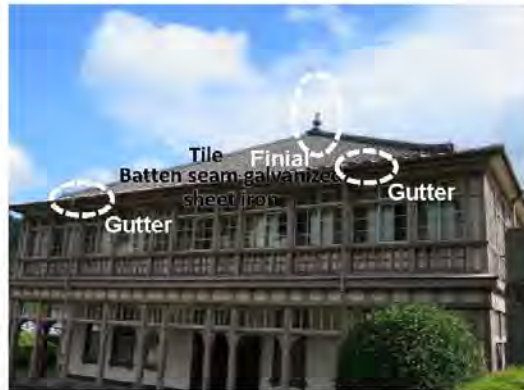
Floor No.	Roof	Part 1	Exterior side (North side)	Part 2	Roof
Materials	State/Remarks			Points to keep in mind (points to pass along in particular, etc.)	
Tile	Good			Check for tile breakage, missing tiles, cracks, etc.	
Batten seam galvanized sheet iron	Good			Check base materials for warping, displacement, breaks, corrosion, etc.	
Gutters (copper plate)	Gutter breakage in two locations.			Check for damage, fallen portions, instability of support hardware, etc.	
[Diagram, photos, etc.]

Position of degradation or damage			
Date of record	2016/12/15	Position of damage (location)	Gutters (2 locations)
Position diagram/photo	<p>Exterior side (North side)</p>		
Special remarks (measures to be taken)	The edge of the roof is curled up and there is breakage, so repairs will be done at the appropriate time.		
History of repairs, etc.

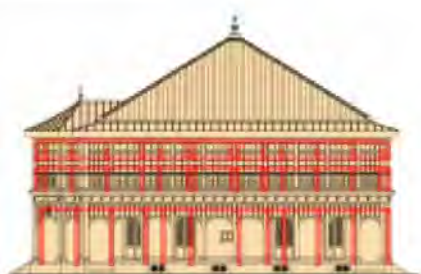
Floor No.	1st and 2nd floors	Part 1	Exterior side (North side)	Part 2	Columns, beams
Materials	State/Remarks		Points to keep in mind (points to pass along in particular, etc.)		
Wooden columns, beams	Overall fading, some paint peeling; vertical fissures can be seen on one column		Check for peeling paint, cracks, fading, corrosion, termite damage, etc.		
Railing, banister	Overall fading, some paint peeling		Check for peeling paint, cracks, fading, corrosion, etc.

Date of record 2016/12/15 Position of damage (location) 1st floor column portion

Special remarks (measures to be taken) There is deterioration of the paint on the columns, beams, railings and banisters due to UV light, and along with fading, there is some peeling. We will continue to observe the impact on the base wood materials and will paint it at the appropriate time. In addition, cracks can be seen on a column. We do not believe that this requires immediate repair, so we will monitor the progress and will fix it appropriately in response to the situation.

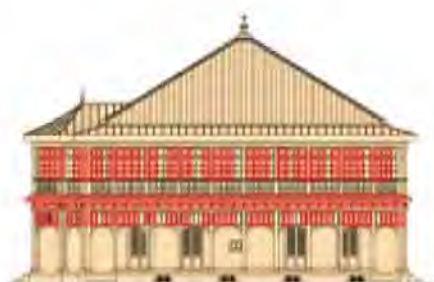
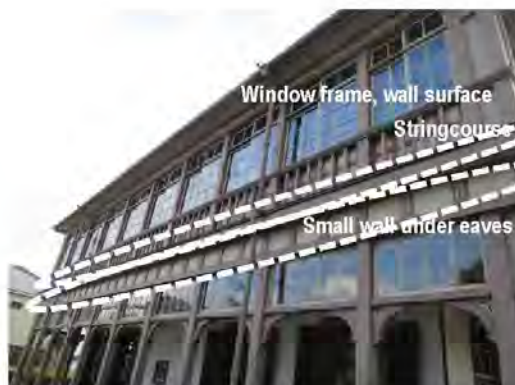
Floor No.	1st and 2nd floors	Part 1	Exterior side (North side)	Part 2	Exterior wall
Materials	State/Remarks		Points to keep in mind (points to pass along in particular, etc.)		
Wall surface (wood & plaster)	Good		Check plaster surface for fissures and peeling, fading, stains, dirt, etc.		
Stringcourse (galvanized steel)	Good		Check for fissures and breakage, peeling, cracks, etc.		
Small wall under eaves (wood)	Good		Check for fissures and breakage, peeling, cracks, etc.		
Window frame (wood)	Overall fading, some paint peeling		Check for fissures and breakage, peeling, cracks, etc.

Position of degradation or damage			
Date of record	2016/12/15	Position of damage (location)	Window frame (wood)
Position diagram/photo	<p>Exterior side (North)</p>		
Special remarks (measures to be taken)	There is deterioration of the paint on the window frames due to UV light, and along with fading, there is some peeling. We will continue to monitor the impact on the base wood materials and will paint it at the appropriate time.		
History of repairs, etc.

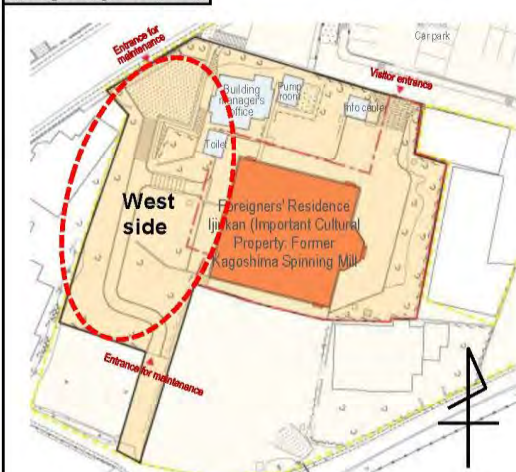
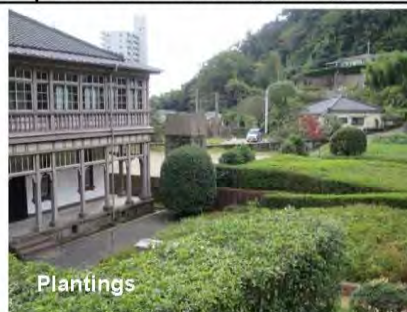
Floor No.	1st floor	Part 1	Exterior elements	Part 2	West side of building
Materials	State/Remarks		Points to keep in mind (points to pass along in particular, etc.)		
Plantings	Good		Pruning of branches, check for harmful insects, etc.		
Pathway, staircase	Damage/missing pieces in brickwork (2 places)		Check for presence of unevenness, tilting, cracks, damage, etc.		
Entrance for maintenance	Good		Check for presence of unevenness, tilting, cracks, damage, etc.		
Water cannon	Good		Check condition of metal fittings, check for breakage, etc.		
Toilet	Good		Check for fissures, breakage, peeling, cracks, etc.

Position of degradation or damage			
Date of record	2016/12/15	Position of damage (location)	Staircase, brickwork
Position diagram/photo			
Special remarks (measures to be taken)	There is damage and missing pieces in the brickwork on the stairs in two locations. This does not require immediate repair, but we will monitor how it progresses. It will be fixed the next time repair work is being carried out.		
History of repairs, etc.

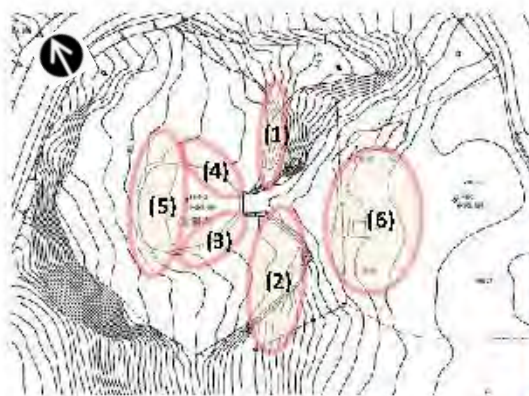
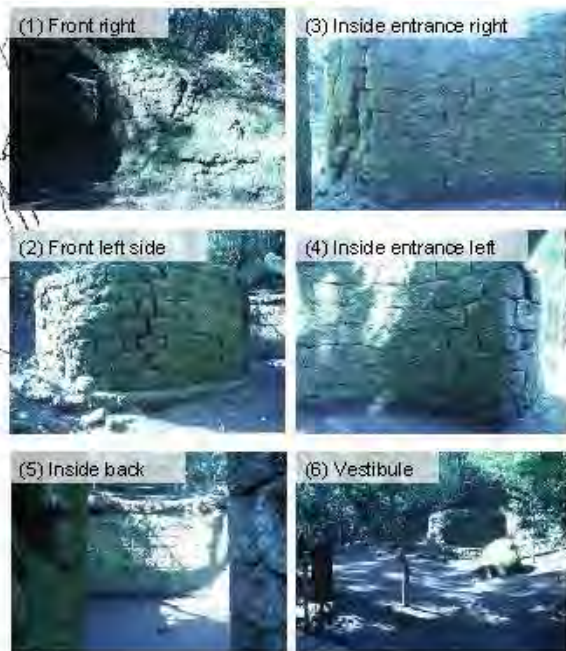
Position of surveyed part

Surveyed Part		State/Remarks	Points to keep in mind (points to pass along in particular, etc.)
Part 1	Part 2		
Stonework	Front right side	Looseness, bulging, gaps in seams	Looseness, bulging, gaps in seams in stonework; tree growth
	Front left side	Looseness, bulging, gaps in seams	Looseness, bulging, gaps in seams in stonework; tree growth
	Inside entrance right side	Looseness, bulging, gaps in seams	Looseness, bulging, gaps in seams in stonework; tree growth
	Inside entrance left side	Looseness, bulging, gaps in seams	Looseness, bulging, gaps in seams in stonework; tree growth
	Inside back face	Good	Looseness, bulging, gaps in seams in stonework; tree growth
Vestibule	Ground surface	Good	Ground surface condition
[Diagram, photos, etc.]

Part	(1) Front left side		
Date of record	February 15, 2017	Position of damage (location)	Looseness in the stones near the entrance, gaps in the seams, and overall bulging can be seen.
Position diagram/photo			
Special remarks (measures to be taken)	We have been taking measurements since 2015. We will analyze records from multiple years and consider repairs.		
History of repairs, etc.
