“Sites of Japan’s Meiji Industrial Revolution: Iron and Steel, Shipbuilding and Coal Mining” (No.1484)  
**Status of Damages Caused by Heavy Rain at the Terayama Charcoal Kiln  
 (Component Part 2-2) and Future Measures**

The Terayama Charcoal Kiln (Kagoshima City, Kagoshima Prefecture), Component Part 2-2 of the “Sites of Japan’s Meiji Industrial Revolution: Iron and Steel, Shipbuilding and Coal Mining” was damaged in a landslip caused by heavy rains between June 27 and July 1, 2019. The following report will be submitted to the UNESCO World Heritage Centre on the status of the damages and measures to be taken in future.

**Appendix 1: Drawings and photos of damage places**  
(Surveyed and drawn July 9, 2019)

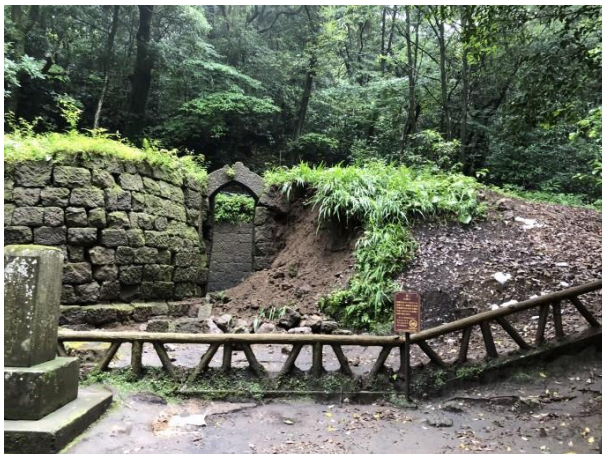
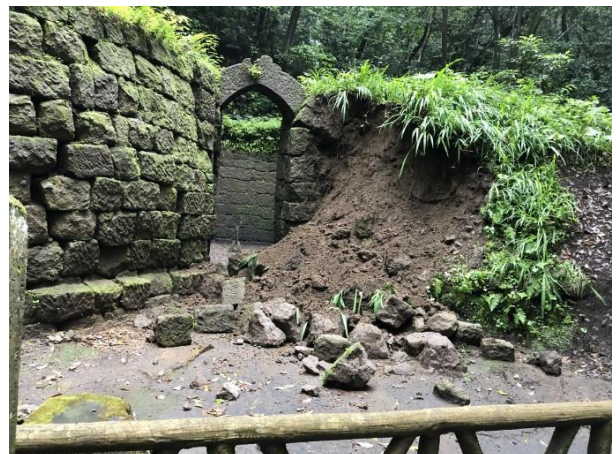
Following the heavy rains beginning on June 27, water seeped into the soil behind the masonry surrounding the charcoal kiln site. The masonry, unable to bear the resulting weight, collapsed over a section on the right side (facing) of the kiln site (approx. 2.5m high by 2m wide).
