## STATE OF CONSERVATION REPORT

### PROPOSED WORKS AT THE IMPERIAL STEEL WORKS, JAPAN, AND ONGA RIVER PUMPING STATION— COMPONENT PARTS OF THE *SITES OF JAPAN'S MEIJI INDUSTRIAL REVOLUTION—IRON AND STEEL, SHIPBUILDING AND COAL MINING.*

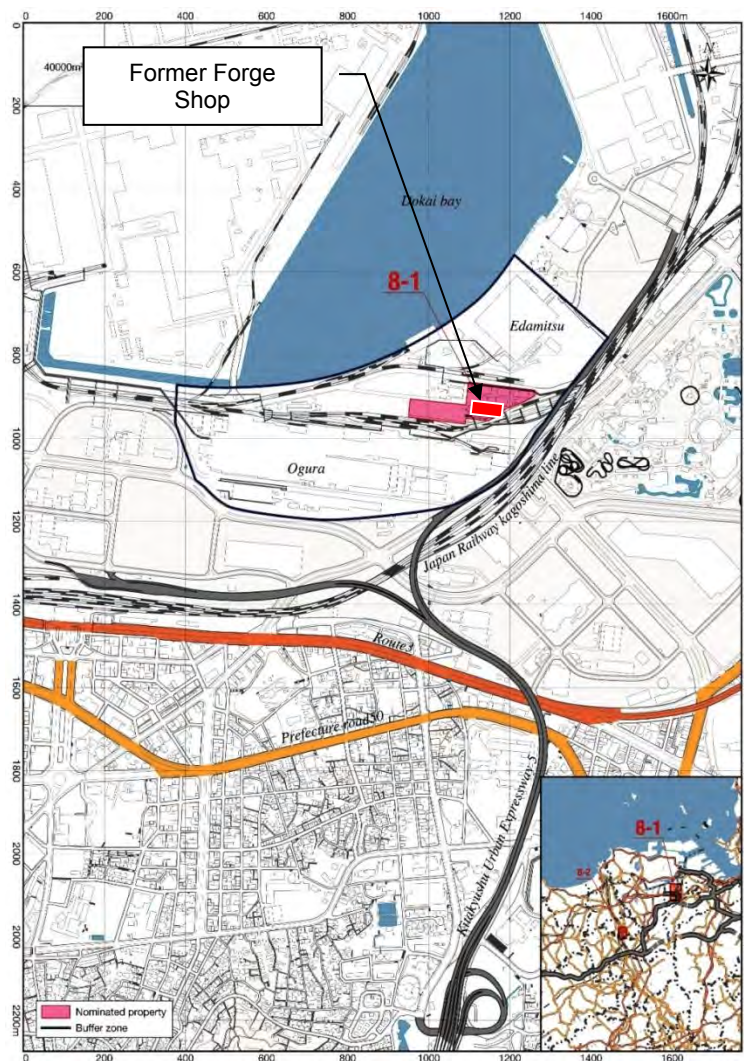
The building, clad with slag-bricks made in the steelworks, has been used for a variety of functions, and maintained in a 'robust' way. This included cement rendering the walls on one side to counter water penetration problems (caused largely by faulty rainwater furniture), and the cladding of one end in metal sheets. The slag brick wall that formed the eastern wall collapsed in an earthquake in 2005, and was temporarily replaced with metal-clad wall. The

potential for reinstating the wall as slag bricks will be part of the seismic strengthening discussions.

Gutters and downpipes will be restored based on existing designs. Conservation works to walls will be based on respect for the original design, and to solve historic problems of steel frame decay and water penetration.

The large windows, the wooden frames of which have also deteriorated, will be restored, with the replacement where necessary of frames with matching detail. Stronger glass will be fitted to withstand typhoon winds, in frames restored and adapted to integrate with any seismic reinforcement requirements. The scope of this work will be determined in September 2017.

The steel frame will have rust removed and then be treated with a rust inhibitor. Any steel frame elements found to be structurally unsound will be reinforced or replaced in a manner sensitive to their heritage significance, and any additional seismic retrofitting will be designed to maximise the conservation and understanding of original fabric.

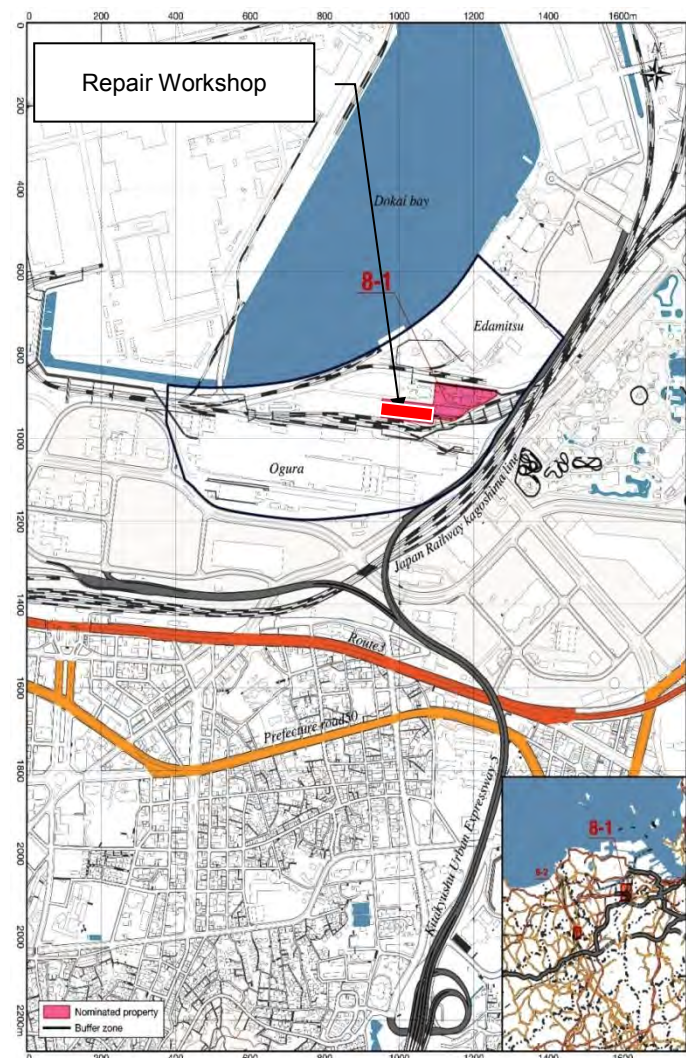
The Repair Workshop is a steel-framed structure with extensive glass window walls, and sections of masonry and galvanised iron cladding. The windows are currently protected within temporary acrylic panels attached outside and inside the original window frames, and some have been covered with metal sheeting. Some sections of the building are in need of varying degrees of stabilisation and restoration to maintain original fabric, and restore or replace degraded fabric to maintain the significant form and design of the building. The building is used for a range of light repair and fabrication functions related to the ongoing operations of the steelworks, continuing its traditional use.

Brick cladding encasing structural steel posts at both ends of the building show cracking, and this will be investigated to ensure ongoing stability, and to repair steel and brick elements as necessary.

As with the Former Forge Shop, sections of the Repair Workshop have infill cladding within the steel frames that include an extensive area of glass windows, iron sheet and slag-brick cladding. As at the Former Forge Shop, the windows frames will be accurately restored or replaced depending on the detailed condition inspection. The scope of the restoration work will be determined after study in September 2017. The use of stronger glass to withstand typhoon damage may require slight modification of frame detailing, as in other buildings. The integration of conservation work with seismic reinforcement will also be determined at this time.

Slag brick sections will be stabilised and repaired, and if necessary treated with the breathable waterproof finish if its reversibility is verified and it has no visual impact.

The steel frame will be subject to the same process of study, rust removal, treatment and reinforcement or replacement as outlined for the Former Forge Shop. All gutters and downpipes will be repaired or replaced to establish a reliable roof-water management system.

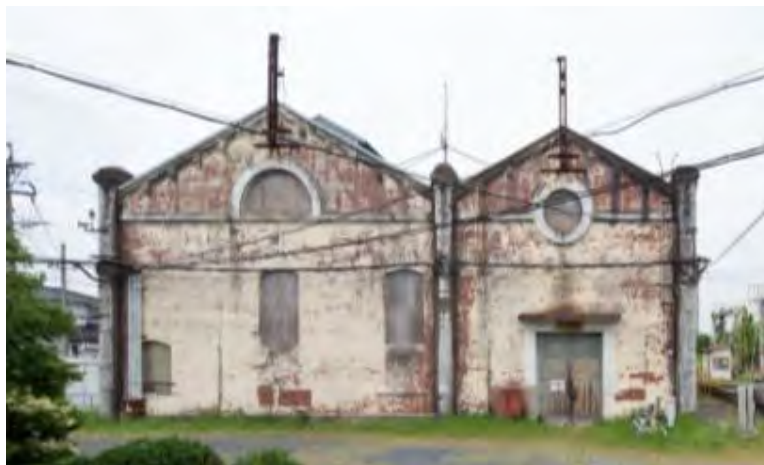
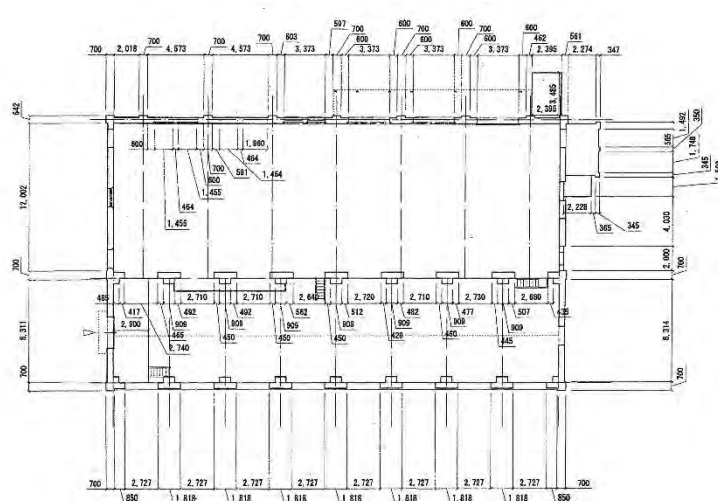
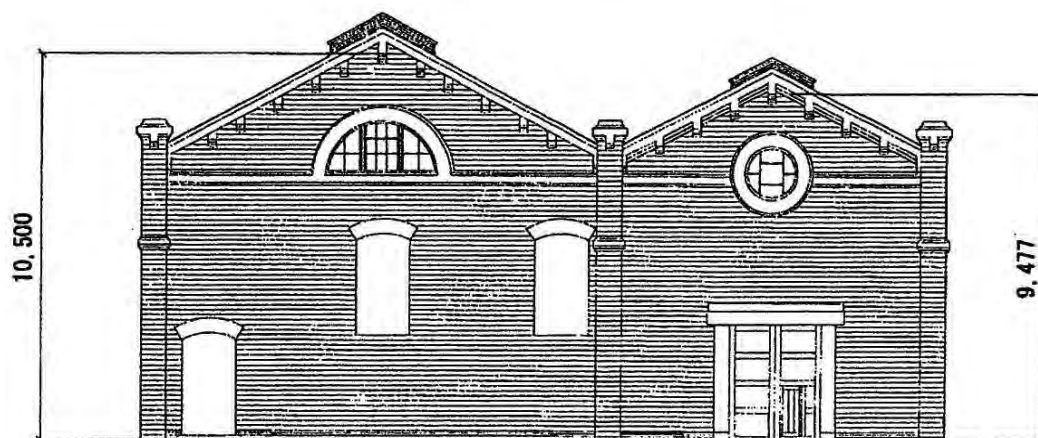
(East side Exterior, Plan and East Elevation)

Over recent years a number of window openings have been overlaid with metal to prevent collapse of the window frames, and some window frames have been replaced with aluminium frames. The proposal is to remove this overcladding and metal framing, and restore or replace as necessary the timber window frames and glass.

The use of stronger glass to withstand typhoon damage may require slight modification of frame detailing, as in other buildings. The integration of conservation work with seismic reinforcement will also be determined in September 2017. In one area where windows were infilled with masonry walls to protect electrical equipment, the infill will be retained, as it is evidence of a significant change in the technology of the pumping station from steam to electric pumps in the 1950s. The brick masonry walls will be cleaned. Exposed steel frame components will have any rust removed and will then be treated with a rust-preventative coating.
