# State of Conservation Report

Sites of Japan's Meiji Industrial Revolution:

Iron and Steel, Shipbuilding, and Coal Mining (Japan) (ID: 1484)

**CABINET SECRETARIAT  
JAPAN**

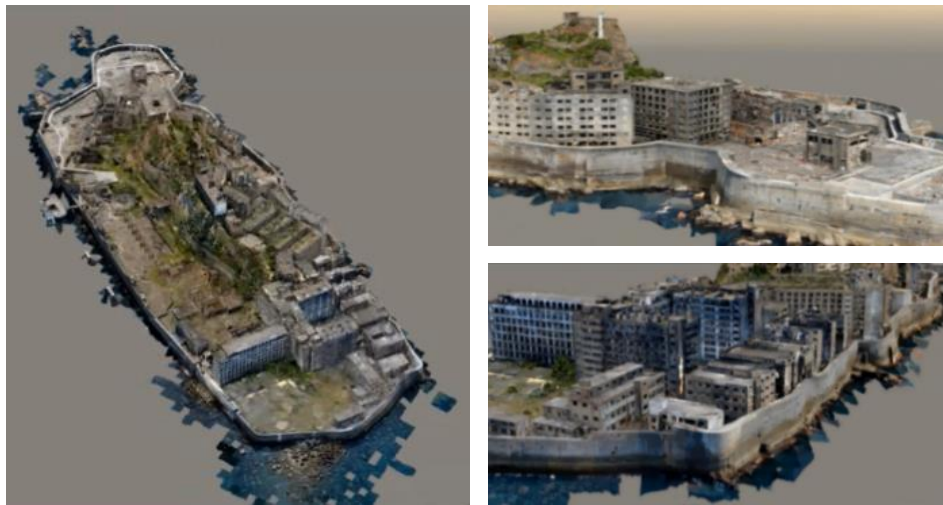
Figure 4. 3D model of Hashima Coal Mine made from 3-D laser survey

The city have surveyed the whole of the island with a 3-D laser (Figure 4), and will install four stationary cameras to record and monitor the current state. The city plans to identify individual spots on the remains of seawall revetments, coal production and housing facilities that are likely to need monitoring in order to measure any slant and widths of cracks every six months.

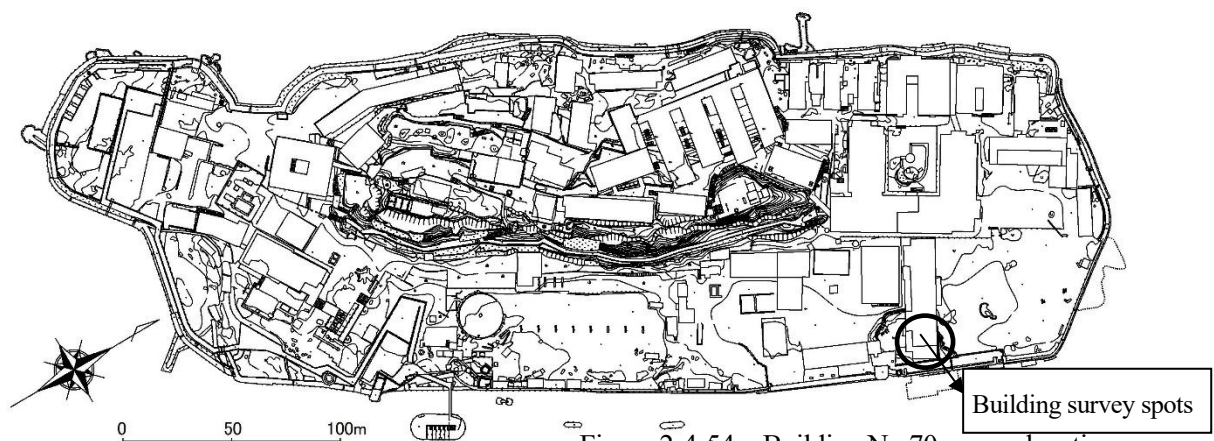
Figure 2-4-54 Building No.70 survey locations

It was estimated that several concrete pile foundations supporting the structure of Building No.70 have been lost or broken after having been scoured by sea water, losing their proper function. Therefore, a survey was conducted to understand the deterioration levels of the building and the foundation. To the deterioration level of the building, we applied the methods of deterioration survey and durable year prediction based on the category of damage degree of structures, which was calculated in the “Deterioration survey of concrete structures in Gunkanjima” conducted by the working group for the Deterioration survey of concrete structures in Gunkanjima in March 2013.

Meanwhile, the deterioration level of the foundation was calculated using the three-dimensional elastic analysis by FEM, in which foundation piles and the undermost layer of the structure were turned into a model, and the results obtained were summarized as the current deterioration level. In considering the deterioration level of the foundation, the “Foundation status drawing” created in fiscal 2014 was used as a reference (see Chapter 2, Section 3, 2. (4)).

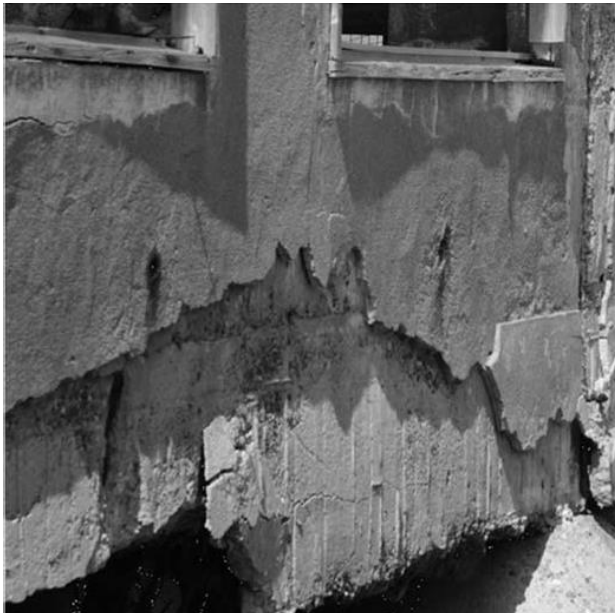
Photo 2-4-112 Building No.70 east face

The point without the danger of surface peeling-off, etc. was selected from among the four points selected, and rivets were placed at 70-2 (see Figure 2-4-55), which served as a reference. As a result of leveling using the near third-order control point (NO. 2 H=5.171) (Photo 2-4-113), the altitude of 70-2 was  $H = 6.550$  m. Then, we set all of the four points at the same altitude ( $H = 6.550$  m) so that we can promptly calculate displacement at the time of next measurement.

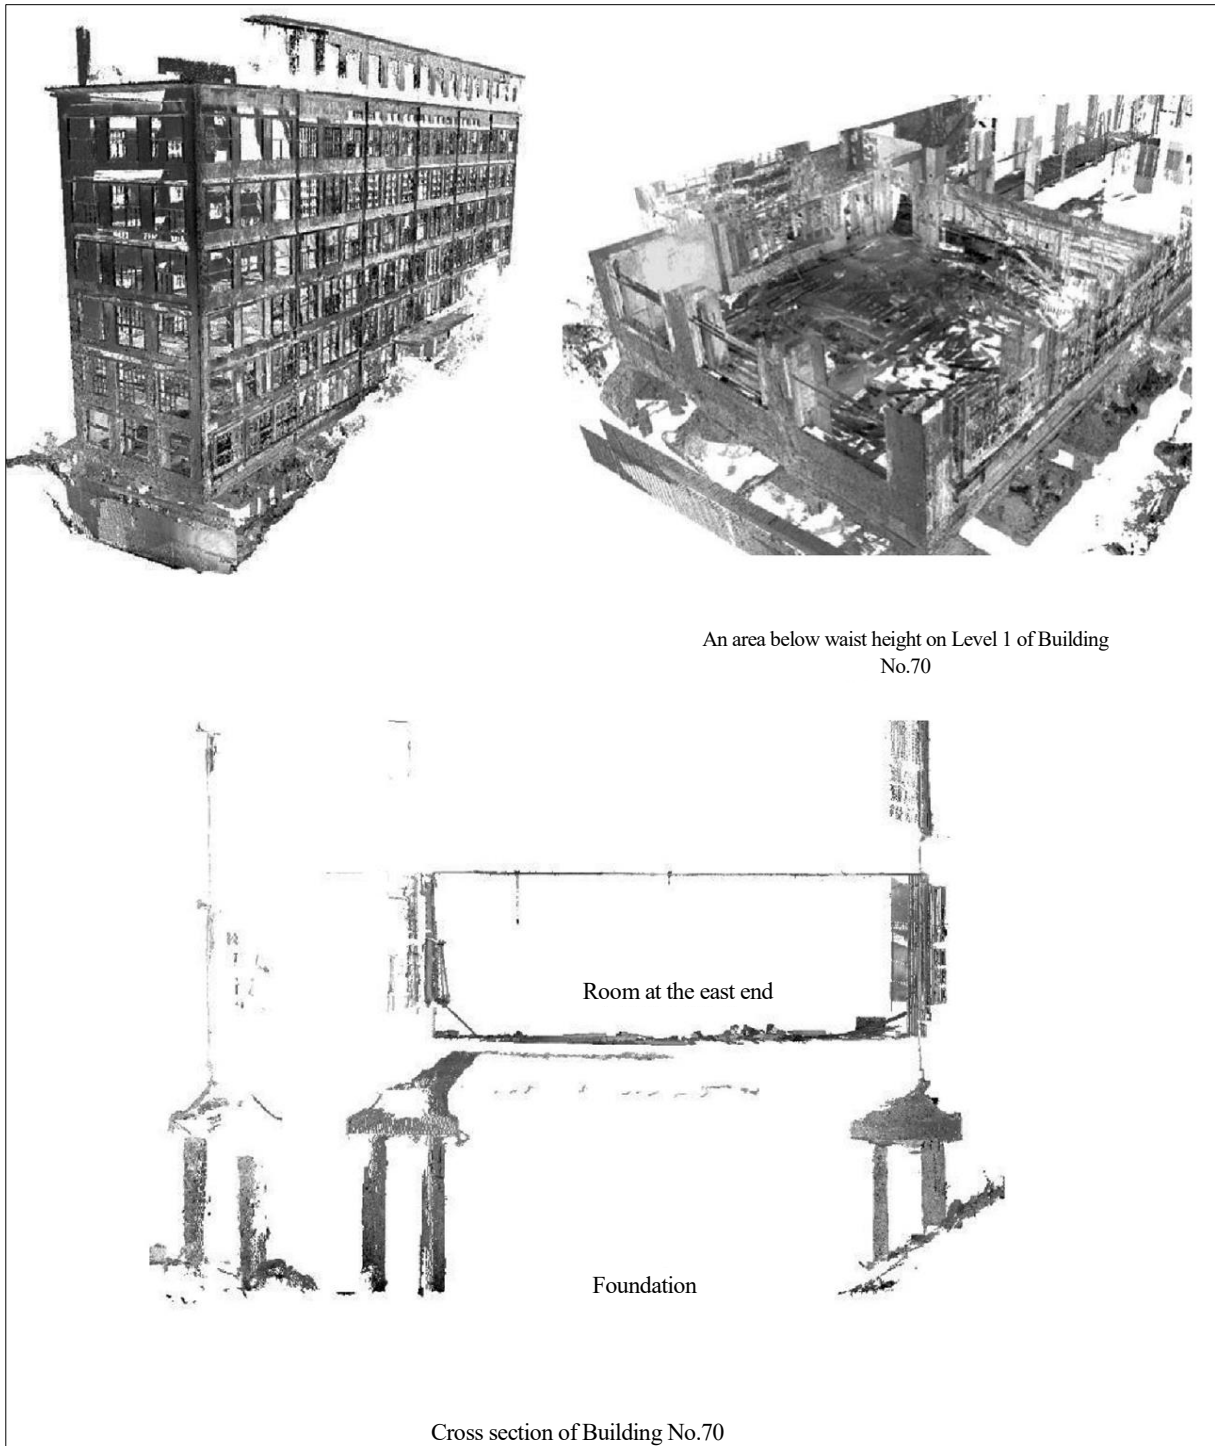
Figure 2-4-57 Building No.70 data of a group of three-dimensional points

In calculating the gradient of Building No.70, a three-dimensional laser measurement was performed supplementarily. Shown below is the result obtained by combining a total of 10 cuts measured around Building No.70 as well as in the east end room within Building No.70. All the data are expressed as points with three-dimensional coordinates. Extracting an arbitrary section is also possible; the thickness of wall/slab can be calculated by measuring the inside and outside of the building.

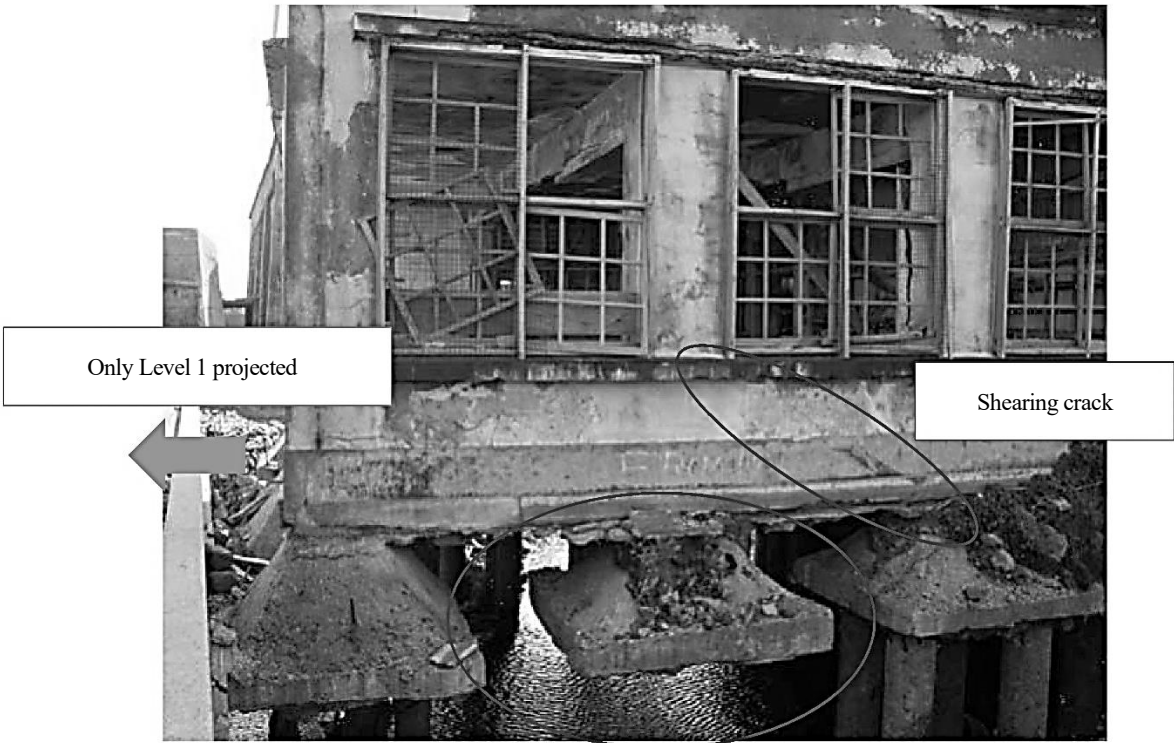
Figure 2-4-59 shows the displacement of a wall surface from a plane vertical to a reference line, which is set below the window on Level 1 of the east face of Building No.70, using colors. As the legends show, the green color is used as a reference, while the red and blue colors indicate the groups of points measured on the wall surfaces 30 mm front and 30 mm back of the reference plane, respectively. It should be noted that measurements were conducted only from the ground this time, and accordingly, the point density is low in the upper areas. Observation of measurement results show the upper areas exhibit colors closer to blue, suggesting that wall surfaces are at the back of the reference plane. However, because only Level 1 strongly shows a green to red color, Level 1 appears to project to the east side by 15–20 mm compared with Level 2 and upper floors.

Only Level 1 projected

Shearing crack

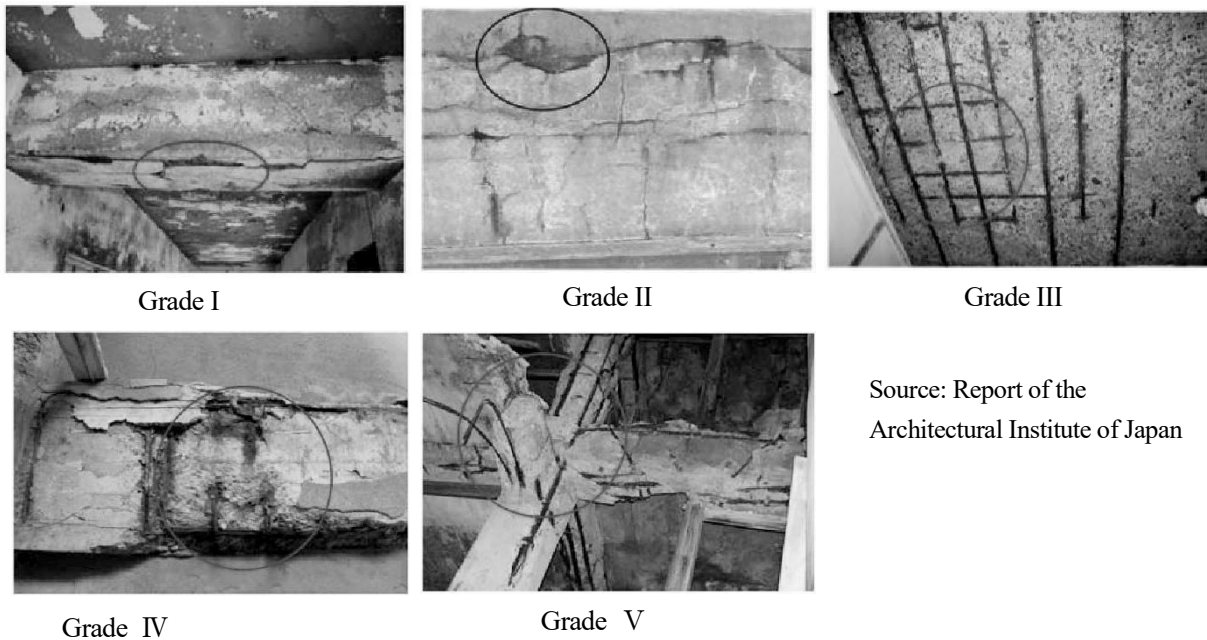
Photo 2-4-116 Examples of deterioration grades tailored to the current state of Hashima

Damage degree	Damaged condition	Legend
Grade I	Cracks + rust fluid on the surface	■
Grade II		■
Grade III	Corroded rebar is exposed	■
Grade IV		■
Grade V	Rebar leaves its trace but has decayed (does not exist)	■

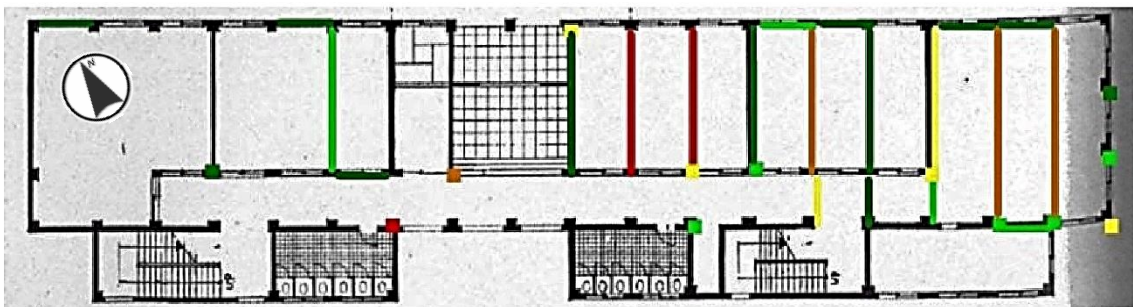
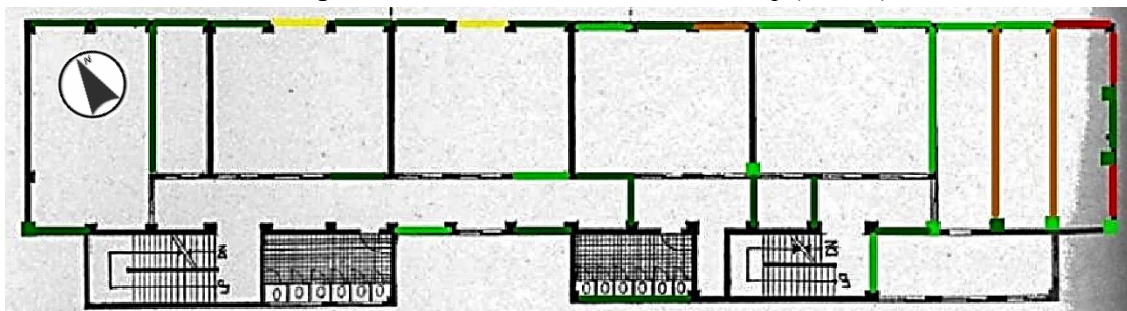
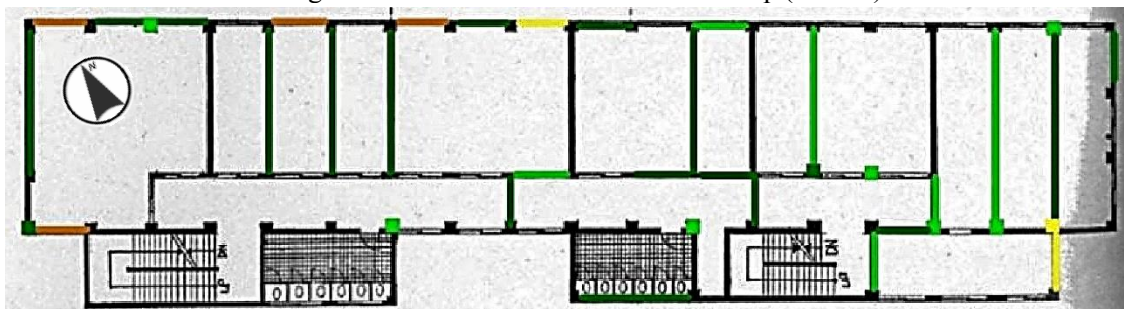
Figure 2-4-60 Building No.70 deterioration level distribution maps (Level 1 to Level 3)

Through the observation of the evaluation results, we can find marked deteriorations on the east side on many Levels. In addition, deteriorations are more serious on the north side than on the south side. This is presumably because there are no structures that block wind and rain as well as sea breezes on the east side and the north side.

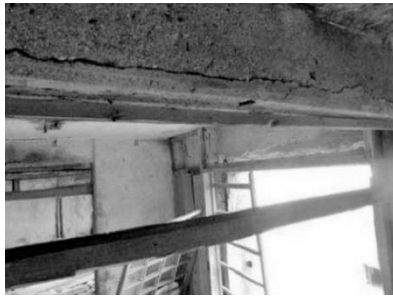
Damage degree III

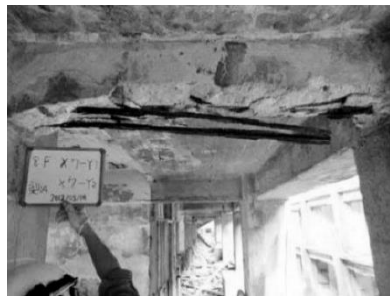
Damage degree IV

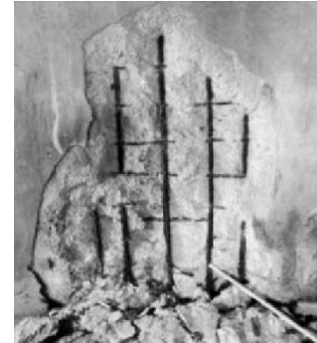
Wall: Damage degree IV

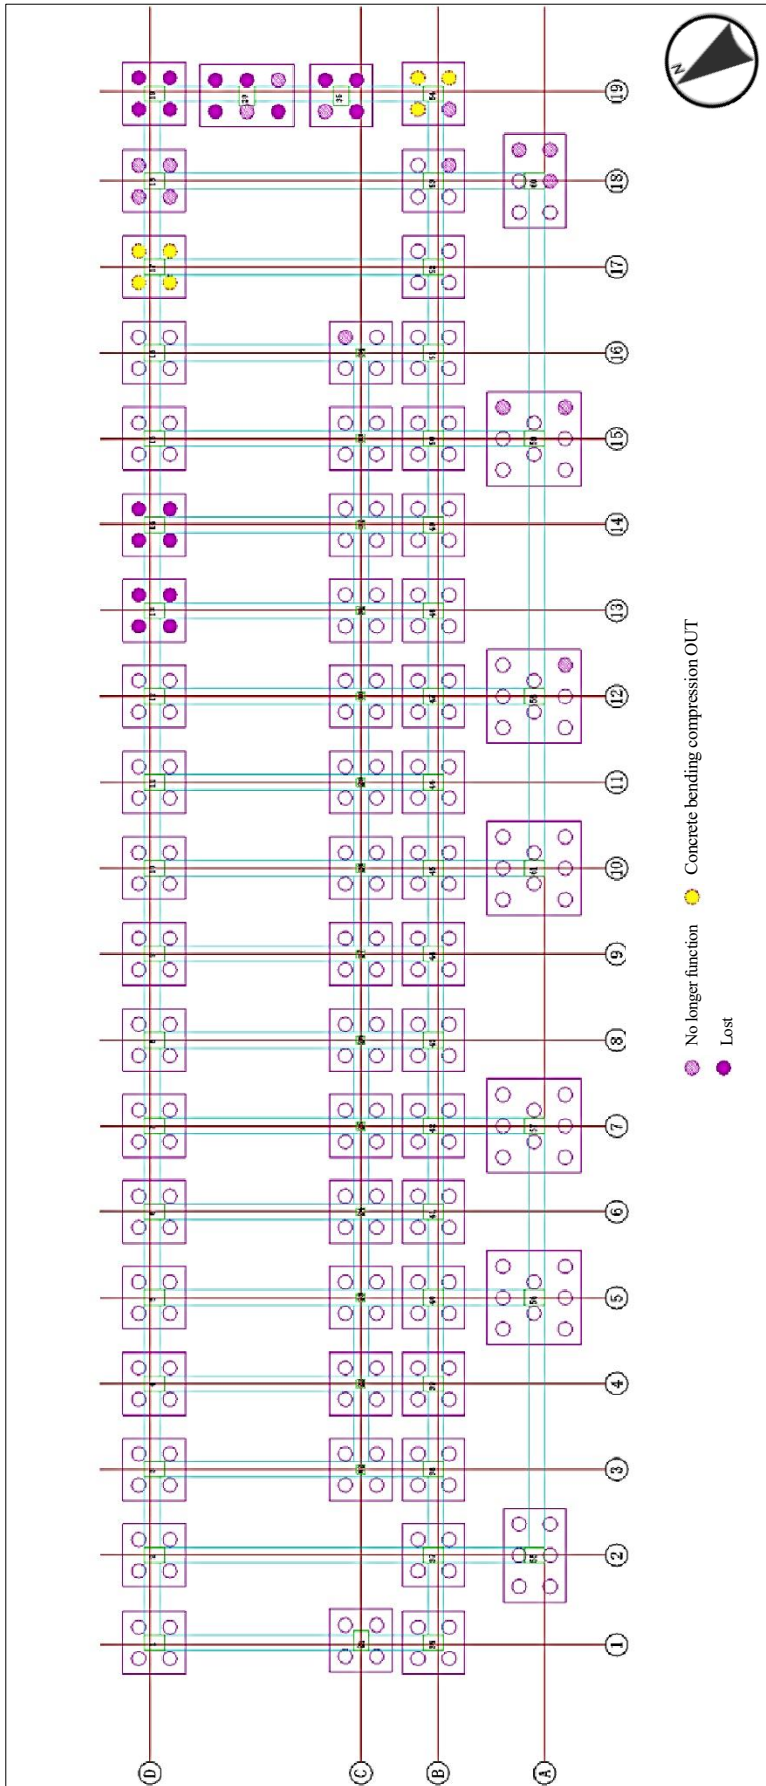
Figure 2-4-68 Current condition: Pile bending checking – concrete bending compressive stress OUT parts

Axial force maximum	0.5	0.08	0.1056	9.09	2647.47	22.600	Not caused	-338.100	13.30	155.00	-155.00	1.699	OUT	-	-	2.181	OUT
	Axial force minimum	0.5	0.08	0.1056	10.01	-774.02		809.100	Not caused	13.30	155.00	-155.00			5.220	OUT	-	-

As for the current deterioration level of the foundation, the bending stress of the piles was determined to be NG, and the bearing capacity exceeding the allowable value was confirmed in some piles.

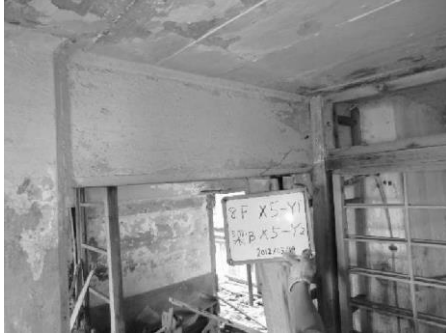
Photo 2-4-118 Deterioration level I

The condition in which a small number of cracks are found.

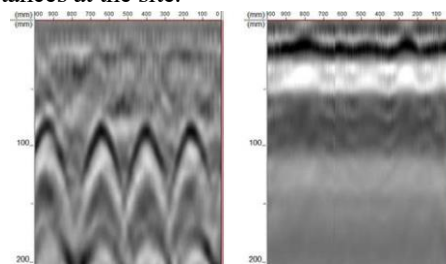
Figure 2-4-73 Electromagnetic wave radar image

Figure 2-4-73 shows the result of an exploration using the electromagnetic wave radar method, which was conducted for a column of Building No.70. In an image obtained from an exploration using the electromagnetic wave radar method, rebar is usually shown as “mountain shapes” as in the image (a). The image (b) does not clearly show “mountain shapes” that were seen in the image (a), and rebar inside the member was extremely corroded at this part. These images indicate that the depth of concrete cover is greater in (a), but at the same time confirms that even if the depth of concrete cover is small, reinforcement corrosion can make an image unclear. Reinforcement corrosion has progressed in most of the buildings in Hashima, which prevented the confirmation of rebar with the electromagnetic wave radar method in some cases. In a survey using the electromagnetic induction method too, the location of rebar was not accurately detected in some cases when rebar was corroded or the depth of concrete cover was great. With these fundamental limits of measuring instruments, individual inspectors conducted the exploration by adapting to circumstances at the site.

(a)Waveform of sound reinforcement (b)Waveform of corroded reinforcement

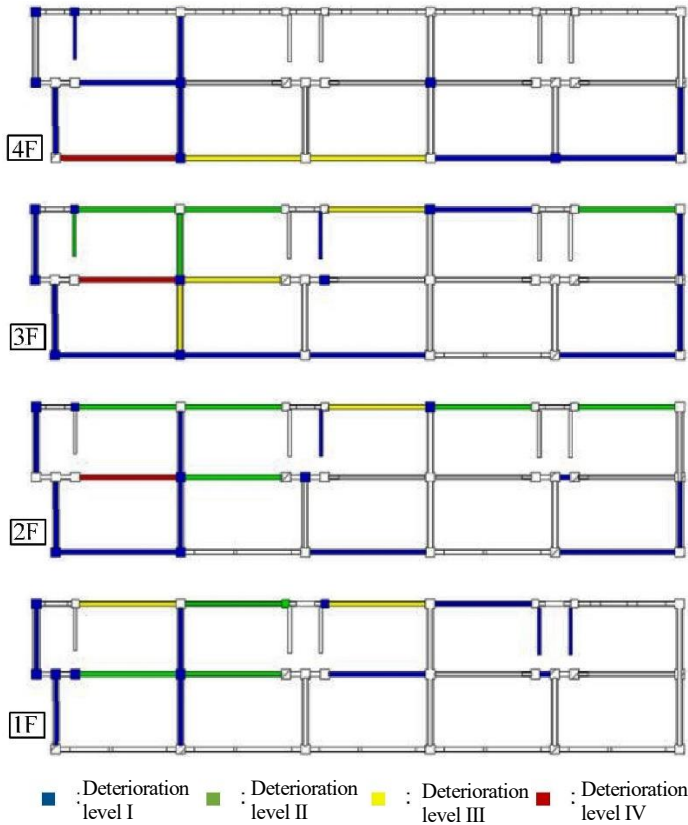
Figure 2-4-79 Structural member deterioration condition

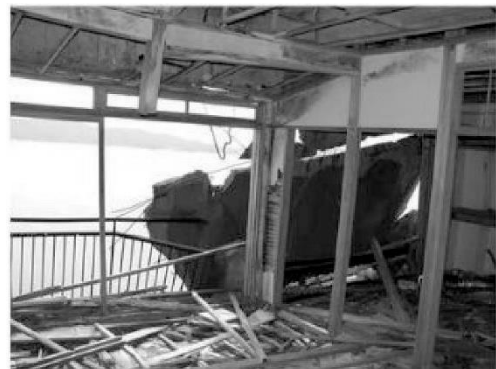
Photo 2-4-124 Interior fixture deterioration condition

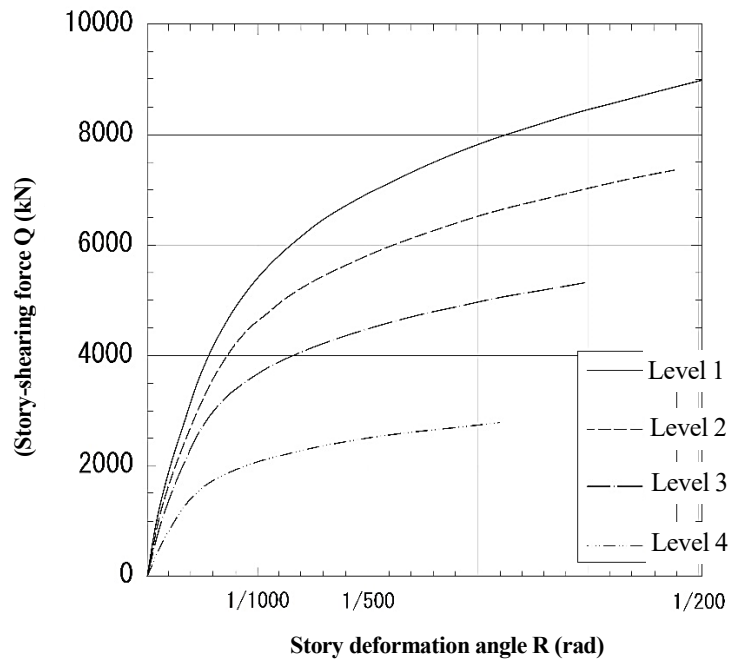
Figure 2-4-85 Story-shearing force  $Q$  - Story deformation angle  $R$  relationship (X direction)

The static incremental analysis was performed using incremental displacement until one of the stories reaches a story deformation angle of  $1/200$ . Figure 2-4-85 shows the relationship between the story-shearing force of each story  $Q$  and the story deformation angle  $R$  with respect to the X direction. It indicates Level 1, which showed the minimum  $I_s$  value in the seismic diagnosis, first achieved  $R = 1/200$ . Figure 2-4-86 shows the damaged condition of the X3 frame, which had the most noticeable damage. This figure reveals that damage is concentrated in beam ends and gradually exhibiting a beam yielding preceding total collapse mechanism. However, floor slabs have not been surveyed, and thus the beam model for analysis does not consider rebar of a floor slab, etc. under the current condition; detailed studies are required in the future.

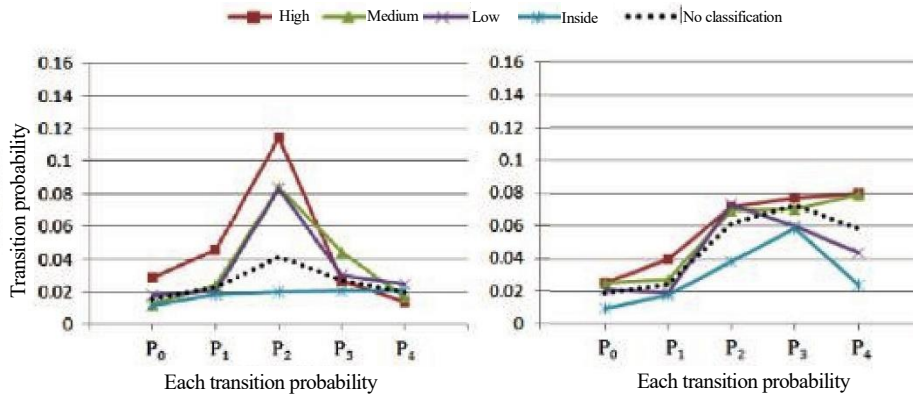
Figure 2-4-91 Transition probability (left: column, right: beam)

Figure 2-4-91 shows the transition probabilities for columns (including walls without a column) and beams calculated using the method described above. Figure 2-4-92 shows the deterioration curves drawn by the expected values, which are calculated from each transition probability and deterioration level. The expected values were rounded off to the closest whole number.

As a general trend, members existing outside rather than inside and those in severer incoming salt environments were shown to have higher transition probabilities and deterioration progress rates. The deterioration curves indicated that the deterioration progress is faster in beams than in columns for all the classifications.

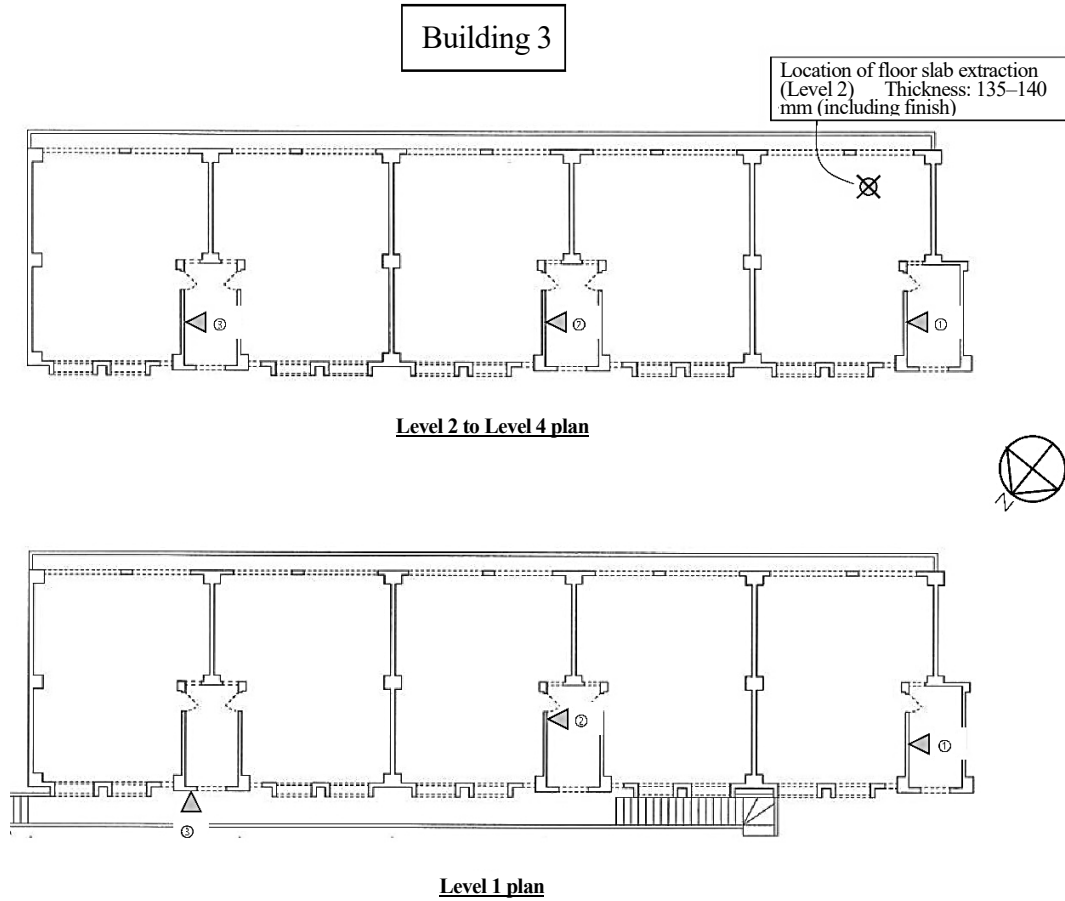
Figure 2-4-107 Locations of concrete core sampling for compressive testing at Building No.3

Concrete cores were sampled at Buildings No.3, 16, and 65 and compressive testing was conducted. Core sampling locations and results of compressive testing at each building are shown in Figures 2-4-107 to 109 and Tables 2-4-84 to 86, respectively. Despite a large standard deviation noted for all the buildings, the average compressive strength was 18.4 (N/mm<sup>2</sup>) for Building No.3, 21.6 (N/mm<sup>2</sup>) for Building No.16, and 15.2 (N/mm<sup>2</sup>) for Building No.65, showing values equivalent or superior to concrete strength generally seen at the time of construction. When the structural safety is evaluated by considering the current deterioration state, Building No.3 has almost no problems in light of the current earthquake standards and is unlikely to collapse in case of a moderate earthquake, although there is a concern in case of a large earthquake.

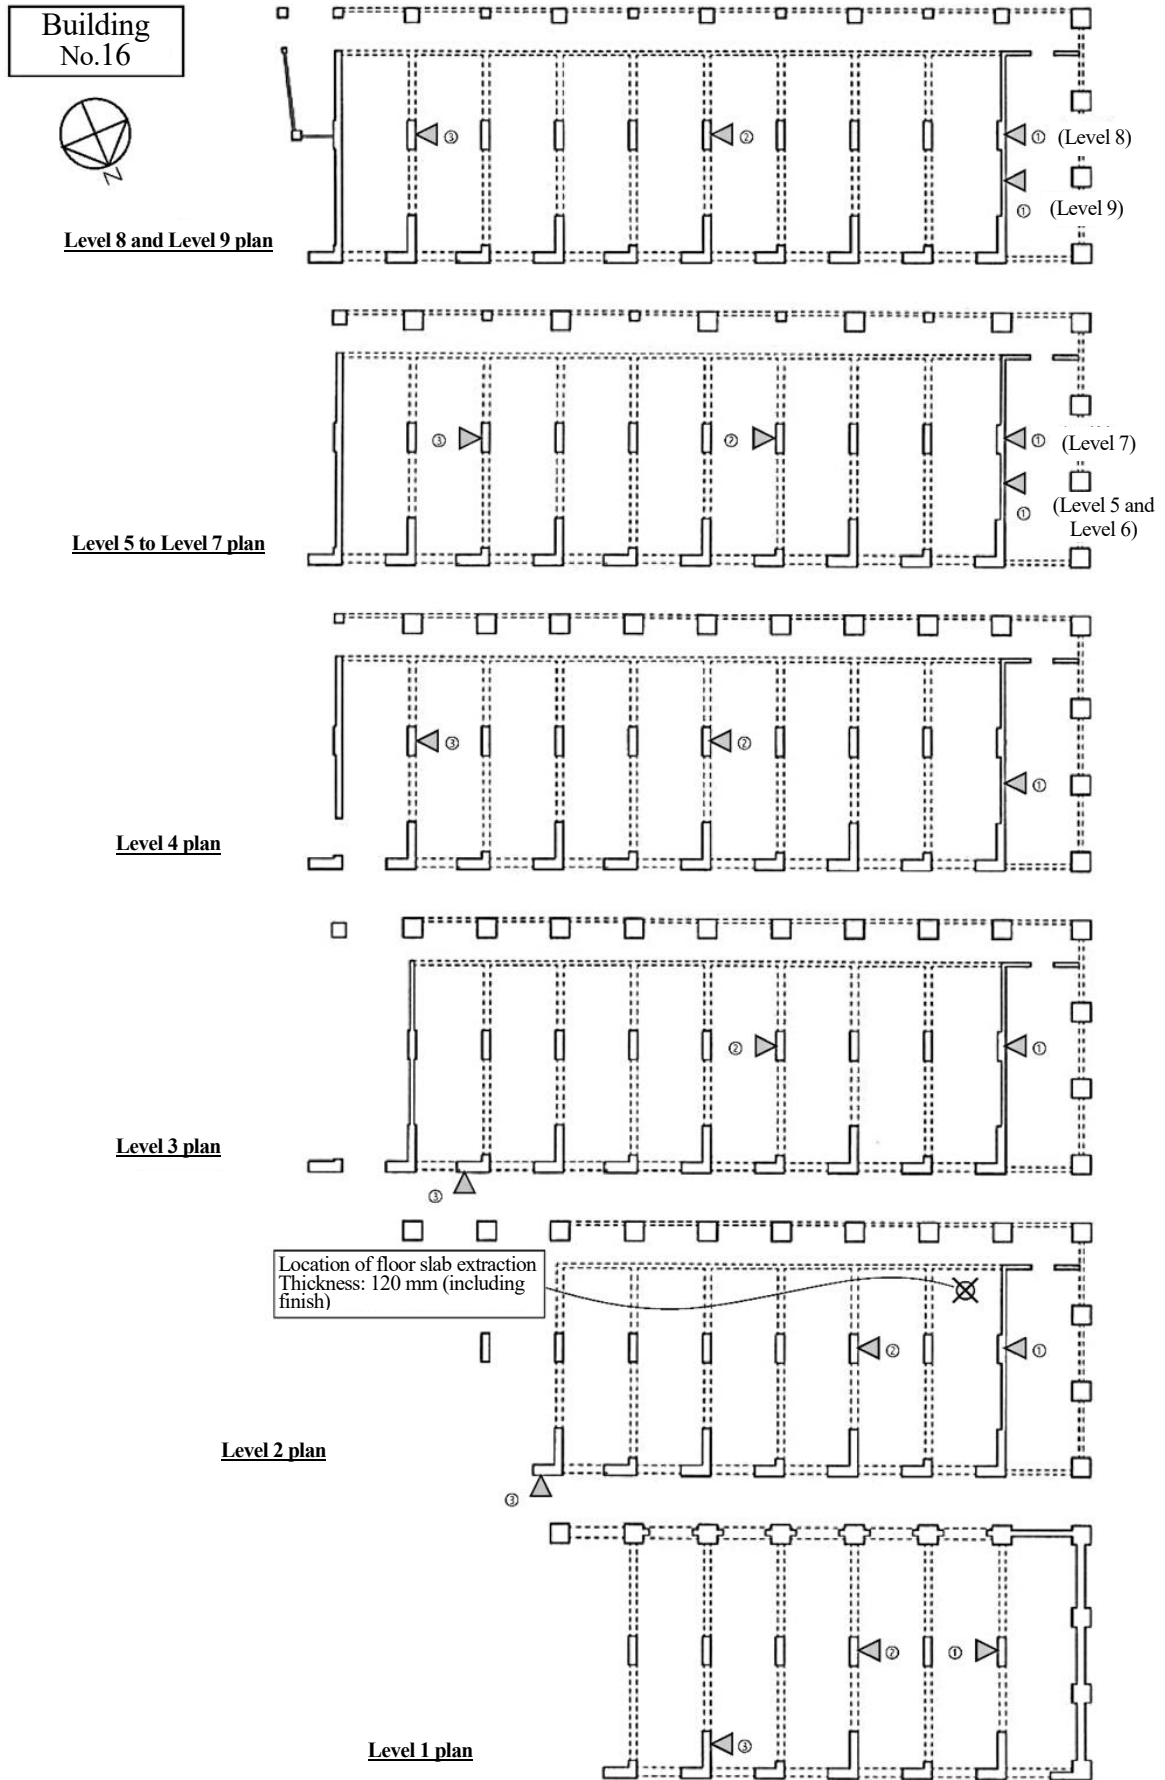
Figure 2-4-108 Locations of concrete core sampling for compressive testing at Building No.16

On the other hand, Buildings No.16 and 65 have insufficient structural performance and there is a fear of suffering huge damage even from a moderate earthquake.

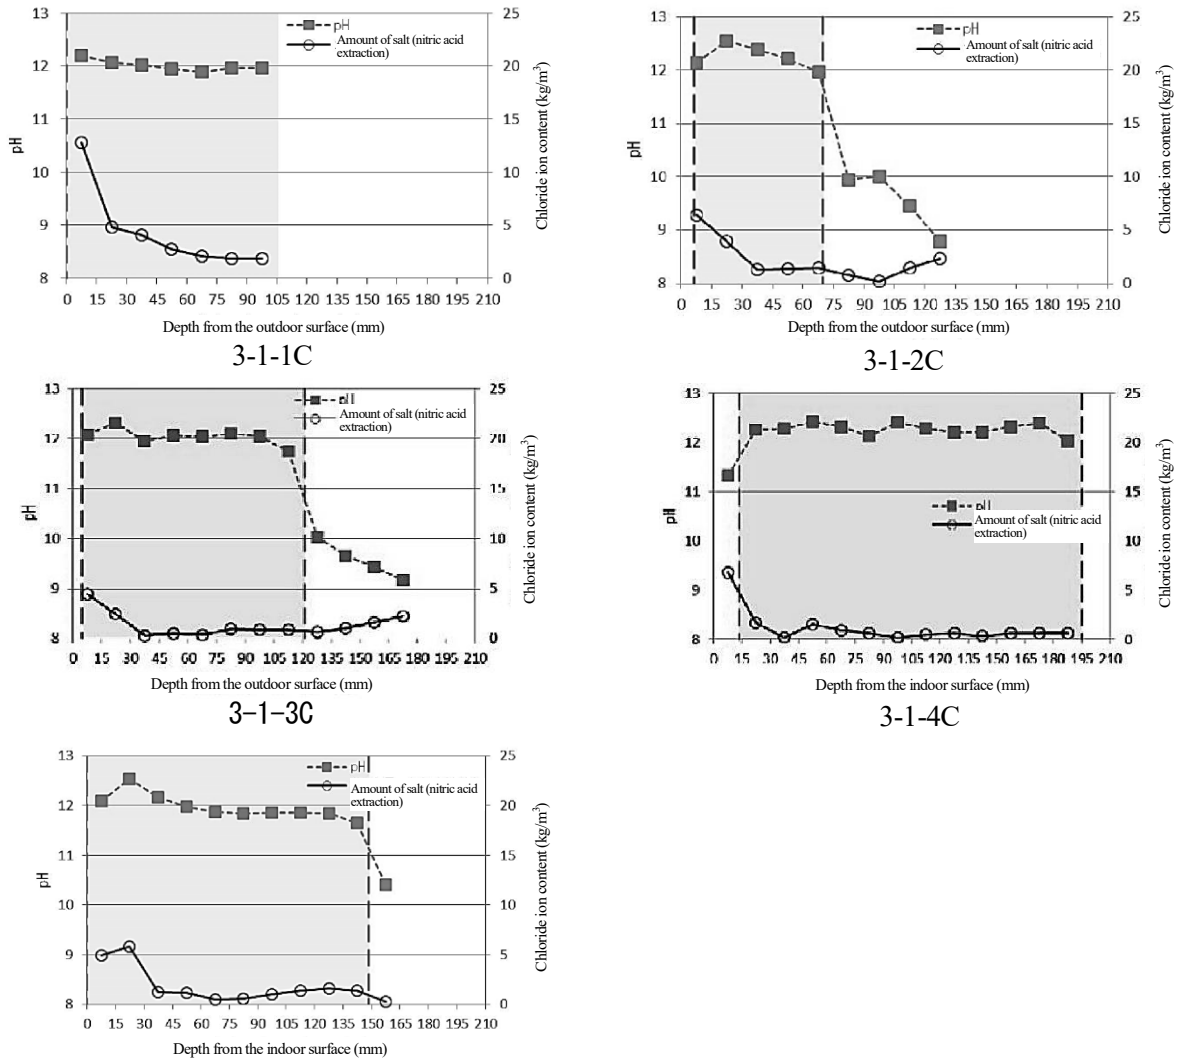
Figure 2-4-111 Distribution of chloride ion in concrete at Building No.3

As described below, there are three possible factors for very high concentrations of salt contained; however, in-depth studies need to be conducted to reach a conclusion in the future.

- Seawater may have been used as water for concrete mixing.
- Unwashed sea sand/sea gravel may have been used as concrete aggregate.
- Seawater have splashed over the building many times at high tide and may have penetrated inside.

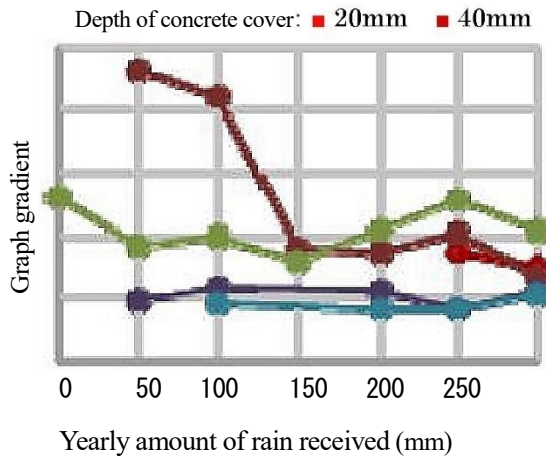
Figure 2-4-117 Yearly amount of rain received and graph gradient

Only the results for Buildings No.16, 17, 18, 19, and 20 are shown here as survey results are similar for the other buildings. Figure 2-4-117 shows the relationship between the graph gradient ( $\zeta$ ) of the expected deterioration level (an expected value calculated from the ratios of deterioration level for different members in the same area exposed to the rain within the same building) and the average annual incoming salt amount.

In almost all cases, the graph gradient shows a positive value; the greater annual average incoming salt amount is, the higher the expected deterioration level becomes. Figure 2-4-118 shows the relationship between the yearly amount of rain received and the mean value of expected deterioration level in the total incoming salt range. Basically, the smaller the depth of concrete cover is and the larger the yearly amount of rain received is, the higher the expected deterioration level becomes; however, the larger the depth of concrete cover is, the smaller the increment of the expected deterioration level with respect to an increase in the yearly amount of rain received becomes, with the depth of concrete cover as great as around 80 mm being hardly affected by the amount of rain received.

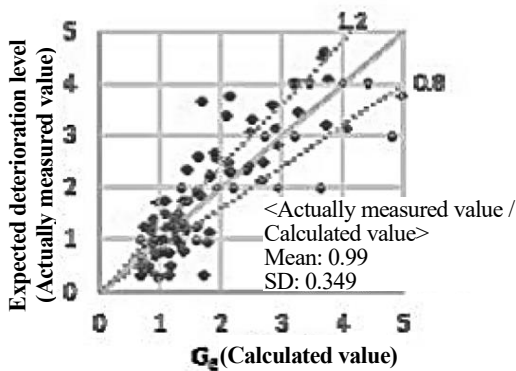
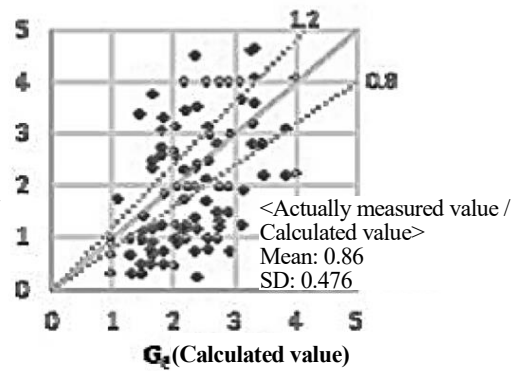
Figure 2-4-119 Comparison between actually measured values and calculated values: Buildings No.16 to 20

Equations 1 and 2 show the evaluation equations derived for  $G_E$ . Figure 2-4-119 shows a comparison between the calculated value of  $G_E$  and the actual expected deterioration level. While proper evaluations were generally made in the case of Equation 1, slightly large variations were shown in the case of Equation 2. Therefore, data on the depth of concrete cover should not be omitted in essence in order to properly evaluate  $G_E$ . Table 2-4-87 shows the transition probabilities obtained for each value of  $G_E$  using Equation 3, after the deterioration

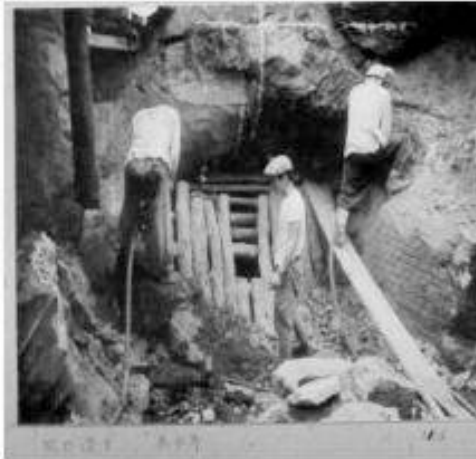
Photo 2-3-50. June 1956; Structure of the mouth of Pit

were left there at the time the business was opened. Since the scattered pieces of lumber were boards, rather than rods as those photographed in Photo 2-3-50, it is likely that they were used for forms. A pipe can be seen on the floor, what it was used for is unclear.

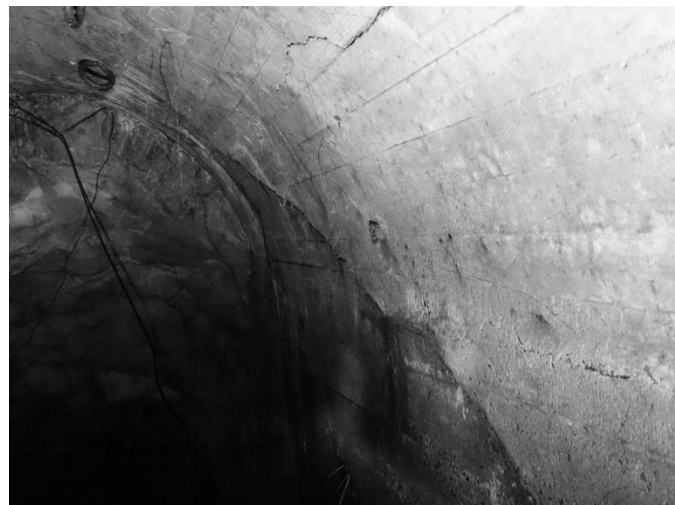
Photo 2-3-51. 1-F100; Direct front view

The survey found that the inclined passage at Mouth of Pit No. 1 was covered in concrete on the walls, with the pit running slightly to the left (west) for a length of approximately 5 meters based on visual estimates. At the end of the pit, the walls were not covered in concrete but rocks were exposed (Photo 2-3-51).

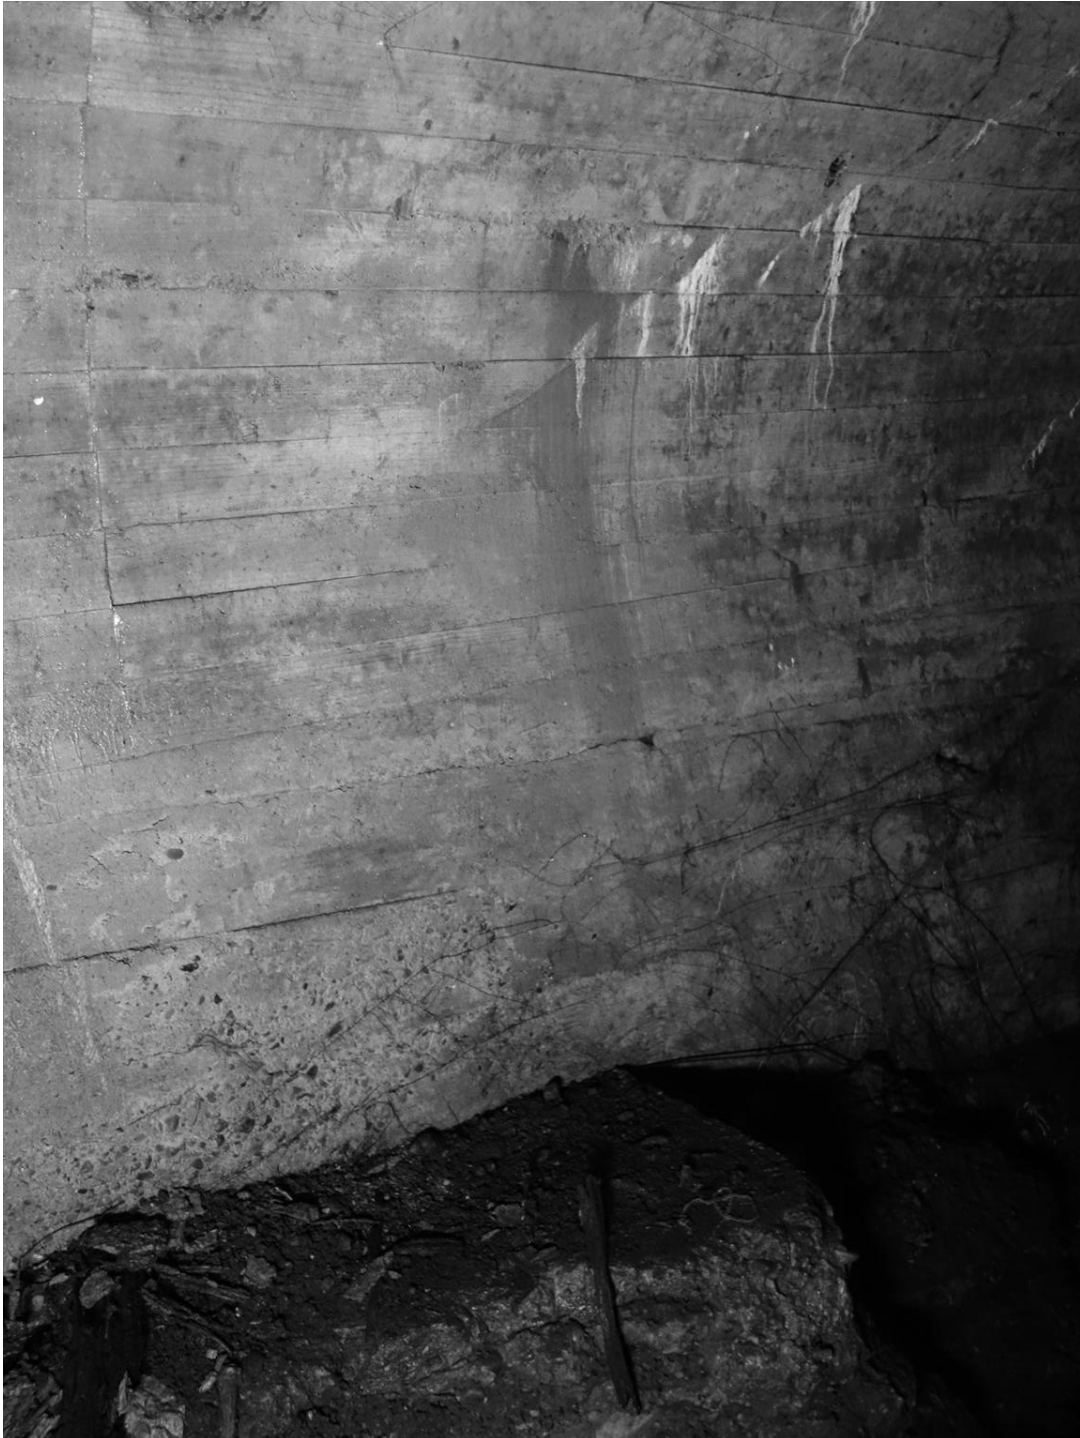
Photo 2-3-54. 1-R107; Wall

Judging by the pictures taken during the survey, the area appeared to be in good condition, with no toxic gas, etc. identified although pieces of lumber and pipes were scattered. Likewise, the concrete walls that cover the rock walls beneath, although some cracks were observed, did not appear to be in an immediate danger of falling off (Photo 2-3-54).

If the scattering pieces of lumber and pipes are removed, it will not be difficult to look closely inside the pit to the rock walls at the end, meaning it should be possible to investigate to determine if the pit is designed to lead down to underground areas near the exposed rock walls.

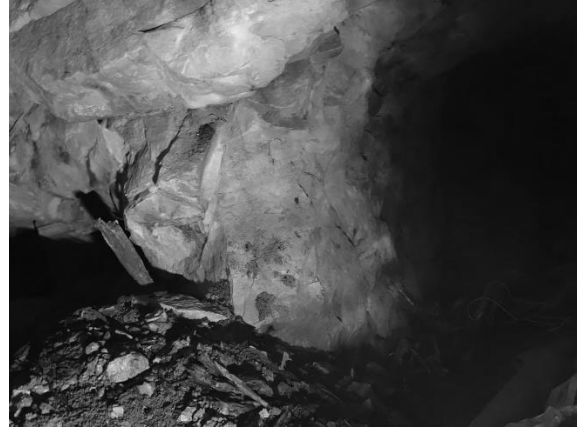
Photo 2-3-61. 2-F03\_Direct front view

Review of the pictures taken through the holes drilled open revealed that the pit was forked into two at a few meters from the entry (Photos 2-3-60 and -61), that the walls were rocks exposed (Photo 2-3-62), and that the tram tracks, which had been found outside the mine, were not visible buried under pieces of wood and coal (Photo 2-3-63).

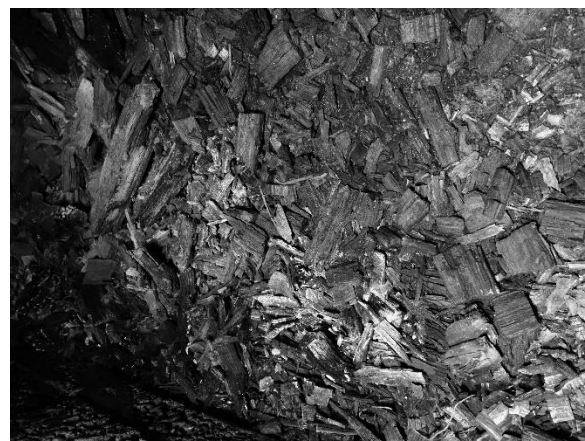
Photo 2-3-63. 2-F03\_Floor

Other than the buildups of pieces of wood and coal on the floor inside the pit, no damage was observed on the walls of exposed rocks, and the area appeared to be in good condition. If the pieces of wood on the floor are removed, it will be possible to see any remaining sections of tracks inside the pit. Examining such tracks may also help offer clues to understanding how they may have been related to the pit fork, and what the inclined passage may have been used for.

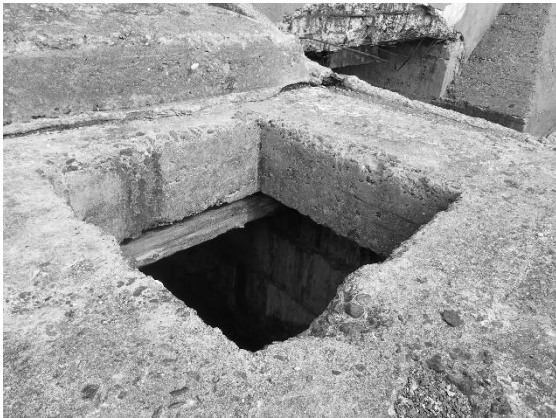
Photo 2-3-65. 3-A26\_Opening

At Pit No. 3, one could go approximately 7.45 meters below the opening (0.97 m × 0.93 m) to reach soiled surface, beneath which was filled. Inside the pit, there was spring water in part (Photos 2-3-65 and -66), and there was a 6.0-m × 3.81-m space observed. The walls surrounding this space were partly ashlar masonry of sandstone from the ground up to approximately 4-meter levels; the upper parts of the eastern, western, and southern walls above the masonry were cast in concrete with forms still remaining (Photo 2-3-68). The upper parts of the northern wall, meanwhile, were brickwork, laid to form an inverted arch, and above the brickwork the empty space continued further on (Photos 2-3-69 and -70).

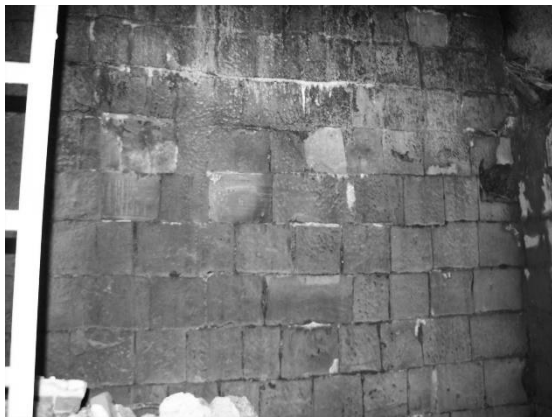
Photo 2-3-67. 3-E37\_Eastern wall, lower parts

The lower parts of the eastern wall were masonry where cut blocks of sandstone were laid in mortar or Amakawa, and the upper parts were a protruding concrete wall, with the forms still remaining in them.

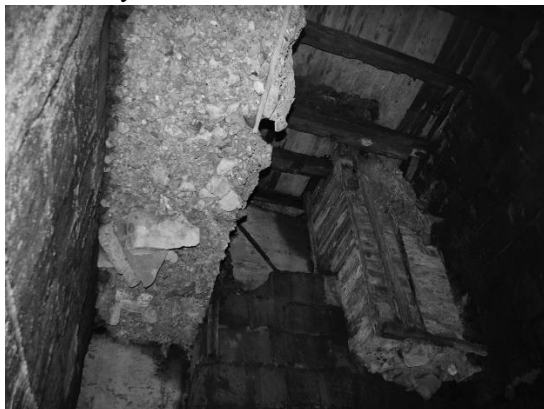
Photo 2-3-73. 3-S25

The western wall had generally the same structure as that of the eastern wall. The western wall differed from the eastern wall in that the former did not have a hole such as the one observed in the latter, and that there were square concrete columns hanging from the ceiling at the southern and northern ends (Photos 2-3-73 and -74). The square concrete columns had forms remaining intact. While the column on the southern side was located on the corner, the northern column was located at some 0.5 meters from the corner. It is unclear as to their structures and purposes. As mentioned above, the western wall was also laid with bricks at the northern end, as were the eastern wall. These may be related to the bricks in the northern wall, but details were not clear.

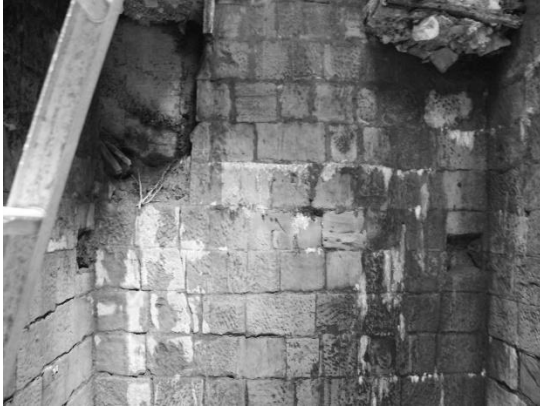
Photo 2-3-75. 3-S02

Similar to the other walls, the southern wall was also a Nunozumi masonry made of cut blocks of sandstone, and the protruding concrete portion of the eastern wall could be seen in the upper parts on the right (eastern) side, and the concrete column attached to the western wall in the upper parts on the left (western) side (Photo 2-3-75). It was not possible to investigate the southern wall up close, due to spring water observed around the wall (Photo 2-3-76).

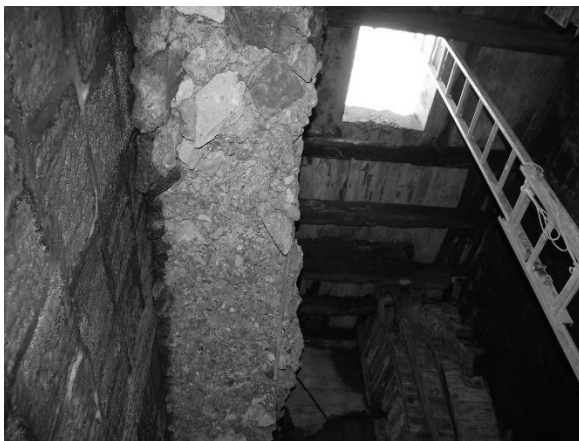
Photo 2-3-81. 3-S12

Observing the other side of the existing opening, wooden beams could be seen running across the structure. While it is unknown if the form of the opening remained unchanged from when the mine was opened or it was altered to the current form after the mine closure, it is likely that the pit entry was larger than it is currently seen because the existing opening (0.97 m × 0.93 m) is too small to be used for the purpose of coal mining. It is unclear why an opening was created instead of the entry having been completely sealed off, but a possible explanation is that it was to be used for the purpose of ventilation even after the mine closure.
