# State of Conservation Report

Sites of Japan's Meiji Industrial Revolution:

Iron and Steel, Shipbuilding, and Coal Mining (Japan) (ID: 1484)

**CABINET SECRETARIAT  
JAPAN**

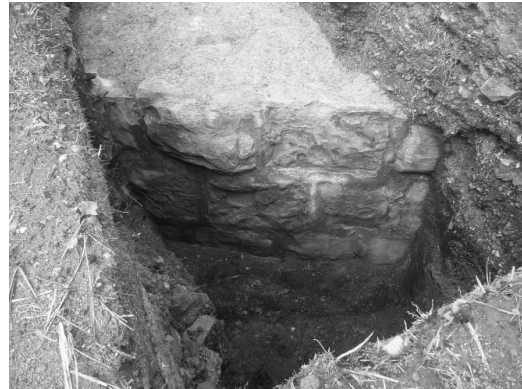
At Trenches No. 2 and No. 3, remains of the stone seawalls built in 1899 were found at the locations predicted. There were foundations of buildings above the stone walls found at Trench No. 2, where it was observed that remains of structures from the Meiji to the early Showa eras (the late 19th to early 20th century) were preserved in good condition. As the purpose of the 20014 survey was to determine the locations of stone seawalls, the stone walls were not dug up in their entirety. Nevertheless, three rows of stone walls were observed, in which stones were laid in mortar using the Nunozumi technique. The upper parts were finished in Amakawa, a type of traditional earth mixture that is light orange in color and is often used in this region. Given that the Amakawa-covered parts extended further beyond the estimated counterfort length, it is possible that the Amakawa finish may not have been used only in the stone walls but extended to the ground surface of that time (Figure 2-3-88 and Photo 2-3-111).

Photo 2-3-94. Trench No. 2, stone seawall

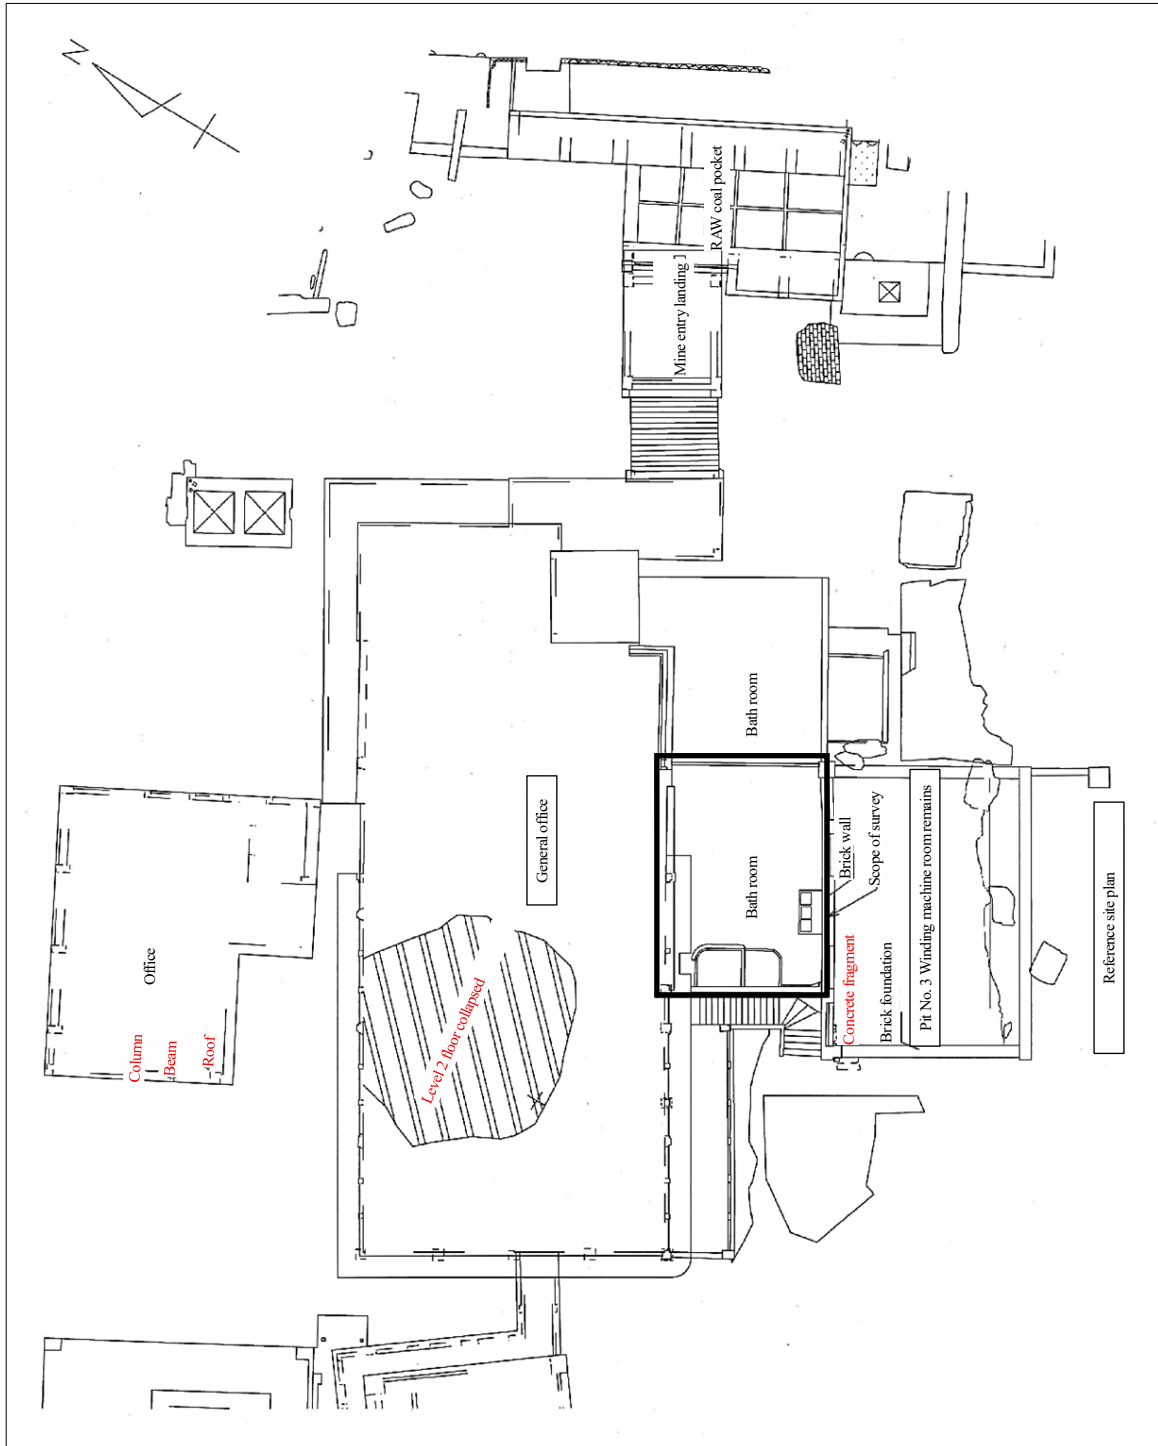
Figure 2-4-33 Survey locations inside building

The outer walls, floors, inner walls, columns, beams, ceilings, and roofs were examined for damage (cracks, floating, concrete cover falling off, rebars exposed, rebars lost, mortar finishes floating, etc.), visually and by tapping on the surface. Investigation was also made to examine the joint between the brick walls and the General Office, cracked walls inside Arch No. 4 of brick walls, and rainwater infiltration at the top of the brick walls.

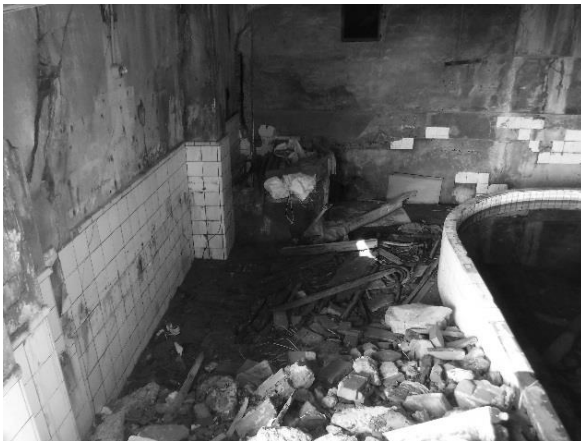
Photo 2-4-63. Appearance of General Office

Current conditions: The building remains as part of a structure that contains brick walls of No. 3 winding machine room remains. The columns, beams, and the underside of the floor slab had the surface peeling off with rebars exposed, and the deterioration may progress even further. The roof and the outer walls of Level 2 have collapsed.

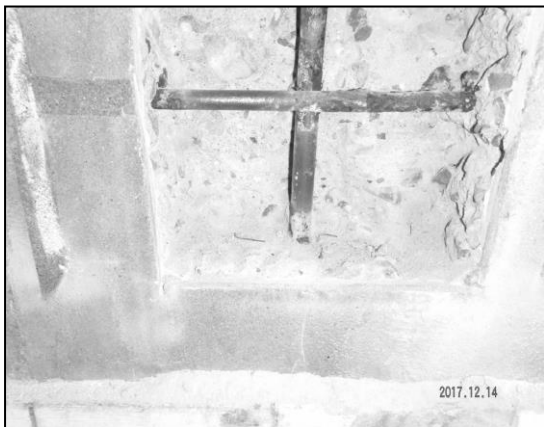
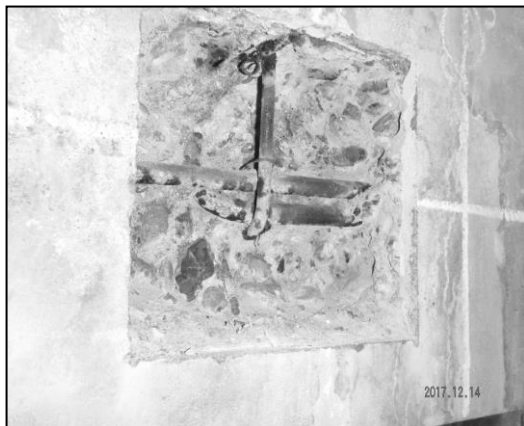
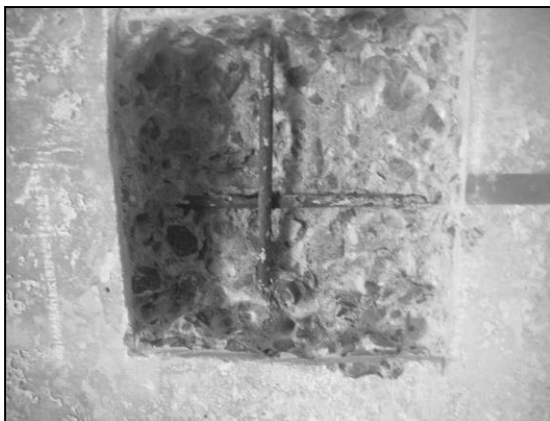
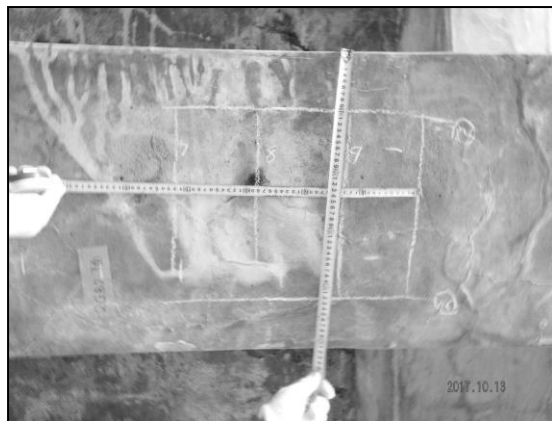
Photo 2-4-66. Conditions of rebars

The rebar diameter, rebar spacing, concrete cover thickness, and degree of rebar corrosion (as determined visually) measured at each measurement sites are provided in Table 2-4-33. The degree of rebar corrosion was Class III for the beams and columns, with floating rust observed around the circumference and along the entire length of the rebars. The rebars in the columns, in particular, had the hoops showing a loss of cross-sectional area, indicating significant levels of corrosion.

The thickness of concrete cover was greater at all the sites compared to the standards specified in the Order for Enforcement of the Building Standard Act (Photo 2-4-66).

A rebar exploration conducted on the beams from down below showed that there were only two rebars for the bottom reinforcement.

Rebar conditions (column)

Rebar conditions (beam)

Rebar arrangement at bottom of beams

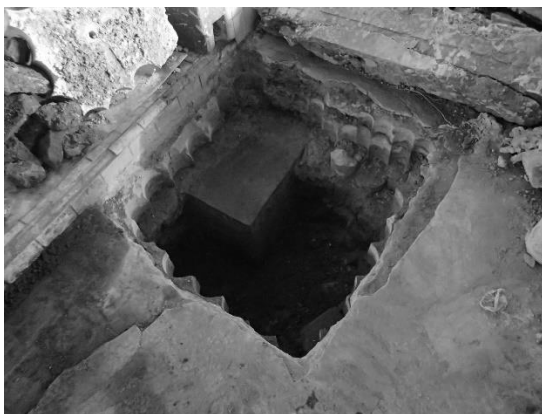
Prior to manual drilling, a layer of concrete with a thickness of approximately 35 cm was removed from the floor, to reveal a concrete structure that was presumed to be the foundation (Photos 2-4-84 and -85). When the areas around the foundation were drilled out, the undersurface was observed at 40 cm deep. The depth from the floor level to the undersurface of the foundation was 75 cm. At Exploratory Drilling Site ①, the existence of a concrete structure that was presumed to be a foundation of the building was confirmed. No deterioration or subsidence was observed with the foundation.

Photo 2-4-84. Exploratory Drilling Site ①, drilling completed

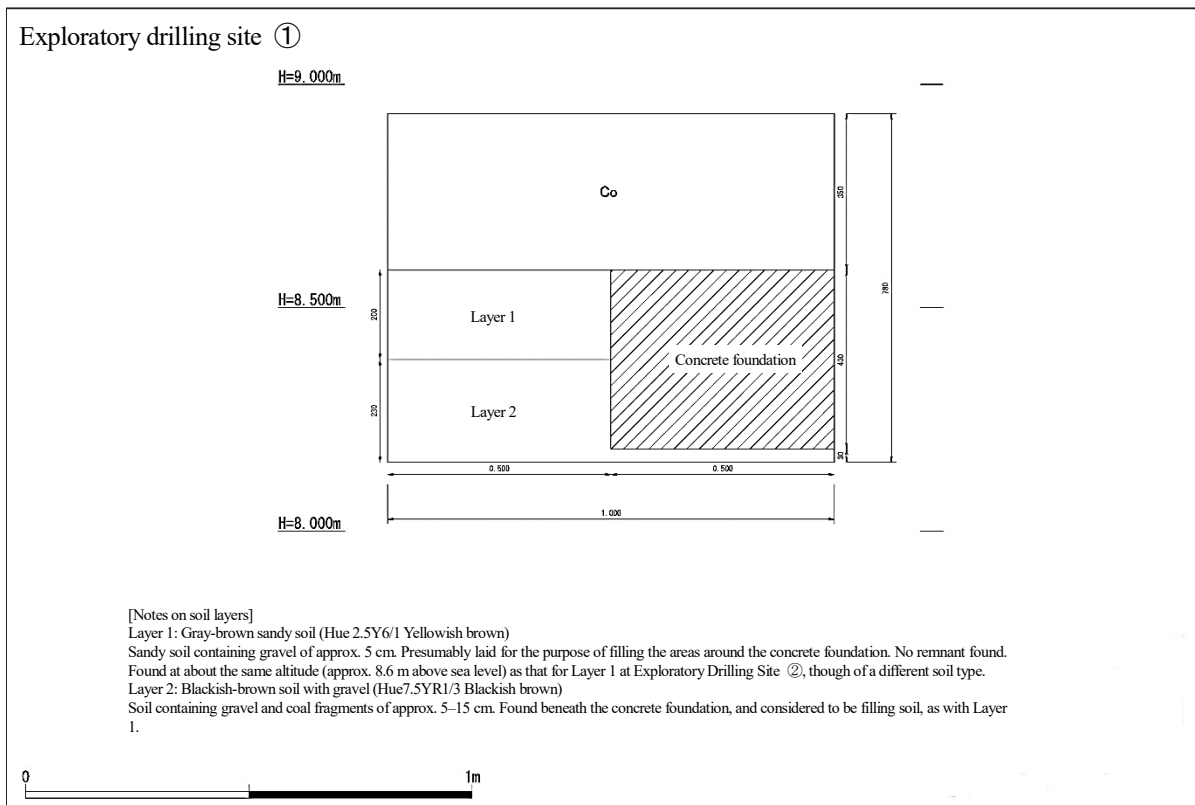
A close inspection of the soil layers at Exploratory Drilling Site ① found a 35-cm concrete layer, laid over Layers 1 and 2 which are considered to have been filling soil layers (Table 2-4-45; Photo 2-4-82; Figure 2-4-47). No remnants were observed in either Layer 1 or 2. What is noteworthy is that the beginning of the sediment of filling soil layers (Level 1) was at nearly the same altitude (approx. 8.6 m above sea level) for both Exploratory Drilling Sites ① and ②. These sediment formations, combined with the fact the thickness of the concrete layer was approximately the same, appear to indicate that Exploratory Drilling Sites ① and ② were built in the same

Figure 2-4-47. Exploratory Drilling Site ①, diagram of soil layers in Northern wall

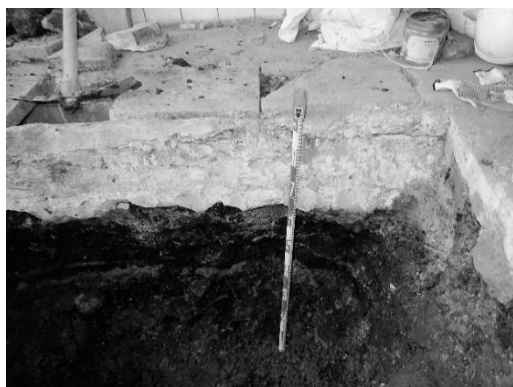
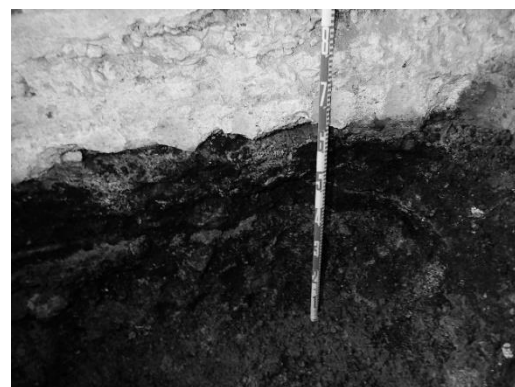
A close inspection of the soil layers at Exploratory Drilling Site ② found a 5-cm concrete layer, beneath which was a layer of crushed stone with a thickness of approximately 5 cm, followed by another layer of concrete and crushed stone with a thickness of approximately 25 cm. Underneath these concrete layers with the combined thickness of approximately 35 cm was a 20-cm filling soil layer, or Layer 1, under which was a layer of a traditional earth mixture, presumably Amakawa, with a thickness of approximately 5 cm (Layer 2). Underneath the Amakawa layer was a deposition of sandy soil (Layer 3) (Photos 2-4-86 and -87). No remnant was found in either Layers 1, 2, or 3.

Photo 2-4-86. Exploratory Drilling Site②, Southern wall

Photo 2-4-87. Exploratory Drilling Site②, Southern wall

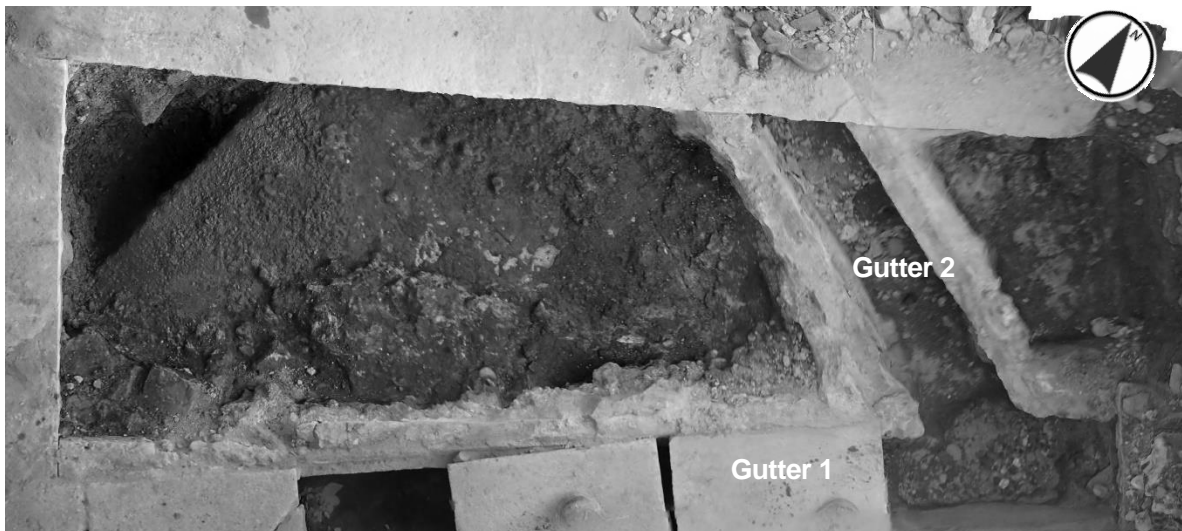
thickness that had deposited underneath the concrete was removed, a surface of what appeared to have been a concrete floor slab was observed (Photo 2-4-88). The concrete floor slab was cut off diagonally on the western side, suggesting a possibility of it being one side of a gutter. Details are unknown, however.

Photo 2-4-88. Exploratory Drilling Site ②, viewed from south

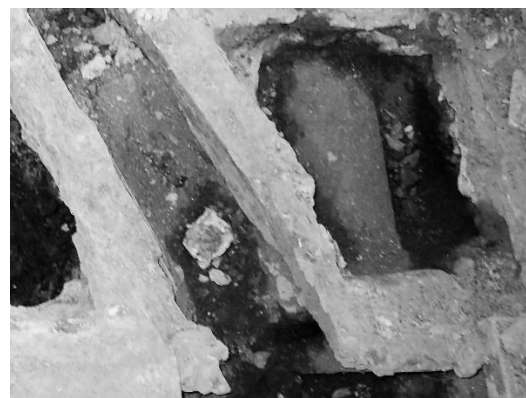
Underneath the concrete floor slab was a layer of crushed stones, and together they were approximately 25 cm thick. The level below the concrete floor slab was Layer 1, which consisted of filling soil. Beneath this was a layer of a traditional earth mixture, presumably Amakawa. On the eastern side, an iron pipe with a diameter of approximately 23 cm was found at 20 cm below the ground level (Photos 2-4-89 and -90). The iron pipe was laid so that it ran through Gutter 2 and Gutter 1 (Photo 2-4-90). As the iron pipe and Gutter 2 both led towards the bathtub, it can be surmised that they were used to drain water in the bathtub. As for in what order the gutter and the pipe were built, it was either “the iron pipe was laid first, then the gutter was installed so that it overlapped the pipe,” or “the gutter and the pipe were laid at the same time,” considering it is difficult to lay an iron pipe through a concrete gutter. Whatever the case may have been, it would be difficult to create such a formation as this using a standardized gutter, it is likely that Gutters 1 and 2 were formed on site. The thickness of the bottom was approximately 7 cm. Meanwhile, a soil pipe with a diameter of approximately 10 cm was observed from directly above Layer 2 on the eastern side. While it ran in the opposite direction from Gutters 1 and 2, it is possible that it may also have been used for bathtub drain (Photo 2-4-90).

Photo 2-4-90. Close-up (iron pipe)

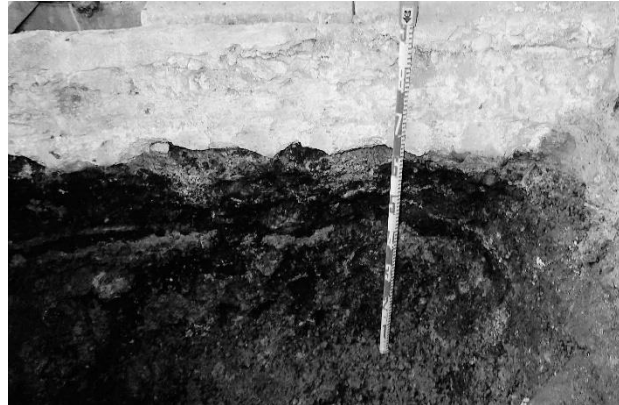
While the depth of the gutters was approximately 55 cm and 50 cm for Gutter 1 and Gutter 2, respectively, the undersurface of the gutters was almost same at around 8.4 m above sea level for both of them, with a layer of Amakawa laid at the level of the undersurface (Photo 2-4-94). While the reason why a layer of Amakawa was laid at the level of the undersurface of the gutters is unknown, it may have been done for the purpose of packing the ground and cementing the gutters during land reclamation, as well as to shut out the moisture coming from the lower layer (Layer 3) and protect the lower layer against infiltration with water that might leak from the gutters. Beneath Layer 2, or the Amakawa layer, was Layer 3, which presumably consisted of soil fills. Layer 3 was sandy soil with gravel, and was wetter in lower parts. Considering that it was sandy soil and that it was wet, it is possible that Layer 3 contained soil that had deposited there from before the land reclamation.

Photo 2-4-94 Exploratory Drilling Site ②, Southern wall

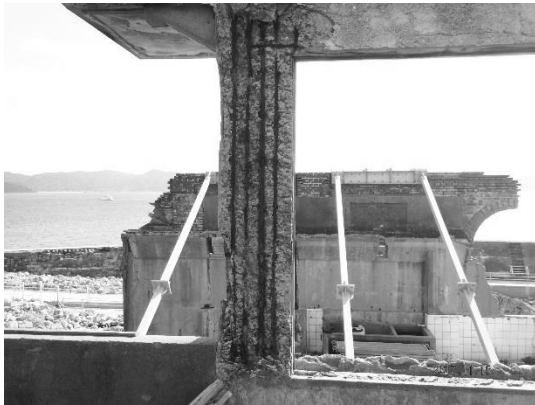
The eaves of Level 2 were in general rife with greater degrees of concrete cracks, explosion, falling-off, and corrosion. As seen in the eaves on base lines C and 2 intersection (Photo 2-4-102), the north-facing sides of the columns generally suffered a loss of cross-sectional area due to explosion, and in some parts, corrosion and a loss of cross-sectional area of reinforcement were observed and the column had entirely disappeared. The eaves themselves had also suffered explosion in some parts of the back side as seen in (Photo 2-4-103). The causes, again, are presumed to have been mortar shrinkage due to temperature changes, insufficient size of cover, and salt damage.

Photo 2-4-102. explosion; Eaves on base lines C and 2 intersection

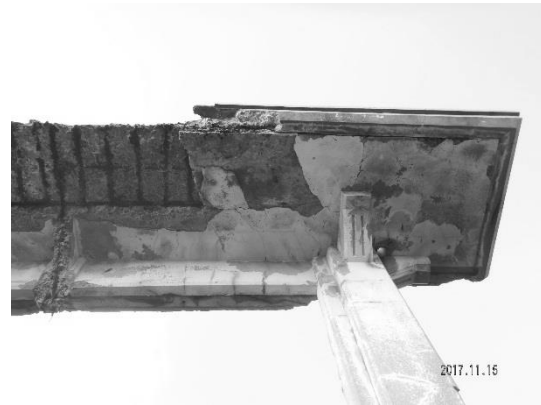
Photo 2-4-103. explosion; back side of eaves

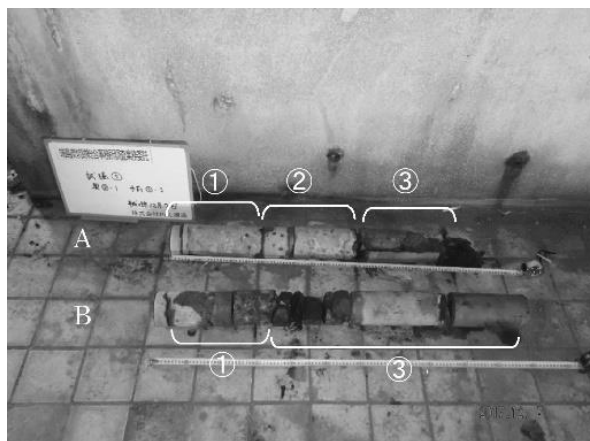
In this survey, exploratory drilling was carried out to understand the conditions of the foundations and footing beams of the General Office building. At Exploratory Drilling Site ② (lower parts of Column on base lines A and 3 intersection), which was situated near the brick walls, gutters were found buried underground and the geometry of footings could not be determined. However, the cores drilled out vertically from the foot of the column (Area A) (Photo 2-4-104) and from where footing beams were estimated to be (Area B) (Photo 2-4-105) showed the existence of a layer of unreinforced concrete with a thickness of approximately 350 mm on the surface in both Areas A and B, as shown in (Photo 2-4-105). Underneath this layer were bricks and foundation stones which were presumably the foundations of the brick walls in Area B. In Area A, meanwhile, beneath the unreinforced concrete layer was a layer of concrete with a thickness of approximately 250 mm which was presumably the footings, under which there were foundation stones that were presumed to be the foundation of the brick walls. Similarly, a layer of unreinforced concrete with a thickness of approximately 350 mm and independent footings of unreinforced concrete with a thickness of approximately 400 mm were observed at Exploratory Drilling Site ①. Estimated cross-section views of the drilling sites are provided in (Figure 2-4-50).

Based on these findings, it is surmised that the foundations of the building are independent, unreinforced footings. For the foundation of the columns where the building was connected to the brick walls, it is presumed that the footings were laid on top of the foundations of the brick walls, which had already existed and were left as is. There was no footing beams found, as a result of core boring and rebar exploration.

Photo 2-4-104. Core boring site; on base lines A and 3 intersection

- ① Floor slab 350 mm
- ② Footing
- ③ Foundations of brick walls

Photo 2-4-105. Cross-section view of drilled cores

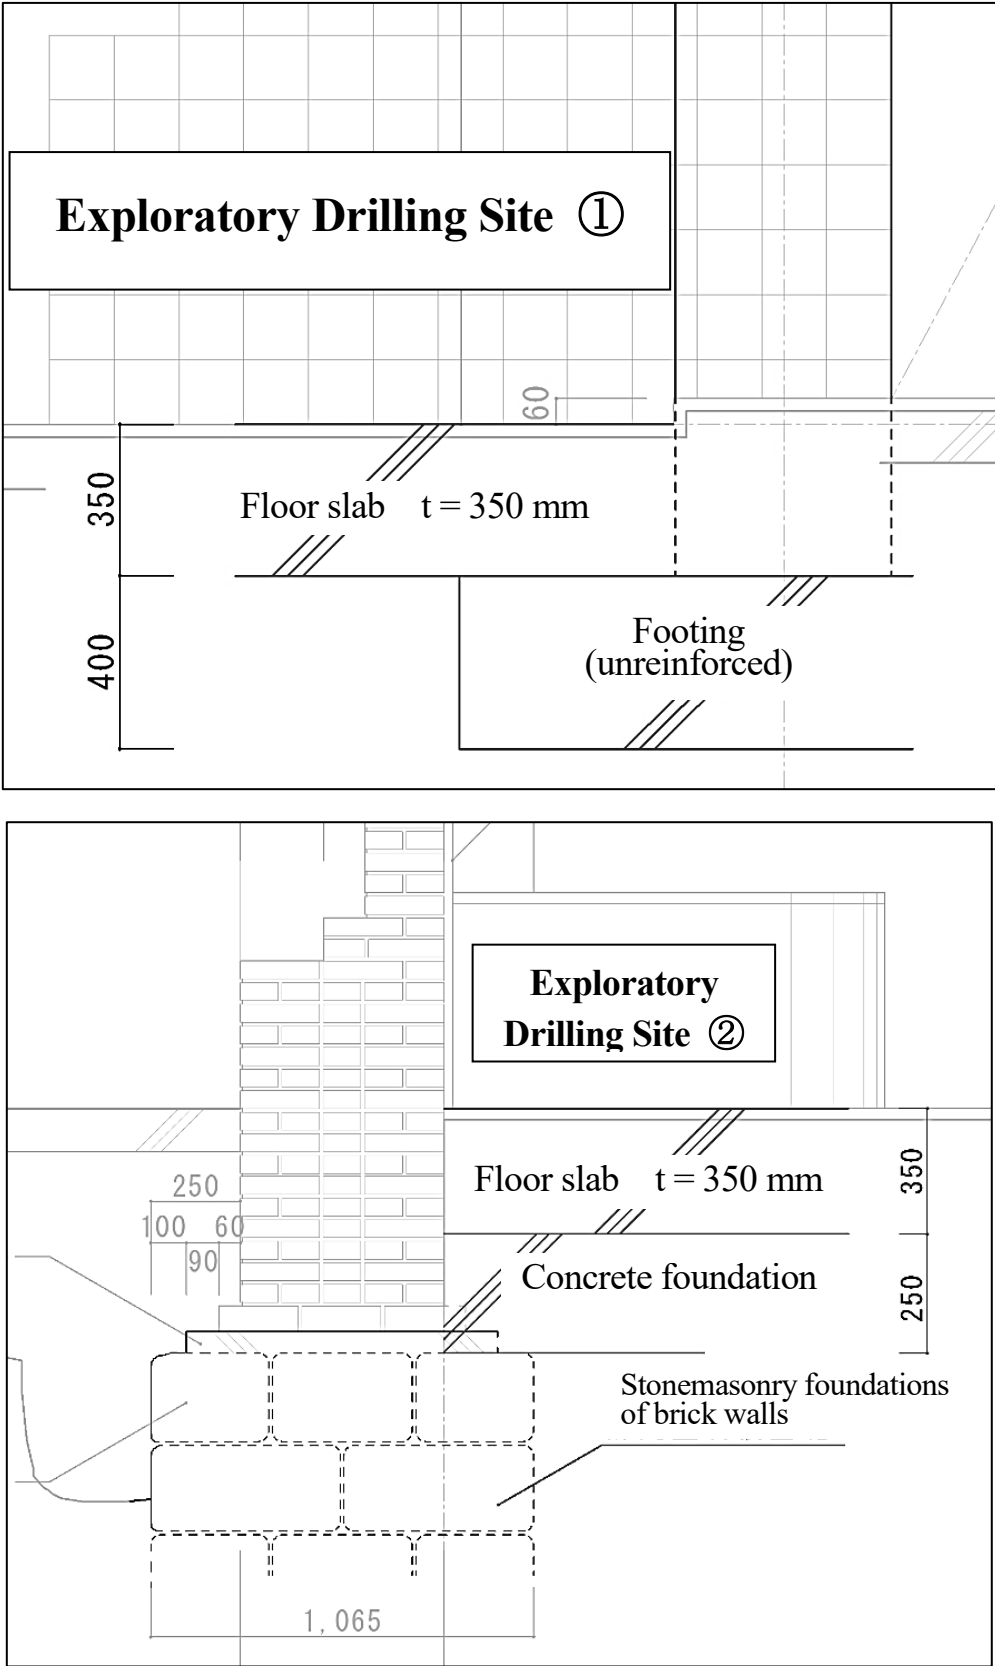
Figure 2-4-50. Estimated cross-section views of foundation exploratory drilling sites

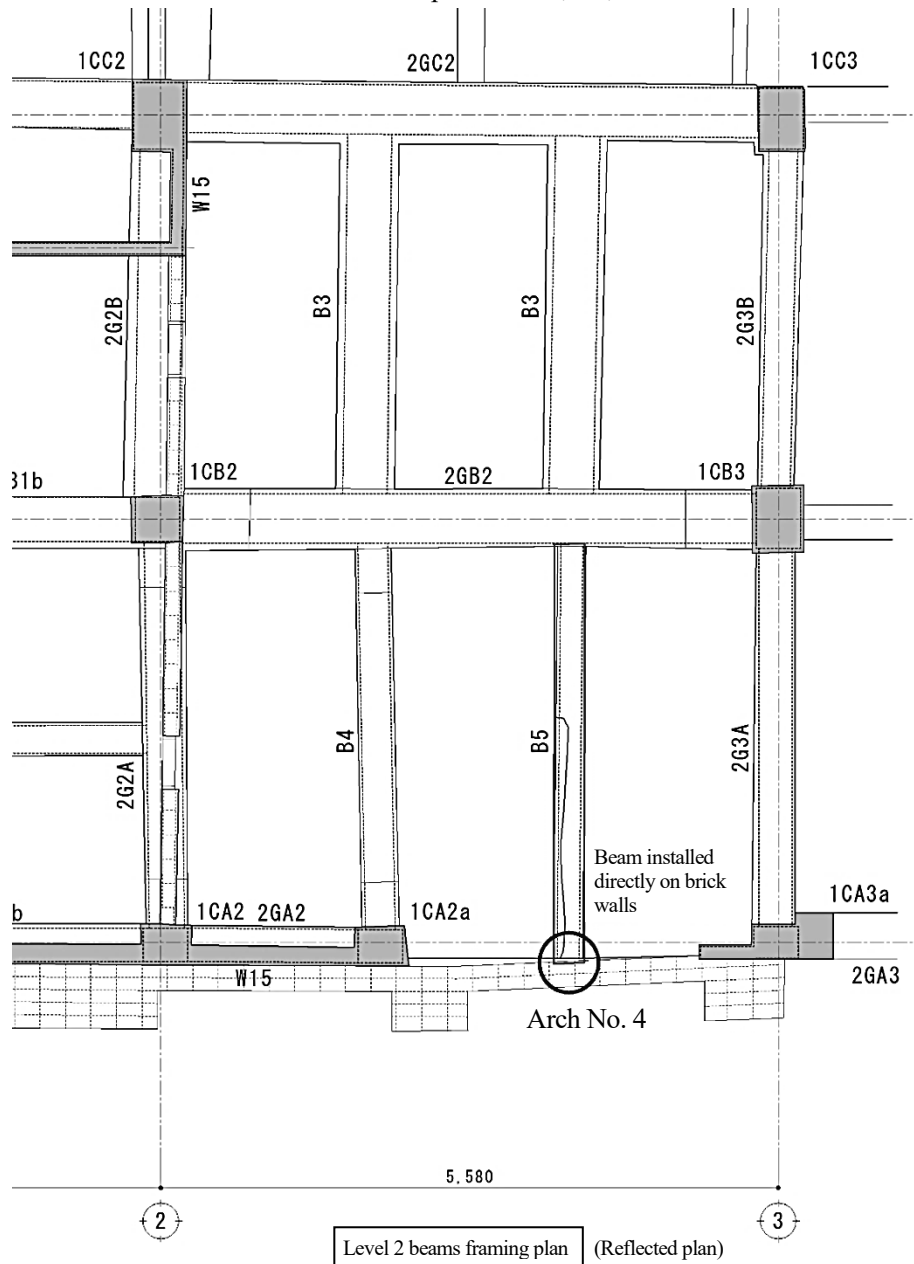
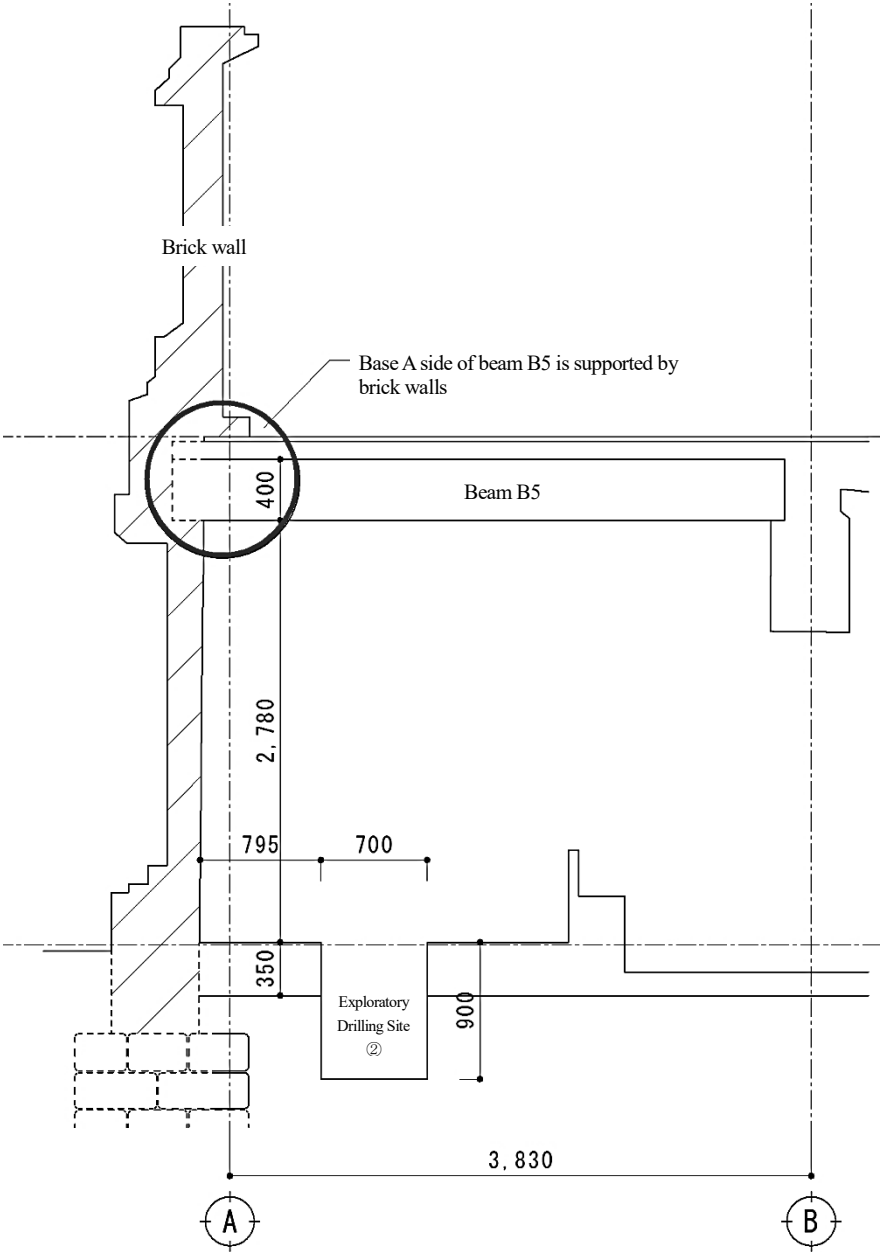
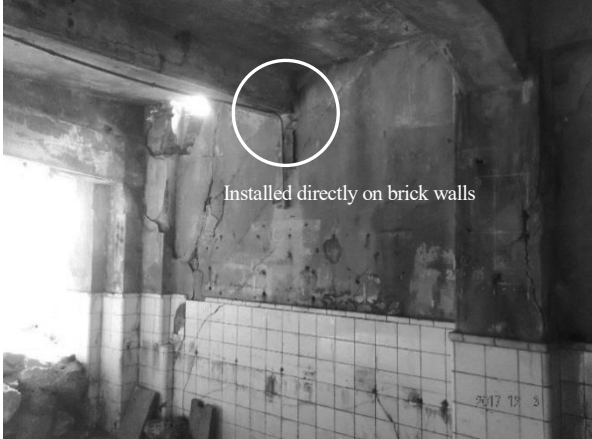
The beam in the General Office (Figure 2-4-51), meanwhile, was installed directly on the top of Arch No. 4 of the brick walls, as illustrated in (Figure 2-4-52) and (Photo 2-4-106). This leaves the upper part of the arch to bear the load.

Visual examination found that the slab supported by this beam showed signs of having been newly placed or re-cast. This indicates that the beam which was laid on top of the arch, too, would have been added at the same timing.

Figure 2-4-51. Level 2 beams framing plan

Figure 2-4-52. Relationship between beam and arch

Photo 2-4-106. Joint condition between Beam B5 and brick walls

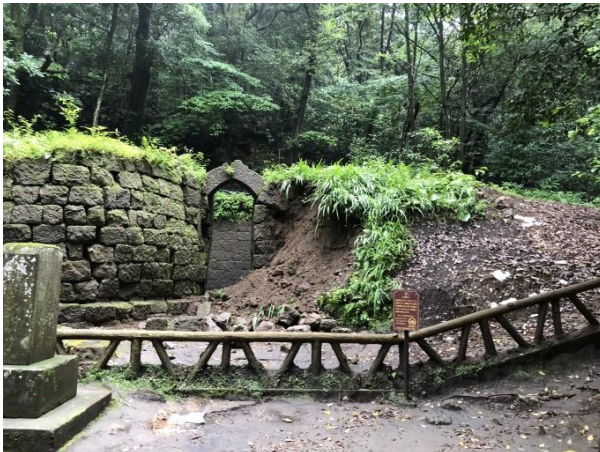
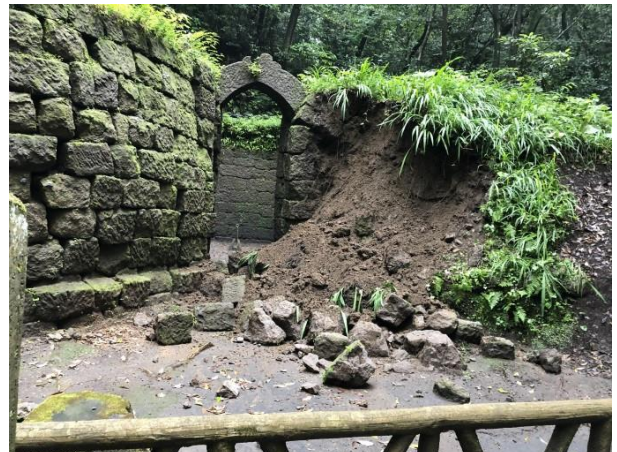
#### (1) June 28

Following the heavy rains beginning on June 27, water seeped into the soil behind the masonry surrounding the charcoal kiln site. The masonry, unable to bear the resulting weight, collapsed over a section on the right side (facing) of the kiln site (approx. 2.5m high by 2m wide).

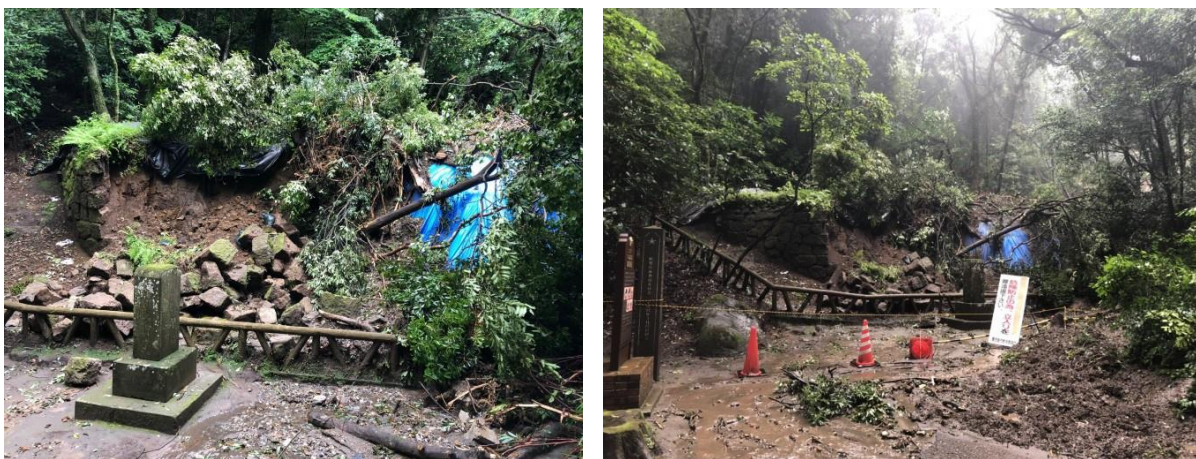
#### (2) July 1

Heavy rains that continued intermittently from June 27 then caused landslips of approx. 100m long and 30m to 50m wide on a slope northeast of the charcoal kiln site. As a result, a large volume of earth, sand, and fallen trees was carried onto the grounds of the site, and a section of masonry on the left side (facing) of the charcoal kiln site collapsed (approx. 2.5m high by 3.5m wide). In addition, most of the charcoal kiln site was buried in soil by the landslide. The "Monument to the charcoal kiln" was not damaged, however. (See the right photograph of the top on p.7)

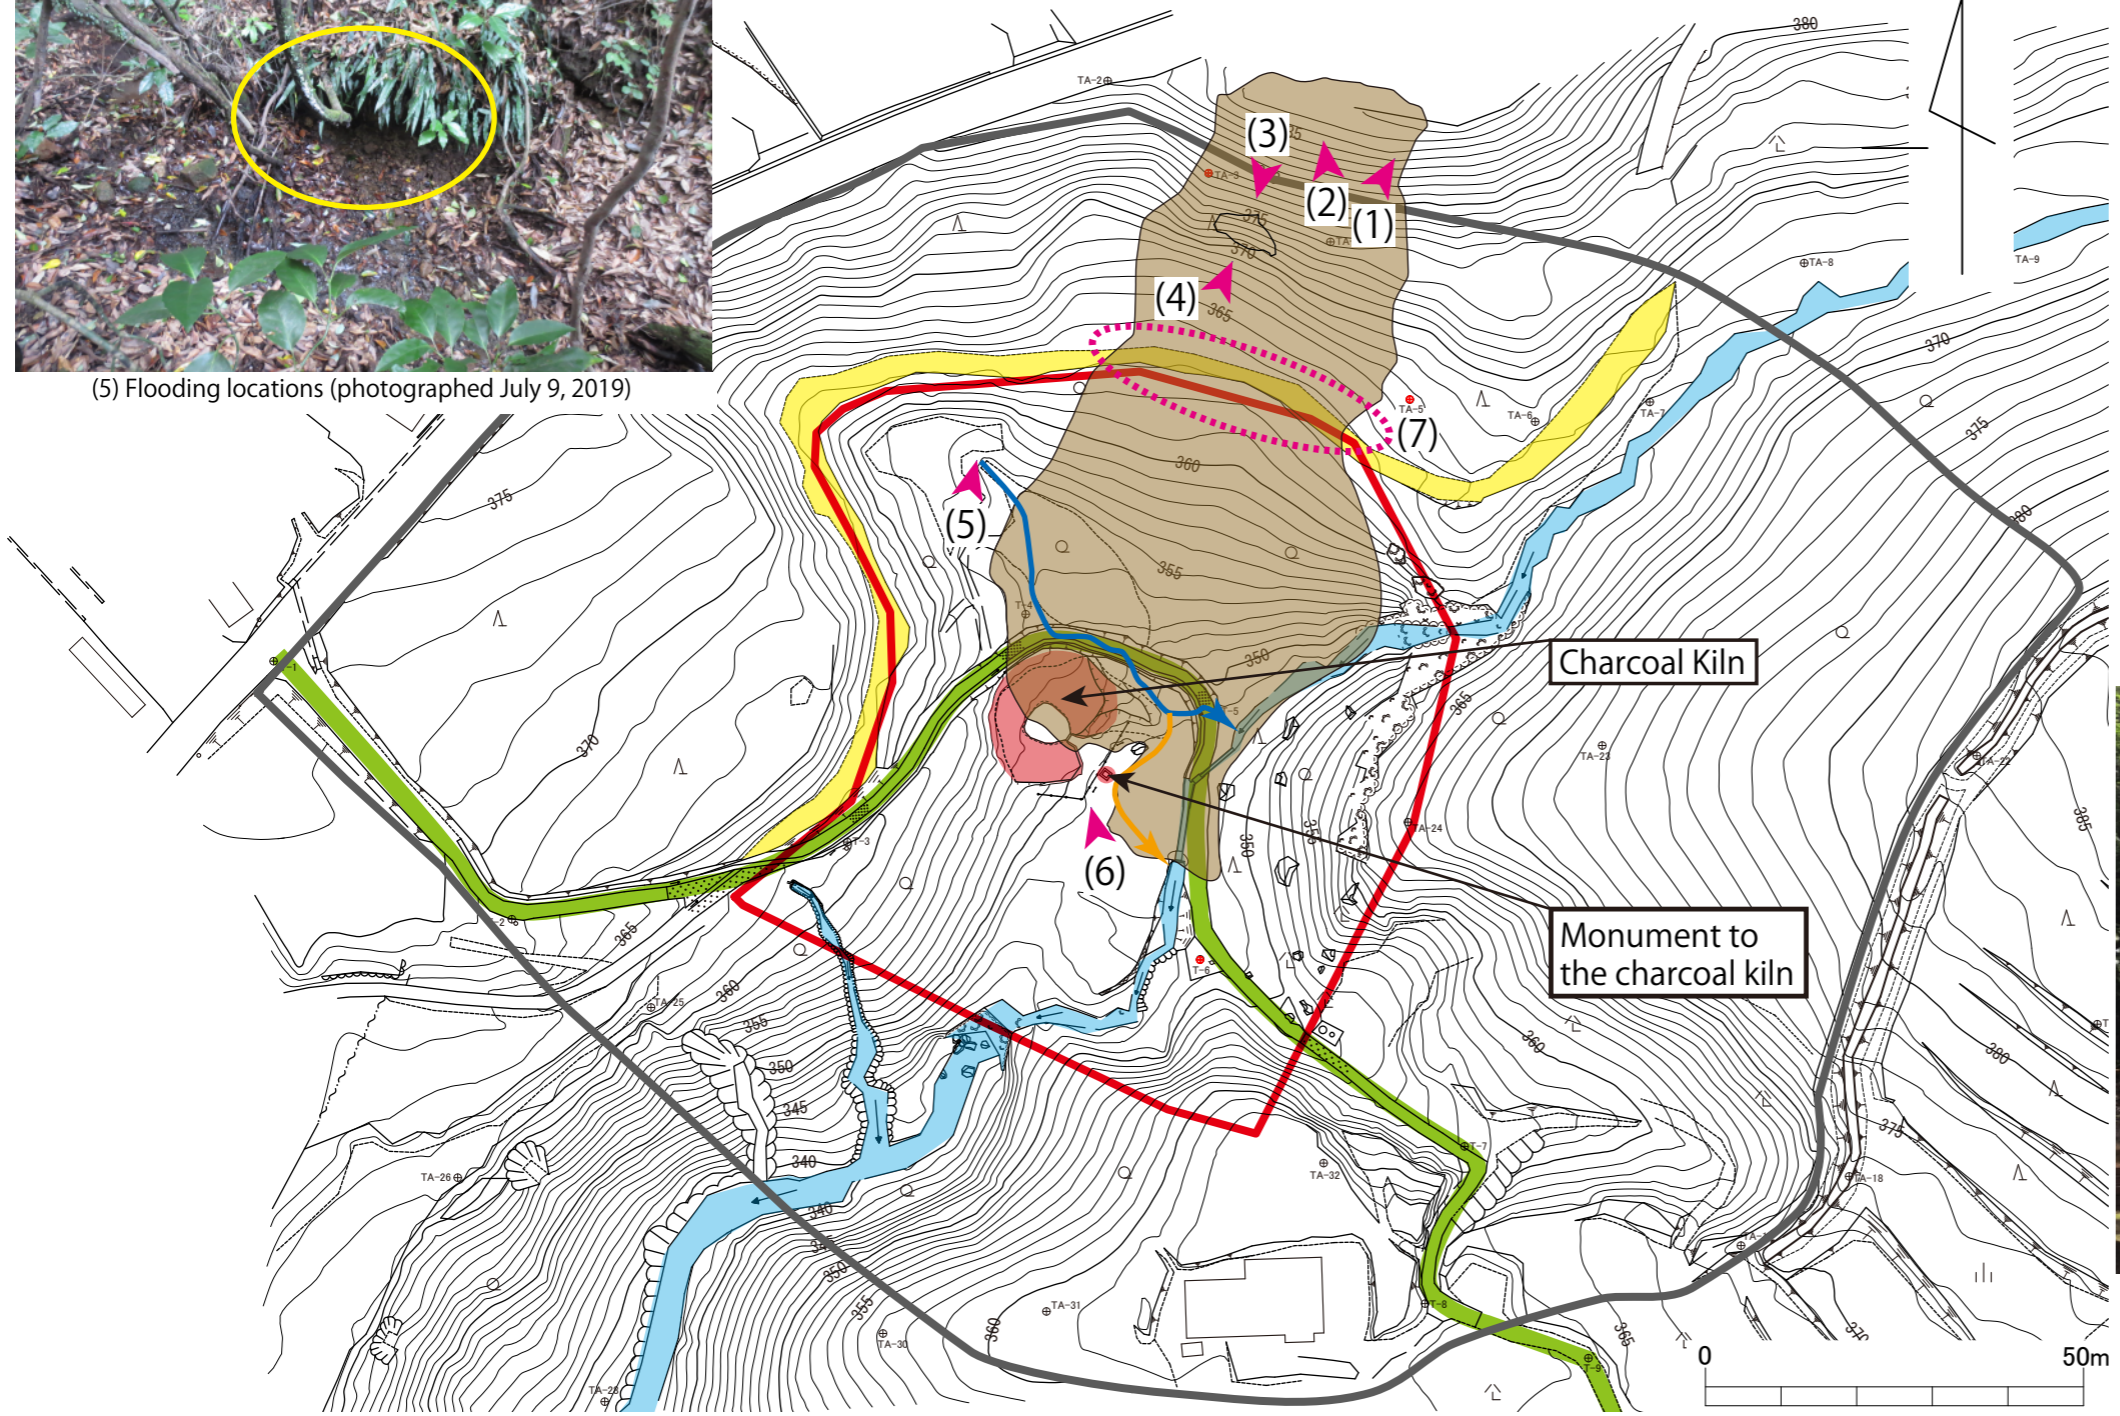
(5) Flooding locations (photographed July 9, 2019)

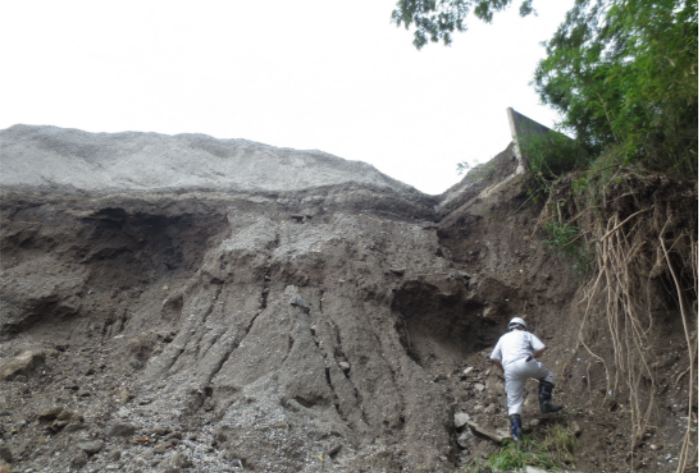
(1) Upper part 1 of landslide (photographed July 9, 2019)

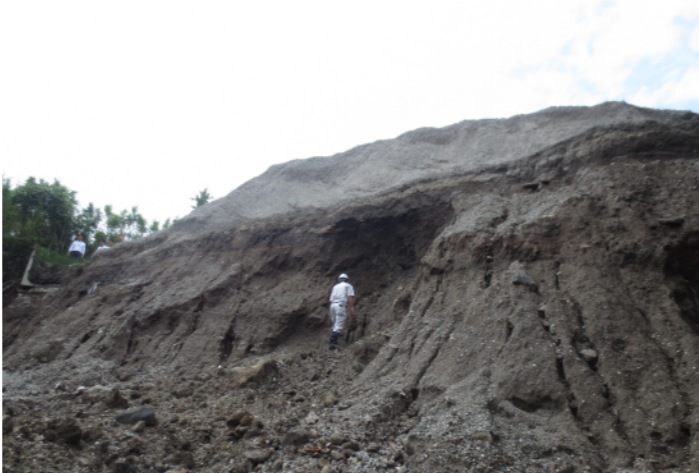
(2) Upper part 2 of landslide (photographed July 9, 2019)

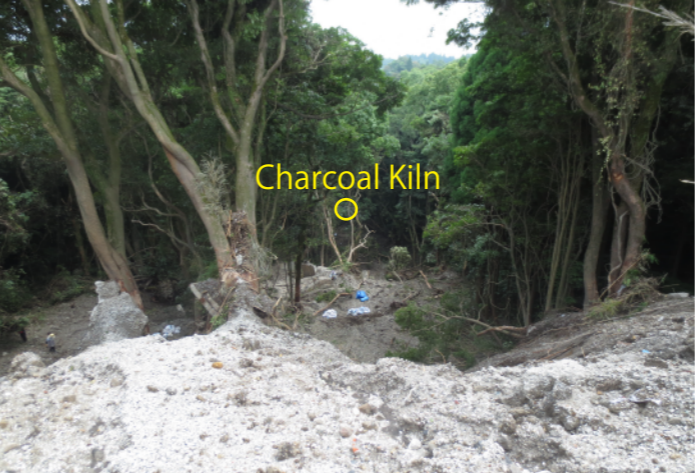
(3) View from upper part of landslide (photographed July 9, 2019)

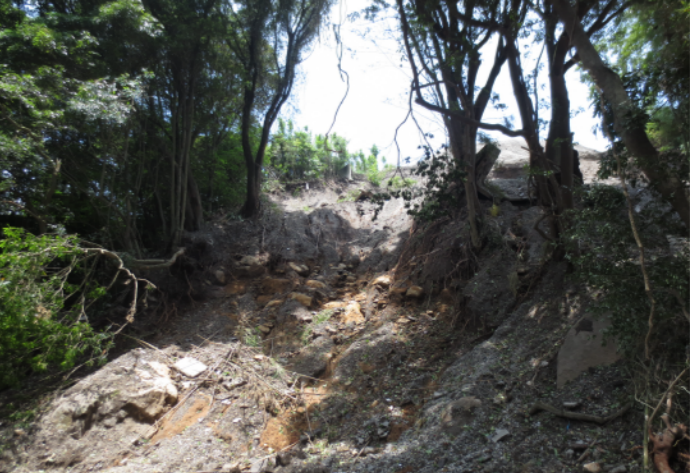
(4) Midslope of landslide (photographed July 9, 2019)

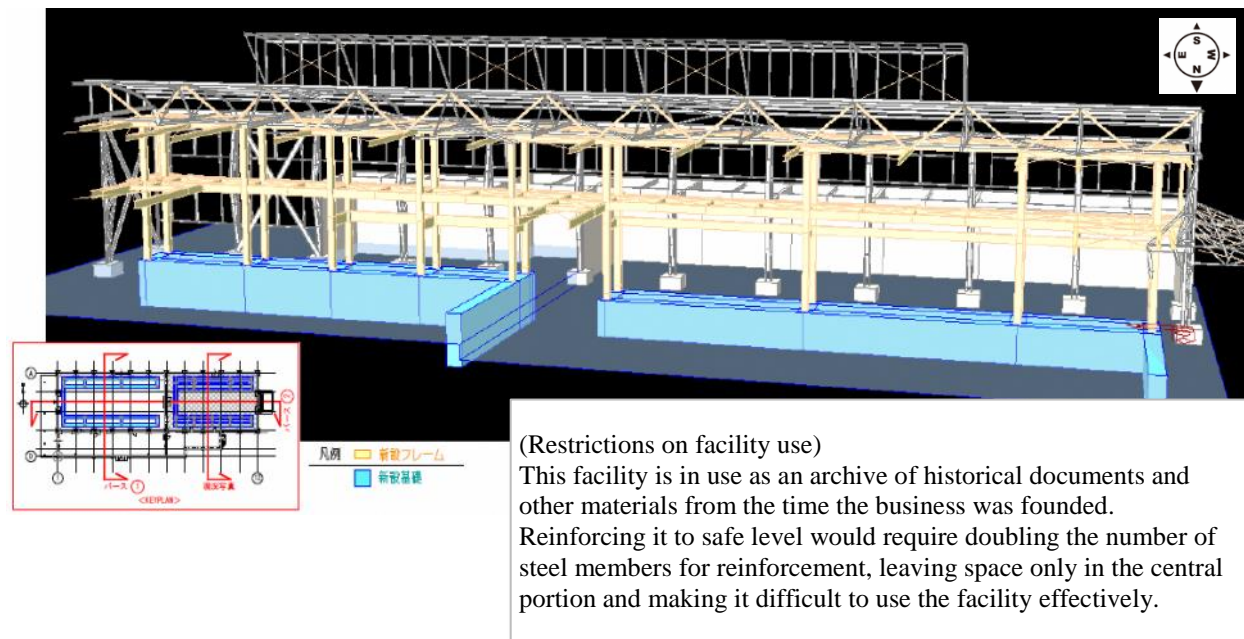
3) Perspective drawing (overall)

This facility is in use as an archive of historical documents and other materials from the time the business was founded. Reinforcing it to safe level would require doubling the number of steel members for reinforcement, leaving space only in the central portion and making it difficult to use the facility effectively.

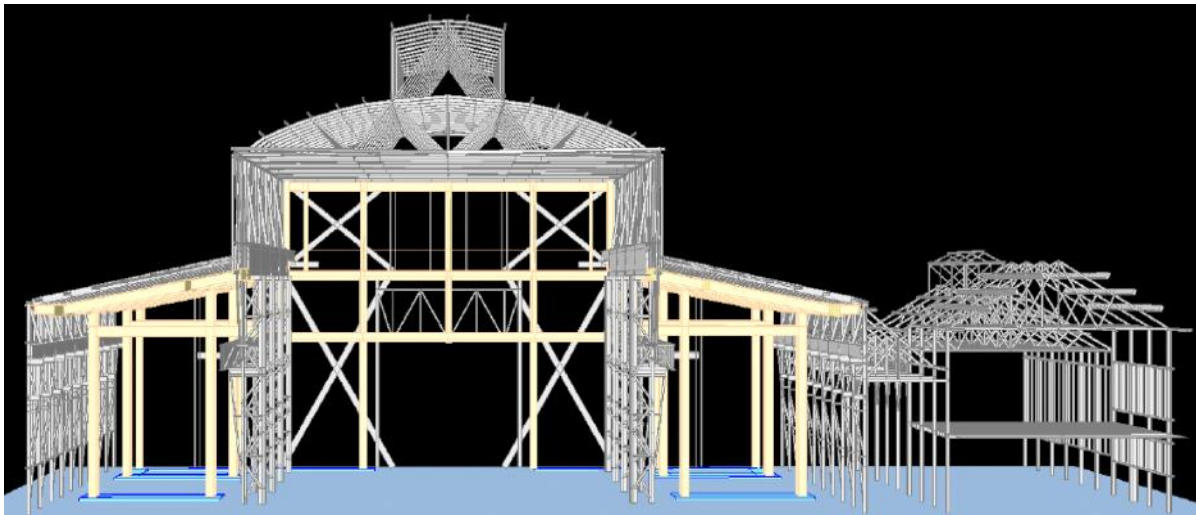
2) Perspective drawing (east → west)

This facility is in use for offline operations during periodic repairs and as a storage place for spare materials. Reinforcing it to safe level would require doubling the number of steel members for reinforcement, leaving no space for storing spare materials and making it difficult to use the facility effectively.

In the case of this reinforcement proposal as well, measures will be needed such as relocation of spare materials racks interfering with reinforcement members in the north wing and provision of new racks due to inability to use the hoist crane in the south wing. Measures for obtaining storage capacity for spare materials are thus under study.
