Archaeological excavation report (A survey of the mouth of Pit at the Hashima Coal Mine remains)

(1) Survey of remains of the mouth of Pit

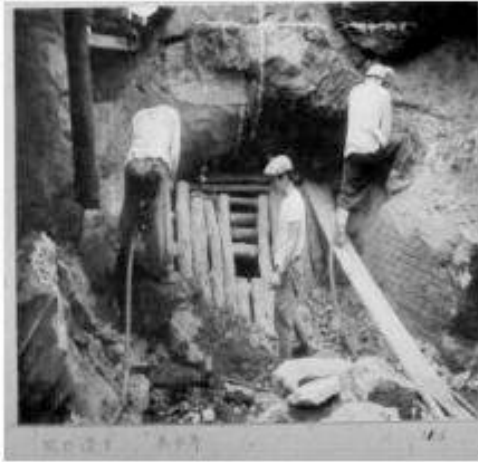
were left there at the time the business was opened. Since the scattered pieces of lumber were boards, rather than rods as those photographed in Photo 2-3-50, it is likely that they were used for forms. A pipe can be seen on the floor, what it was used for is unclear.

Photo 2-3-50. June 1956; Structure of the mouth of Pit

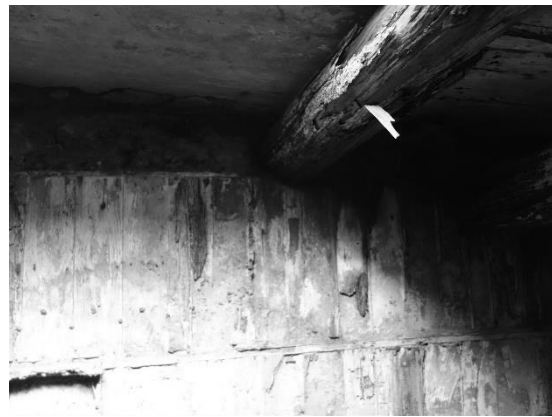
Photo 2-3-68. 3-A04_Eastern wall, upper parts

The lower parts of the eastern wall were masonry where cut blocks of sandstone were laid in mortar or Amakawa, and the upper parts were a protruding concrete wall, with the forms still remaining in them.

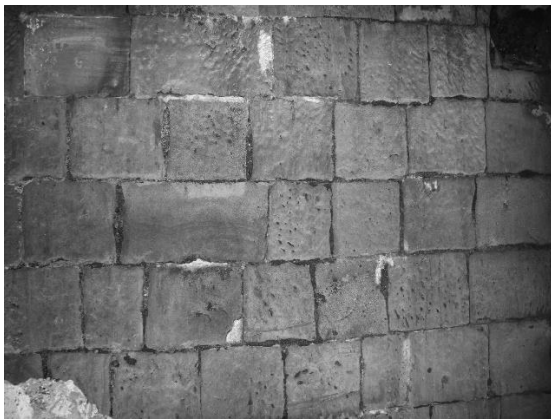
Photo 2-3-71. 3-E35

The ashlar masonry technique used here were the same as those observed in the masonry revetment and elsewhere on Hashima Island, namely the Nunozumi, which uses squared blocks of stone. What characterized these structures was the use of squared blocks of stones, rather than fieldstone. The blocks of stone used here had varying widths ranging from approximately 30 cm to 50 cm, while their height was all standardized to approximately 35 cm. It is noteworthy that the eastern wall had a hole in it at the southern parts (Photo 2-3-71) and that it was laid with bricks at the northern parts (Photo 2-3-72). While it is unclear why these were so, the hole in the southern parts of the eastern wall may have been used for tools to pass through, such as piping.

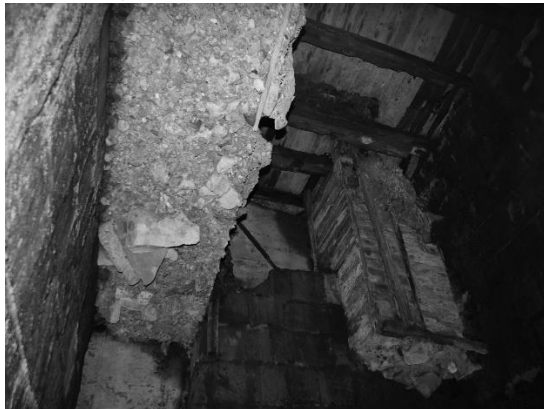
Photo 2-3-73. 3-S25

The western wall had generally the same structure as that of the eastern wall. The western wall differed from the eastern wall in that the former did not have a hole such as the one observed in the latter, and that there were square concrete columns hanging from the ceiling at the southern and northern ends (Photos 2-3-73 and -74). The square concrete columns had forms remaining intact. While the column on the southern side was located on the corner, the northern column was located at some 0.5 meters from the corner. It is unclear as to their structures and purposes. As mentioned above, the western wall was also laid with bricks at the northern end, as were the eastern wall. These may be related to the bricks in the northern wall, but details were not clear.

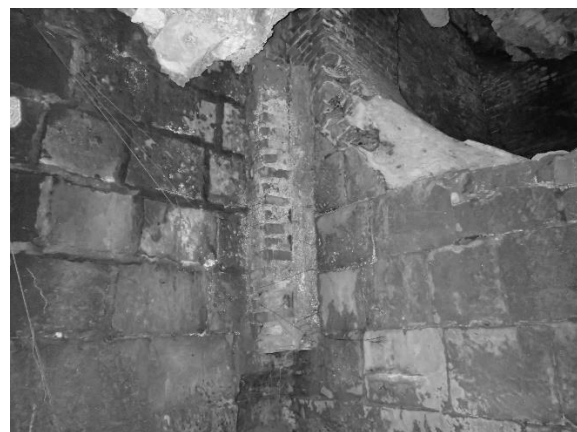
Photo 2-3-78. 3-N19

While the stone masonry in the lower parts were in general done in the same manner as with the other walls, there were horizontally long remnants of metal observed in three locations at approximately 1.4 meters from the floor (Photo 2-3-77). It is speculated that these may have been connected to a tool or machinery, but no definite sign could be found nearby, and details are unknown. In the meantime, the bricks observed on the eastern and western walls were laid in such a manner that they were connected to the arch-shaped brickwork of the northern wall (Photo 2-3-78). This suggests the bricks were probably supposed to serve their roles when connected to something, but this, too, remains unknown.

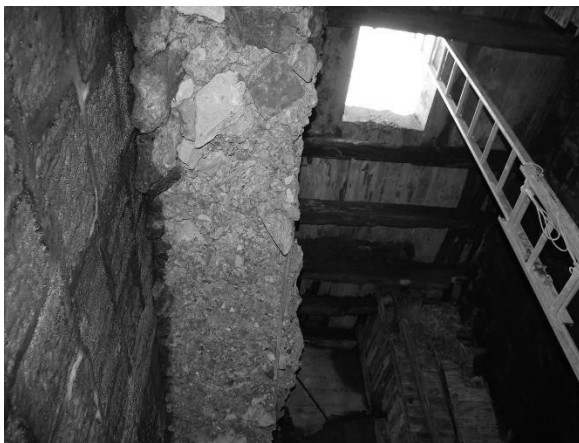
Photo 2-3-81. 3-S12

Observing the other side of the existing opening, wooden beams could be seen running across the structure. While it is unknown if the form of the opening remained unchanged from when the mine was opened or it was altered to the current form after the mine closure, it is likely that the pit entry was larger than it is currently seen because the existing opening (0.97 m × 0.93 m) is too small to be used for the purpose of coal mining. It is unclear why an opening was created instead of the entry having been completely sealed off, but a possible explanation is that it was to be used for the purpose of ventilation even after the mine closure.
