Survey of the structure of Pit No. 3 winding machine room
(Survey of Hashima Coal Mine buildings, etc.)

Appendix 3

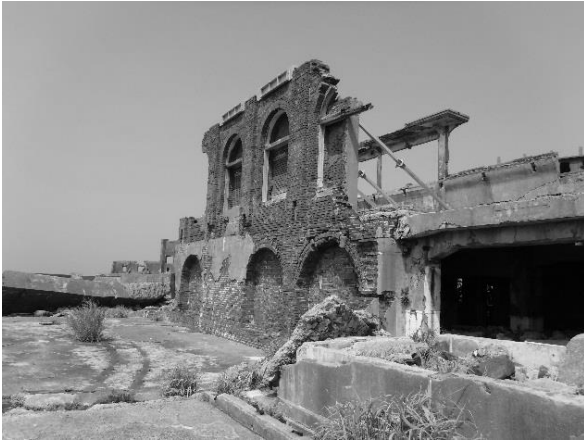
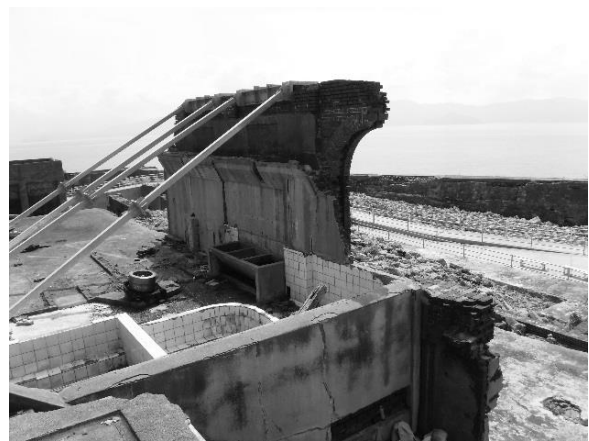
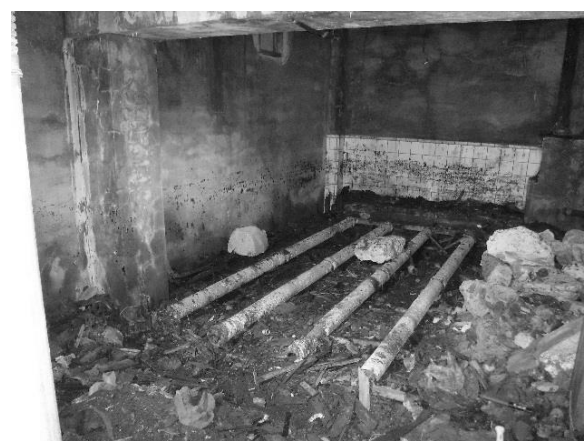
Photo 2-4-63. Appearance of General Office

Current conditions: The building remains as part of a structure that contains brick walls of No. 3 winding machine room remains. The columns, beams, and the underside of the floor slab had the surface peeling off with rebars exposed, and the deterioration may progress even further. The roof and the outer walls of Level 2 have collapsed.

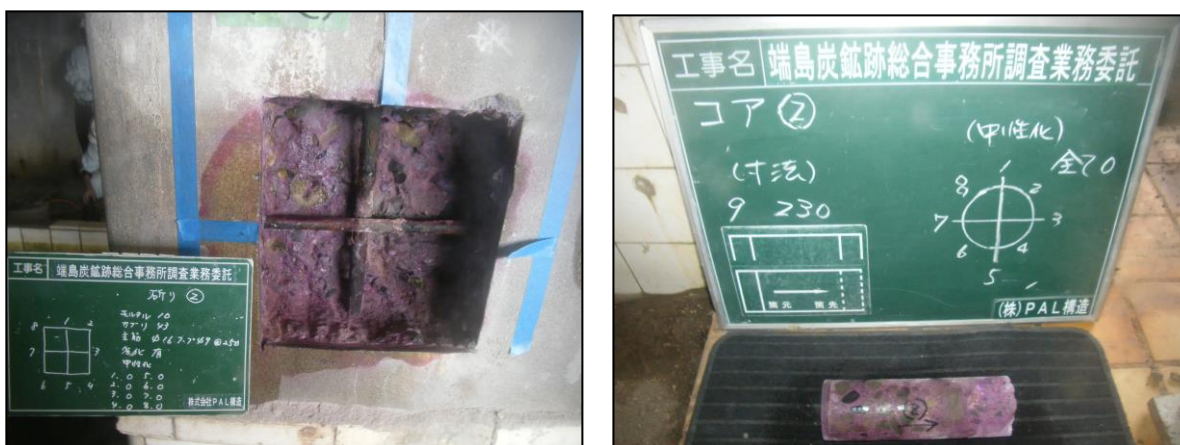
Photo 2-4-68. Testing for neutralization

As shown in Table 2-4-37, the depth of neutralization was 0 mm for all measurement points, indicating that no neutralization had occurred. The results suggest that the corrosion of the rebars had not been caused by neutralization of concrete but by some other factors.

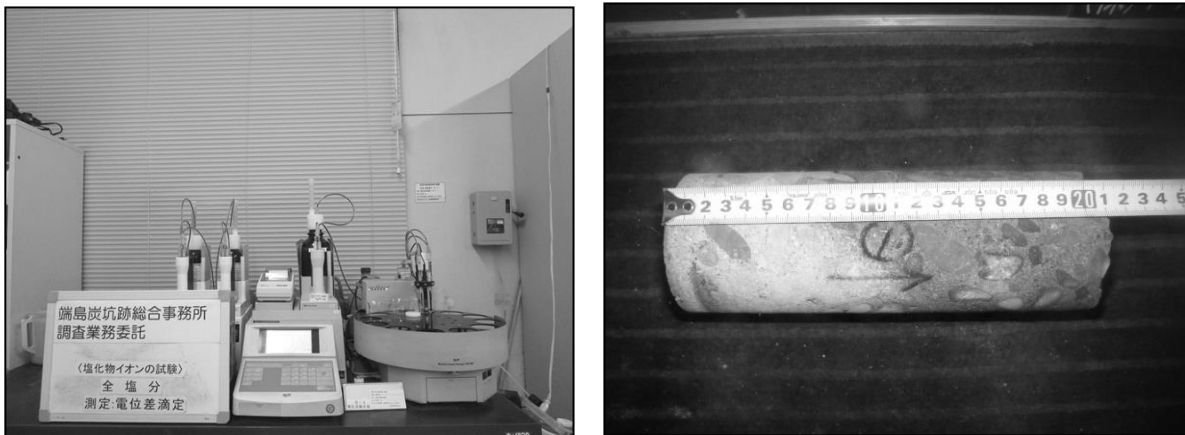
Photo 2-4-69. Measurement of chloride ion content

The results of this test showed that the chloride ion level exceeded the chloride threshold for corrosion in all of the cores on the surface, with the levels generally turning lower in deeper parts. In areas near rebars, the chloride ion levels exceeded the chloride threshold for corrosion in the columns and floor. The rebar corrosion levels were Class III for the columns and Class II for the floor, which show that the high salt levels near the rebars are likely to have been one of the causes of the rebar corrosion.

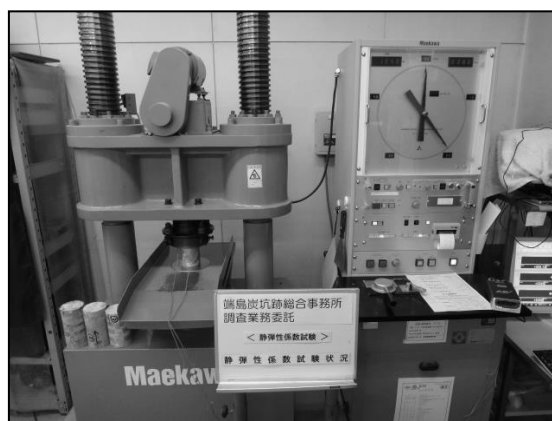
Photo 2-4-70. Performing compressive strength / static elastic modulus tests

The test results are shown in Table 2-4-38. The compressive strength determined in the test ranged between 11.6 N/mm² and 42.4 N/mm². It was lower than the original design specification of 13.5 N/mm² for the beams. The static elastic modulus, meanwhile, was lower than the original design specifications for the columns, beams, and slabs. The decline in concrete strength may have been due to the blend of materials made at the time of construction, or deterioration with age.

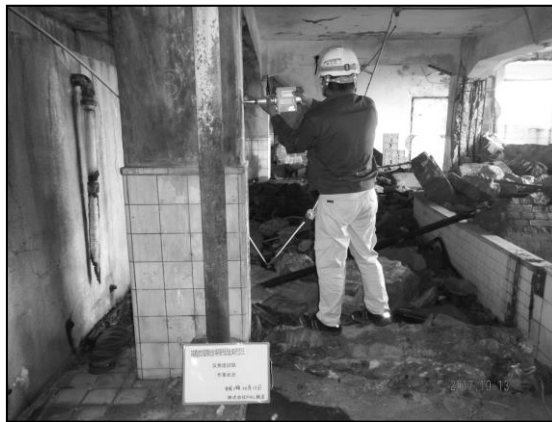
Photo 2-4-71. Performing rebound hammer test

The results from this test range between 18.3 N/mm² and 59.6 N/mm². When the data obtained from the compressive strength test were compared to those from the rebound hammer test for the core ① (Beam 2GB2), there was a large discrepancy was observed, with the former being 11.6 N/mm² compared to 59.3 N/mm² for the latter. Possible reasons for this discrepancy may include the unevenness of the finished surface and floating. The varying results in the estimated strength also suggest a possibility that some parts of the concrete may have lower strength than in other parts. This is suggested also by the results of the compressive strength test, as well.

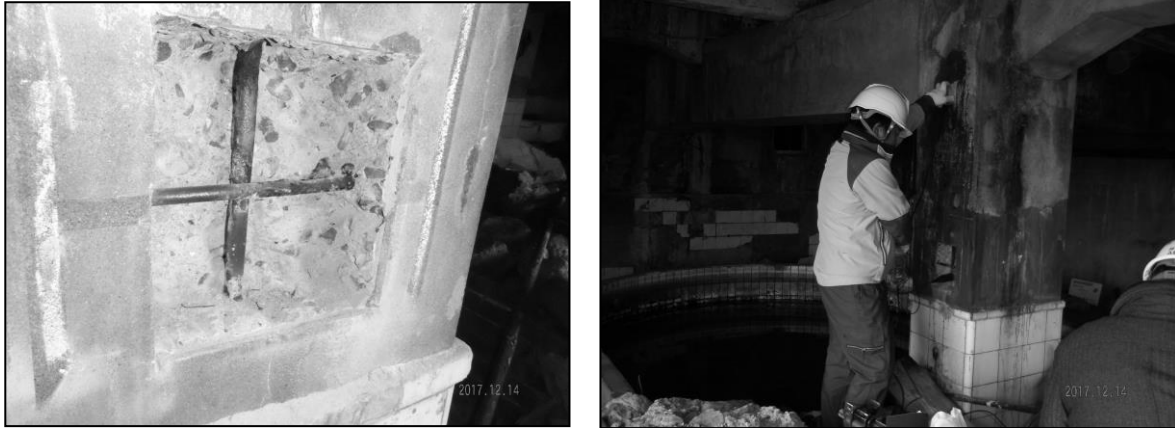
Photo 2-4-72. Measuring reinforcement corrosion degree

The assessment of corrosiveness and corrosion rate of rebars was performed according to the criteria provided in the *Concrete Diagnostic Techniques* (Japan Concrete Institute). With respect to the likelihood of corrosion, parts of the beam were judged to be “corroded with a probability of 90% or higher,” while others were “indeterminate” or “not corroded with a probability of 90% or higher.” According to visual inspection of the chipping sites, however, the level of corrosion was Class III for the column and beam, creating discrepancies in the assessment. Similarly, the corrosion rate as determined by the polarization resistance measurement also produced discrepancies with the results of “no corrosion” at all of the measurement points. A reason for these discrepancies may have been that even though the rust on the surface of the rebars had been polished off, corrosion had progressed deep inside, and taking measurements over the surface of the rust resulted in increased resistance.

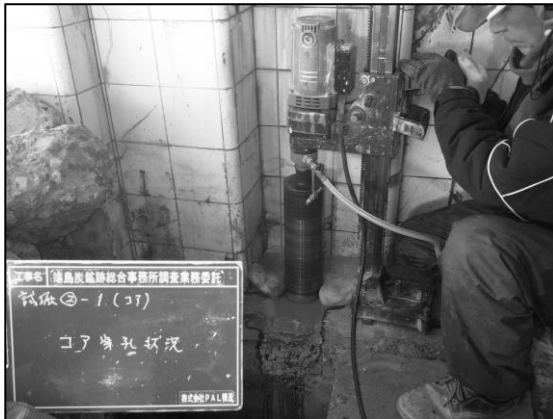
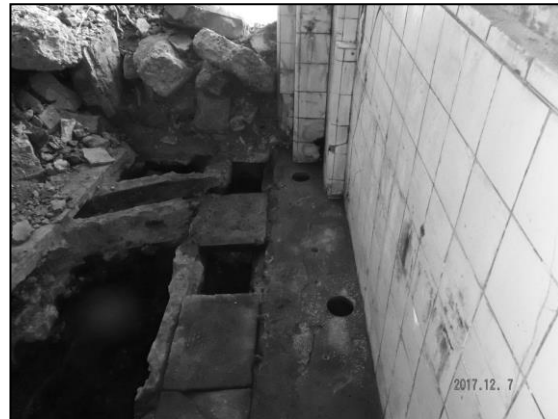
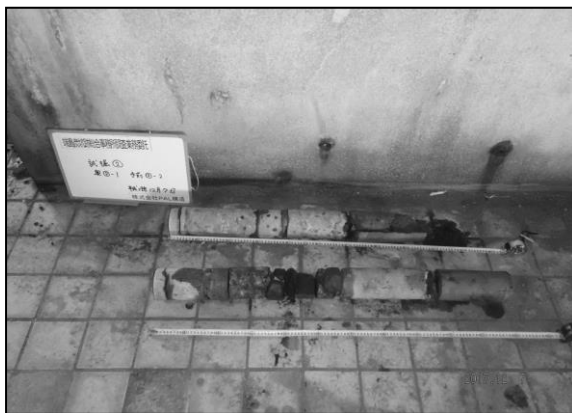
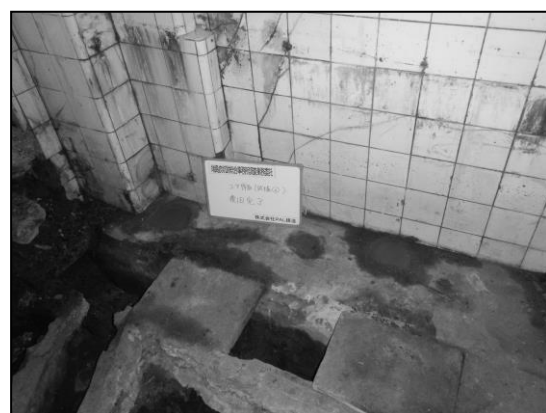
Photo 2-4-73. Measuring reinforcement corrosion degree

In this survey, a thin concrete foundation with a thickness of approximately 250 mm was observed. As a result of the core drilling and rebar exploration, however, it was confirmed that there was no underground beam there.

At both of the two core drilling sites, a layer of unreinforced concrete with a thickness of approximately 350 mm on the surface, and foundation stones were observed at about 600 mm below the surface. Considering that the concrete foundation was laid on the foundation stones and that no rebar had been found as a result of rebar exploration, it can be surmised that the foundation on the side of the brick walls was an unreinforced, eccentric foundation.

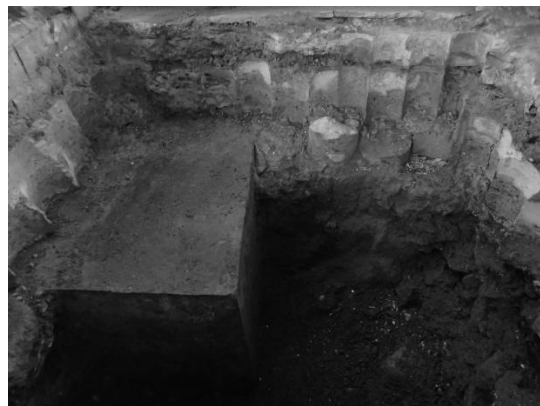
Photo 2-4-83. Exploratory Drilling Site ①, foundation

Prior to manual drilling, a layer of concrete with a thickness of approximately 35 cm was removed from the floor, to reveal a concrete structure that was presumed to be the foundation (Photos 2-4-84 and -85). When the areas around the foundation were drilled out, the undersurface was observed at 40 cm deep. The depth from the floor level to the undersurface of the foundation was 75 cm. At Exploratory Drilling Site ①, the existence of a concrete structure that was presumed to be a foundation of the building was confirmed. No deterioration or subsidence was observed with the foundation.

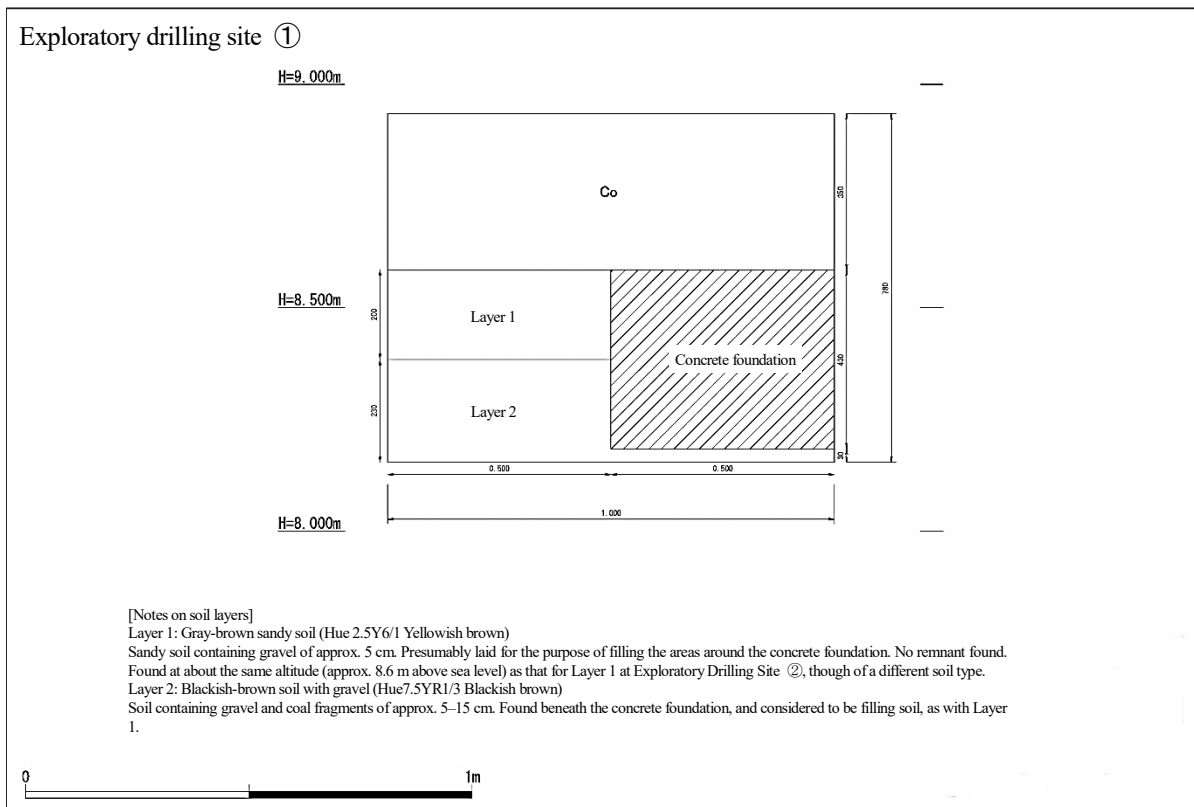
A close inspection of the soil layers at Exploratory Drilling Site ① found a 35-cm concrete layer, laid over Layers 1 and 2 which are considered to have been filling soil layers (Table 2-4-45; Photo 2-4-82; Figure 2-4-47). No remnants were observed in either Layer 1 or 2. What is noteworthy is that the beginning of the sediment of filling soil layers (Level 1) was at nearly the same altitude (approx. 8.6 m above sea level) for both Exploratory Drilling Sites ① and ②. These sediment formations, combined with the fact the thickness of the concrete layer was approximately the same, appear to indicate that Exploratory Drilling Sites ① and ② were built in the same

Figure 2-4-47. Exploratory Drilling Site ①, diagram of soil layers in Northern wall

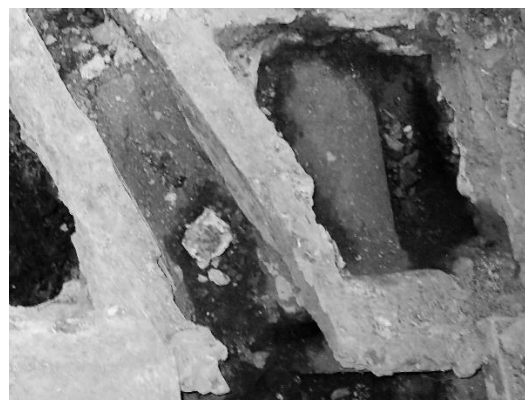
Underneath the concrete floor slab was a layer of crushed stones, and together they were approximately 25 cm thick. The level below the concrete floor slab was Layer 1, which consisted of filling soil. Beneath this was a layer of a traditional earth mixture, presumably Amakawa. On the eastern side, an iron pipe with a diameter of approximately 23 cm was found at 20 cm below the ground level (Photos 2-4-89 and -90). The iron pipe was laid so that it ran through Gutter 2 and Gutter 1 (Photo 2-4-90). As the iron pipe and Gutter 2 both led towards the bathtub, it can be surmised that they were used to drain water in the bathtub. As for in what order the gutter and the pipe were built, it was either “the iron pipe was laid first, then the gutter was installed so that it overlapped the pipe,” or “the gutter and the pipe were laid at the same time,” considering it is difficult to lay an iron pipe through a concrete gutter. Whatever the case may have been, it would be difficult to create such a formation as this using a standardized gutter, it is likely that Gutters 1 and 2 were formed on site. The thickness of the bottom was approximately 7 cm. Meanwhile, a soil pipe with a diameter of approximately 10 cm was observed from directly above Layer 2 on the eastern side. While it ran in the opposite direction from Gutters 1 and 2, it is possible that it may also have been used for bathtub drain (Photo 2-4-90).

Photo 2-4-90. Close-up (iron pipe)

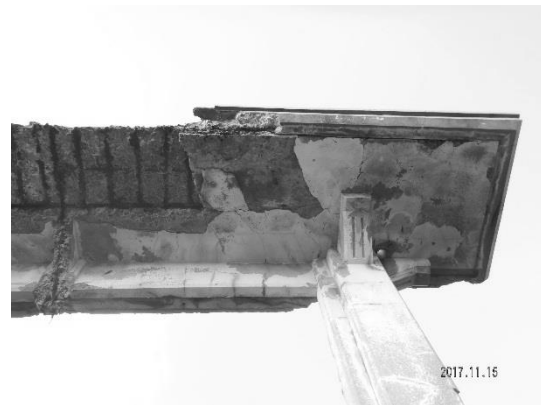
The eaves of Level 2 were in general rife with greater degrees of concrete cracks, explosion, falling-off, and corrosion. As seen in the eaves on base lines C and 2 intersection (Photo 2-4-102), the north-facing sides of the columns generally suffered a loss of cross-sectional area due to explosion, and in some parts, corrosion and a loss of cross-sectional area of reinforcement were observed and the column had entirely disappeared. The eaves themselves had also suffered explosion in some parts of the back side as seen in (Photo 2-4-103). The causes, again, are presumed to have been mortar shrinkage due to temperature changes, insufficient size of cover, and salt damage.

Photo 2-4-103. explosion; back side of eaves

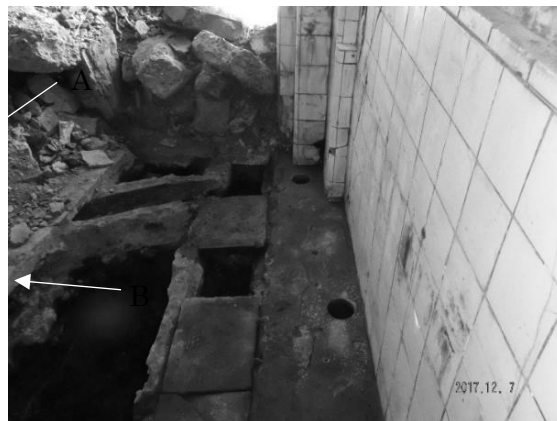
Based on these findings, it is surmised that the foundations of the building are independent, unreinforced footings. For the foundation of the columns where the building was connected to the brick walls, it is presumed that the footings were laid on top of the foundations of the brick walls, which had already existed and were left as is. There was no footing beams found, as a result of core boring and rebar exploration.

Photo 2-4-104. Core boring site; on base lines A and 3 intersection

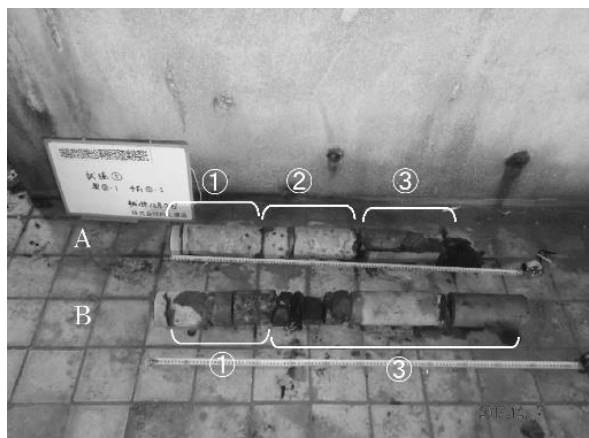
- ① Floor slab 350 mm
- ② Footing
- ③ Foundations of brick walls

Photo 2-4-105. Cross-section view of drilled cores

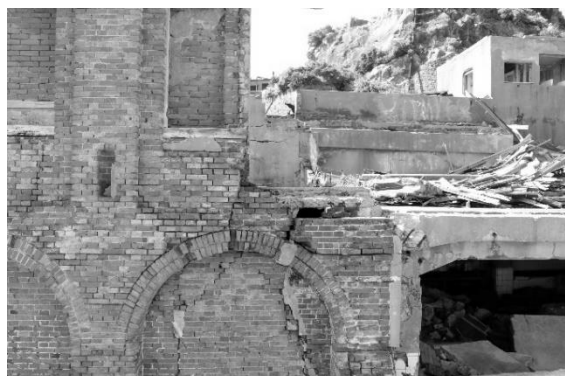
Considering the land subsidence observed on the eastern side of the brick walls, a slip were placed for the purpose of checking the altitude at the front of the brick walls, so that the data should serve as a reference for any change in the amount of subsidence over time.

Photo 2-4-110. Eastern side of brick walls
