PROGRESS STATUS OF PROJECT PROPOSALS CONCERNING THE IMPERIAL STEEL WORKS AND ONGA RIVER PUMPING STATION

PROJECT PROPOSALS FOR THE IMPERIAL STEEL WORKS AND ONGA RIVER PUMPING STATION, COMPONENT PARTS OF THE “SITES OF JAPAN’S MEIJI INDUSTRIAL REVOLUTION: IRON AND STEEL, SHIPBUILDING, AND COAL MINING”

3.1.1. First Head Office (from report by Nippon Steel Corporation)

3.1.2. Former Forge Shop and Repair Shop (from report by Nippon Steel Corporation)

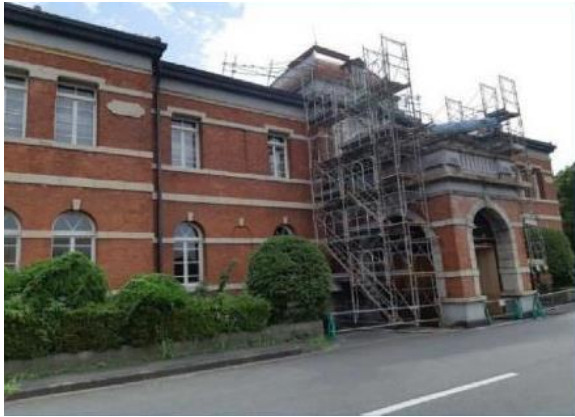
Entrance

Completion status of interior conservation work on east side of ground floor in First Head Office (as of August 30, 2019)
