## Monitoring charts for the “Sites of Japan’s Meiji Industrial Revolution: Iron and Steel, Shipbuilding and Coal Mining”

Appendix e)-2 Monitoring charts consisting of general and individual charts for Shuseikan (Component Part 2-1/Area 2),  
the Terayama Charcoal Kiln (Component Part 2-2/Area 2),  
and the Sekiyoshi Sluice Gate of Yoshino Leat (Component Part 2-3/Area 2)

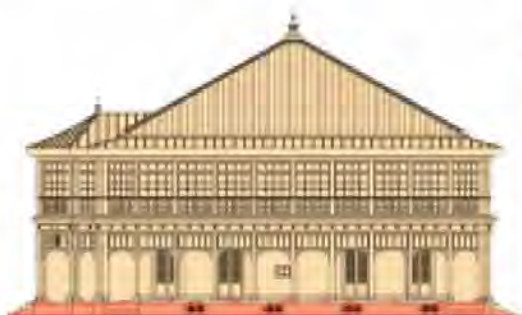
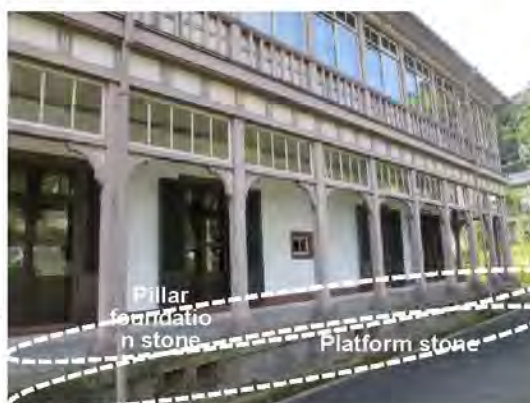
Floor No.	1st floor	Part 1	Exterior side (North side)	Part 2	Foundation
Materials	State/Remarks			Points to keep in mind (points to pass along in particular, etc.)	
Foundation stone	Good				Check stone for cracks, break away parts, damage, etc.
Pillar foundation stone	Good				Check stone for cracks, break away parts, damage, and termite damage
[Diagram, photos, etc.]

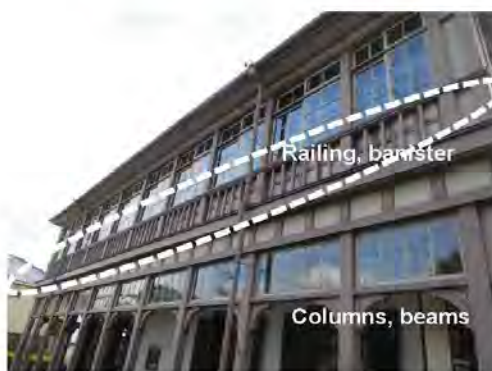
Floor No.	1st and 2nd floors	Part 1	Exterior side (North side)	Part 2	Columns, beams
Materials	State/Remarks		Points to keep in mind (points to pass along in particular, etc.)		
Wooden columns, beams	Overall fading, some paint peeling; vertical fissures can be seen on one column		Check for peeling paint, cracks, fading, corrosion, termite damage, etc.		
Railing, banister	Overall fading, some paint peeling		Check for peeling paint, cracks, fading, corrosion, etc.

Date of record 2016/12/15 Position of damage (location) 1st floor column portion

Special remarks (measures to be taken) There is deterioration of the paint on the columns, beams, railings and banisters due to UV light, and along with fading, there is some peeling. We will continue to observe the impact on the base wood materials and will paint it at the appropriate time. In addition, cracks can be seen on a column. We do not believe that this requires immediate repair, so we will monitor the progress and will fix it appropriately in response to the situation.

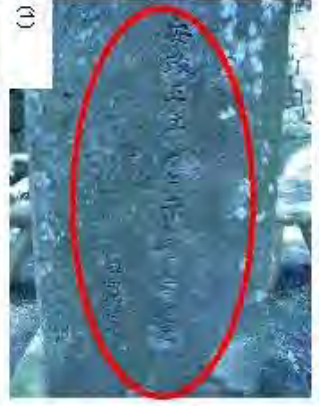
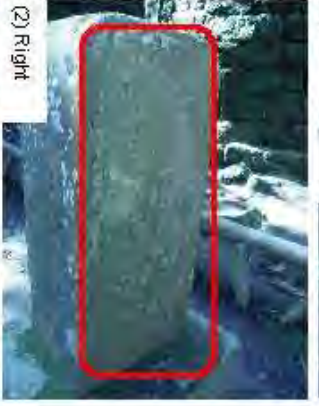
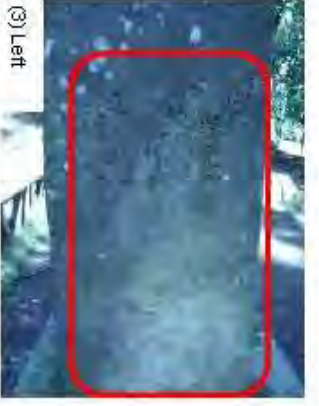
Part	(1) Front, (2) Right side, (3) Left side
Date of record	February 15, 2017
Position of damage (location)	None in particular

Special remarks (measures to be taken)	Currently there is no deterioration or damage, but we will be careful to ensure that there is no weathering of the surface that could render writing illegible.
History of repairs, etc.

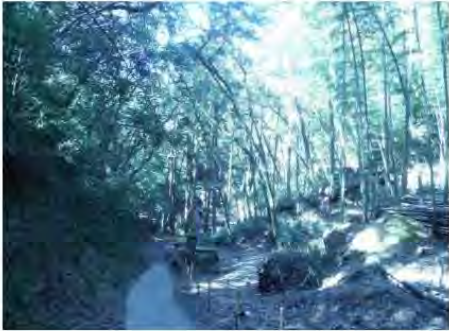
<p>Photo (Scenic view 3)</p>	
Changes in scenic view	
No notable change.	
Handling of guidance, beautification, etc.	
—

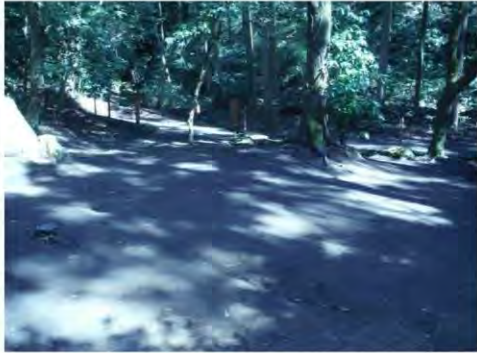
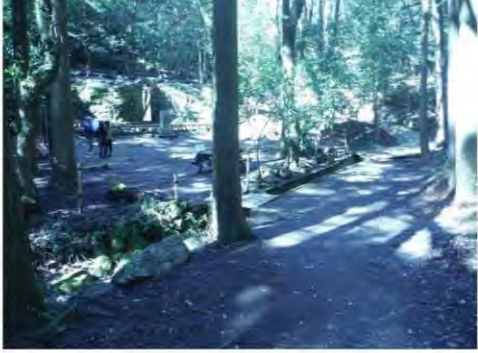
Photo (Scenic view 7)	Photo (Scenic view 8)
Changes in scenic view	
No notable change.	
Handling of guidance, beautification, etc.	
—

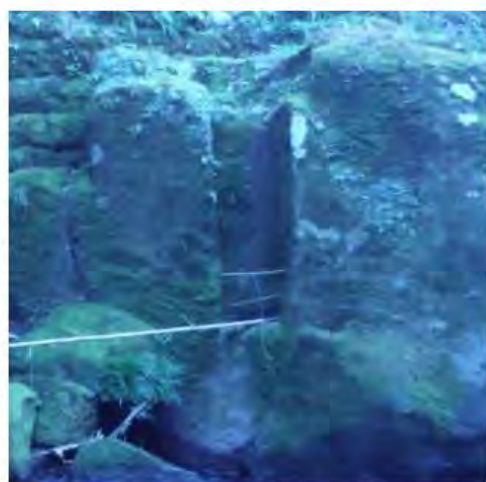
Photo (Remains A)

Part 2	State/Remarks	Points to keep in mind (points to pass along in particular, etc.)
Remains A	Good	Weathering, deterioration, damage, etc.
Remains B	Good	Weathering, deterioration, damage, etc.
Remains C	Good	Weathering, deterioration, damage, etc.
Remains D	Good	Weathering, deterioration, damage, etc.
Remains E	Good	Weathering, deterioration, damage, etc.
History of repairs, etc.	Overview of repairs

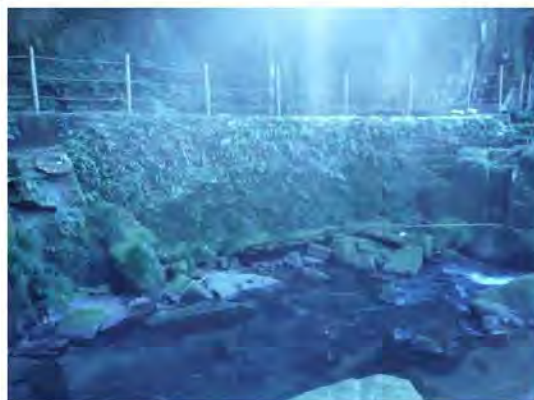
Photo (Stone wall G)

Part 2	State/Remarks	Points to keep in mind (points to pass along in particular.
Stone wall F	Good	Weathering, deterioration, damage, etc.
Stone wall G	Some part of lower area of stone wall has been scoured out	Weathering, deterioration, damage, etc.
History of repairs, etc.	Overview of repairs

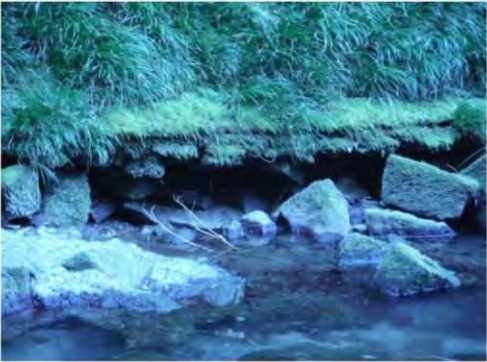
Photo (close-up of lower portion of stone wall G)
