II. The Damage and Accident Responses at the Fukushima Dai-ichi NPS and the Fukushima Dai-ni NPS

1. The Damage at the Major Systems and Facilities of Units 1 to 3 of the Fukushima Dai-ichi NPS

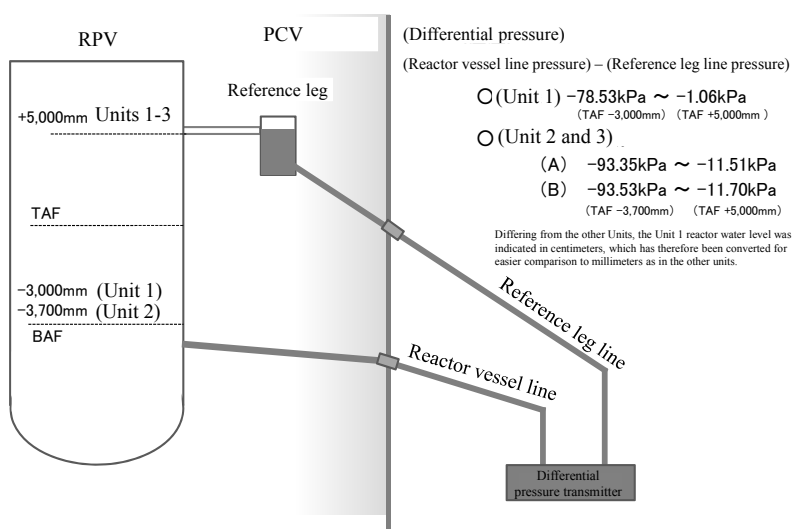
Fig. II-1-7 Differential pressure of the reactor pressure indicator (fuel range)

In terms of the reactor water level indicator (fuel range) actually used in the field responses at Unit 1, the reactor vessel line pressure less the reference leg line pressure ranges from -78.53kPa to -1.06kPa. Converting this range of differential pressure into the reactor water level (fuel range), it is equivalent to the range in water level from TAF-3,000mm to TAF+5,000mm⁴. This is the measurement range of this reactor water level indicator (see Figure II-1-7).

¹⁰ As noted in b (b) (ii), the reactor water level indicator (fuel range) has the measureable range in the differential pressure transmitter of about 80kPa, which is the difference between the upper and lower limits, and converts the differential pressure in this range into reactor water levels.
