**World Cultural Heritage “Sites of Japan’s Meiji Industrial Revolution: Iron and Steel,  
Shipbuilding, and Coal Mining” (No. 1484)**

**Heritage Impact Assessment Report for the Post-Disaster Recovery and Repair Project at  
the Terayama Charcoal Kiln in Area 2 Kagoshima (Component Part 2-2)**

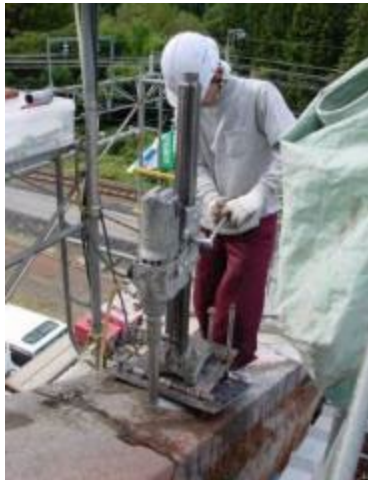
Drill a reinforcing bar insertion hole (42  $\phi$ , 3.8–7.0 m)

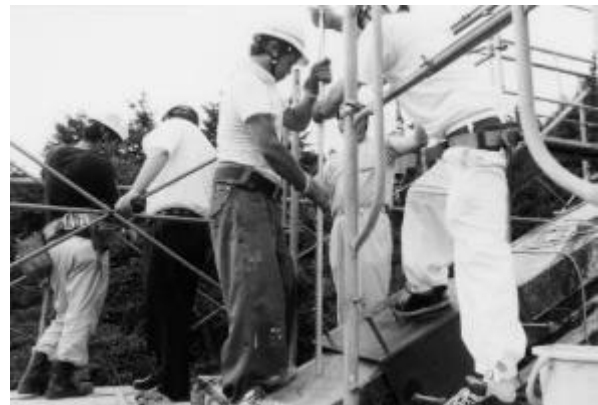
Insert a reinforcing bar (brick width: 333 mm, 1-D22)

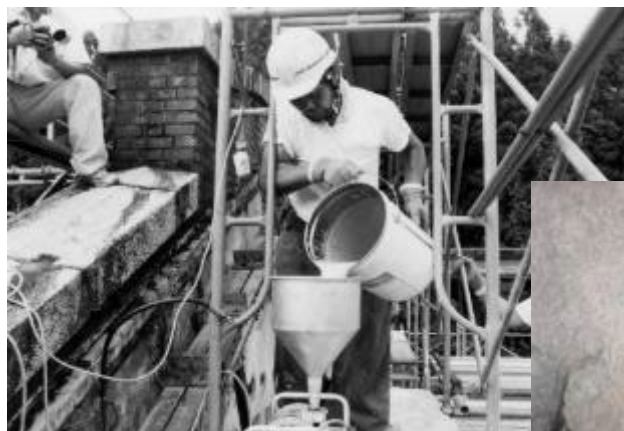
Pour cement slurry

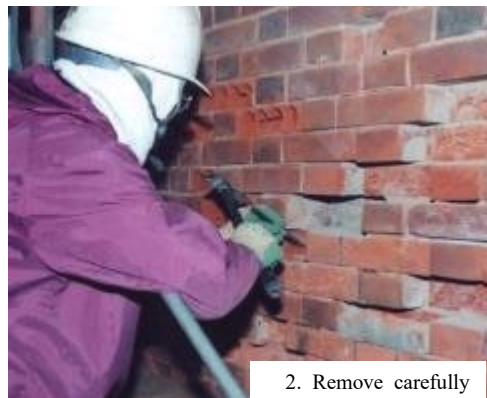
2. Remove carefully

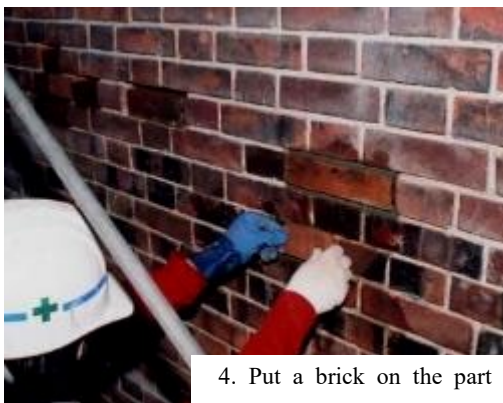
4. Put a brick on the part

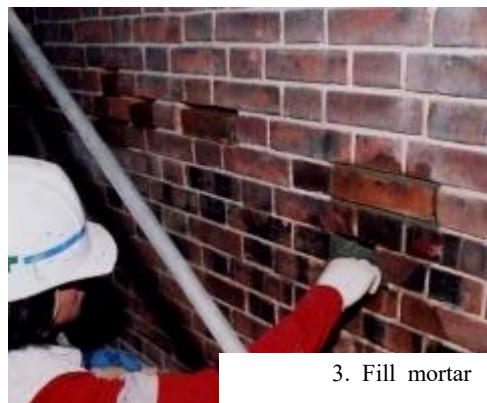
3. Fill mortar
