Photographs showing damage to the Unit 1 reactor building

Damage to the emergency diesel generators (DGs), metal clad switchgear (M/C) and power centers (P/Cs)

Photographs showing damage to facilities required for the supply of external power

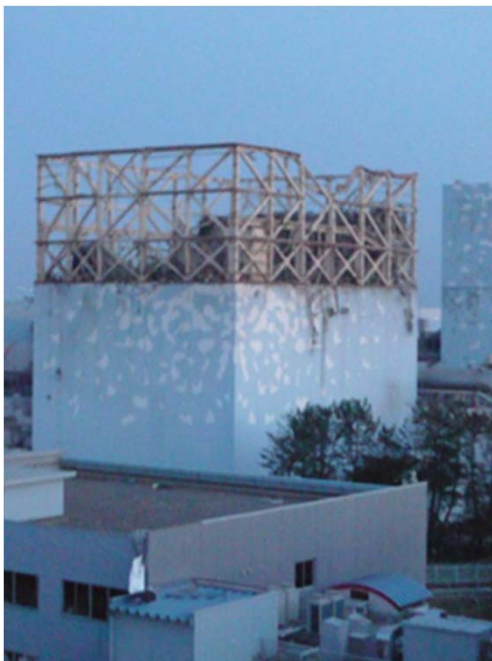
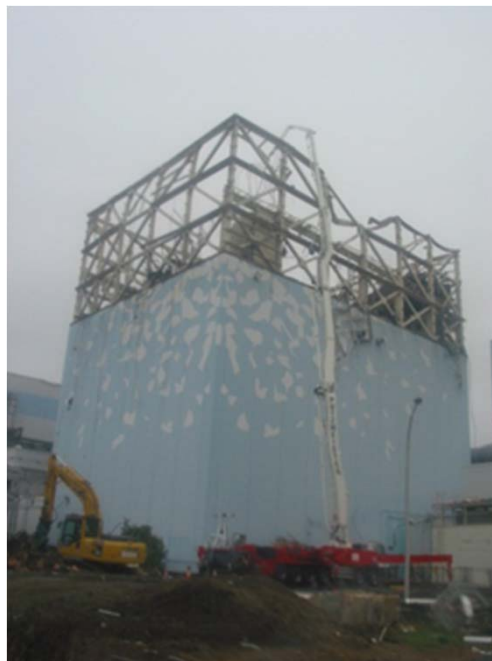
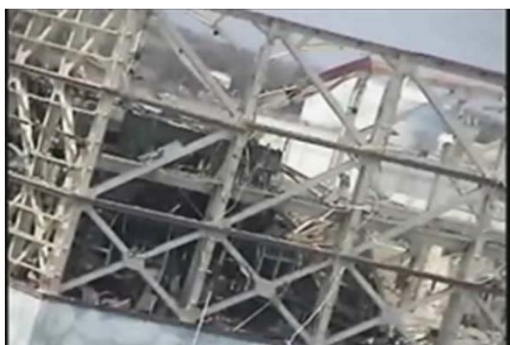
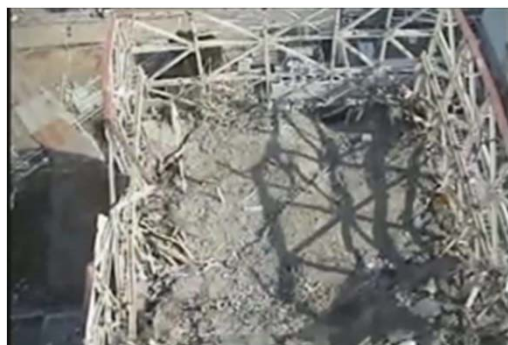
Photographs showing damage to the Unit 1 reactor building

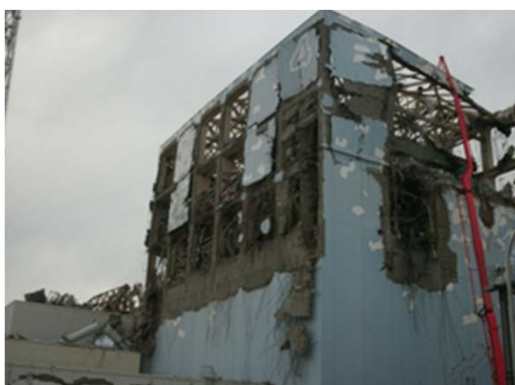
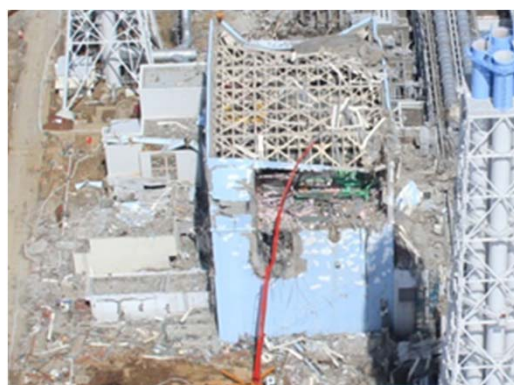
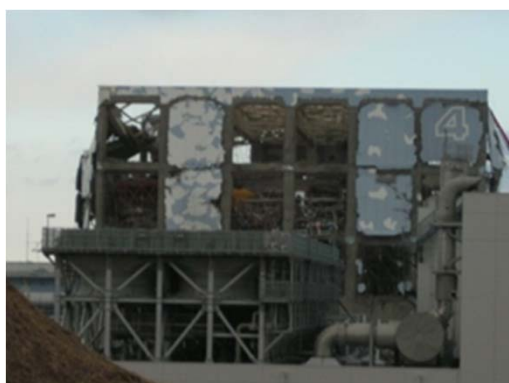
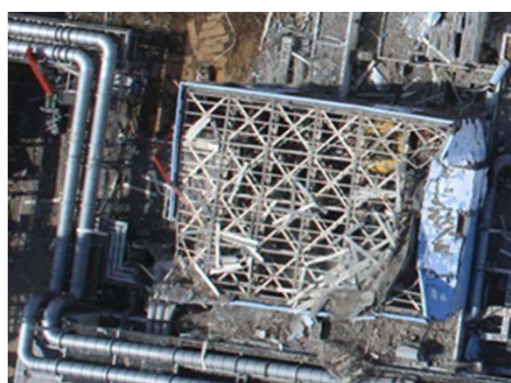
Photographs showing damage to the Unit 4 reactor building

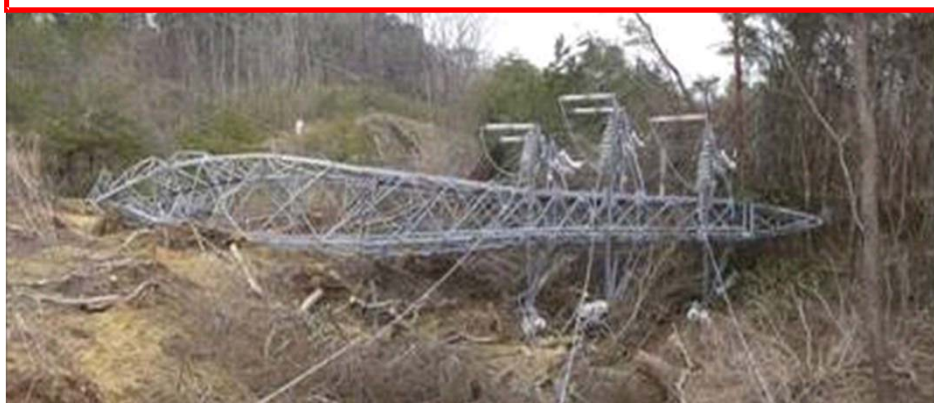
Collapse of the pylon (Viewpoint (ii))

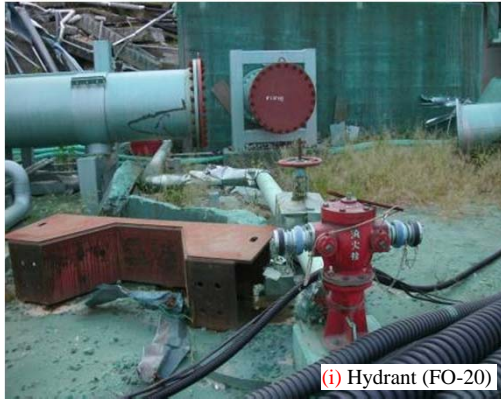
(i) Hydrant (FO-20)
August 24, 2011 Photographed by Tokyo Electric Power Company

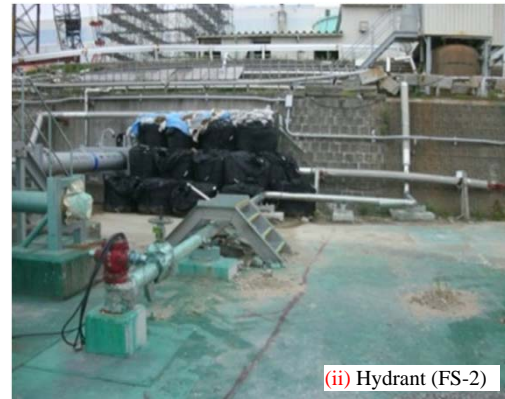
(ii) Hydrant (FS-2)
August 24, 2011 Photographed by Tokyo Electric Power Company

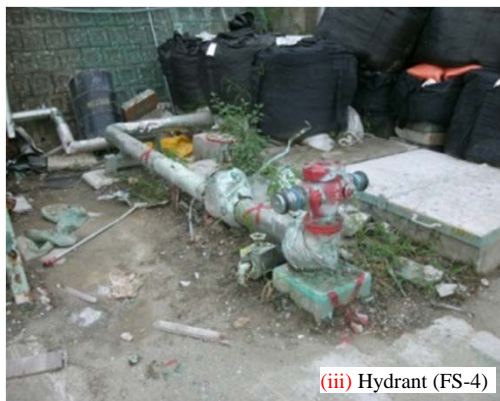
(iii) Hydrant (FS-4)
August 24, 2011 Photographed by Tokyo Electric Power Company

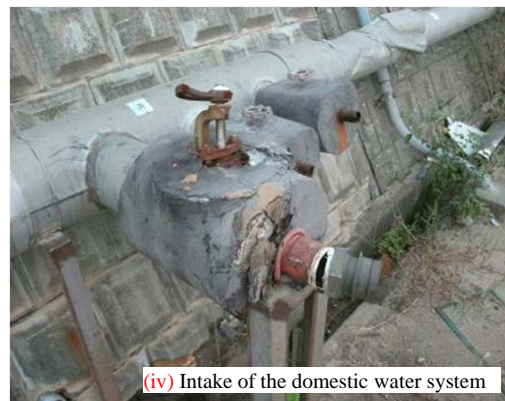
(iv) Intake of the domestic water system
August 24, 2011 Photographed by Tokyo Electric Power Company

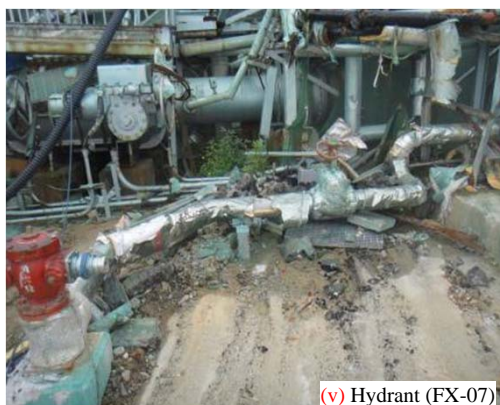
(v) Hydrant (FX-07)
August 24, 2011 Photographed by Tokyo Electric Power Company

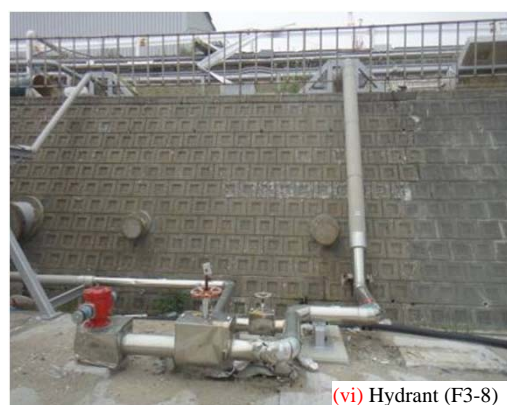
(vi) Hydrant (F3-8)
August 24, 2011 Photographed by Tokyo Electric Power Company

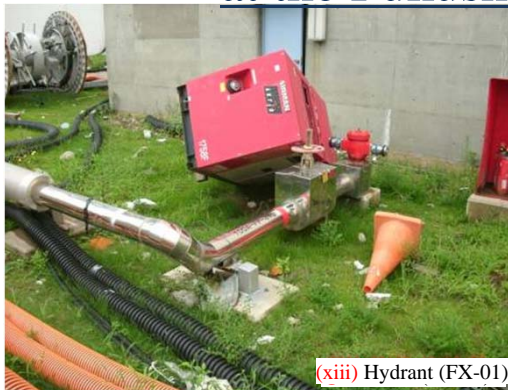
(xiii) Hydrant (FX-01)
August 25, 2011 Photographed by Tokyo Electric Power Company

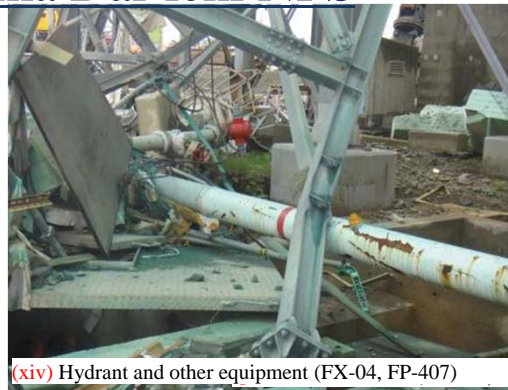
(xiv) Hydrant and other equipment (FX-04, FP-407)
August 25, 2011 Photographed by Tokyo Electric Power Company

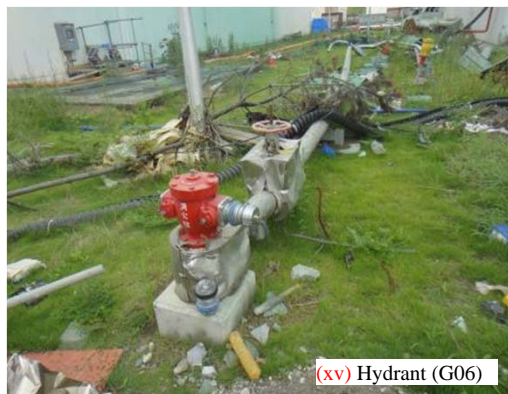
(xv) Hydrant (G06)
August 25, 2011 Photographed by Tokyo Electric Power Company

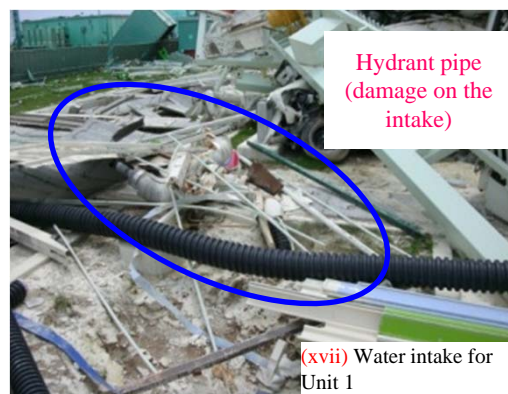
(xvii) Water intake for Unit 1
July 4, 2011 Photographed by Tokyo Electric Power Company
